Lightning Strikes Twice at Rapidan Dam

JIM HERBERT, P.E., VICE PRESIDENT/SENIOR CIVIL ENGINEER, BARR ENGINEERING CO.; AND JOE HJERPE, P.E., SENIOR CIVIL ENGINEER, BARR ENGINEERING CO.; TOM MACDONALD, VICE PRESIDENT/SENIOR WATER RESOURCES ENGINEER, BARR ENGINEERING CO. RYAN THILGES, P.E., COUNTY ENGINEER/PUBLIC WORKS DIRECTOR, BLUE EARTH COUNTY

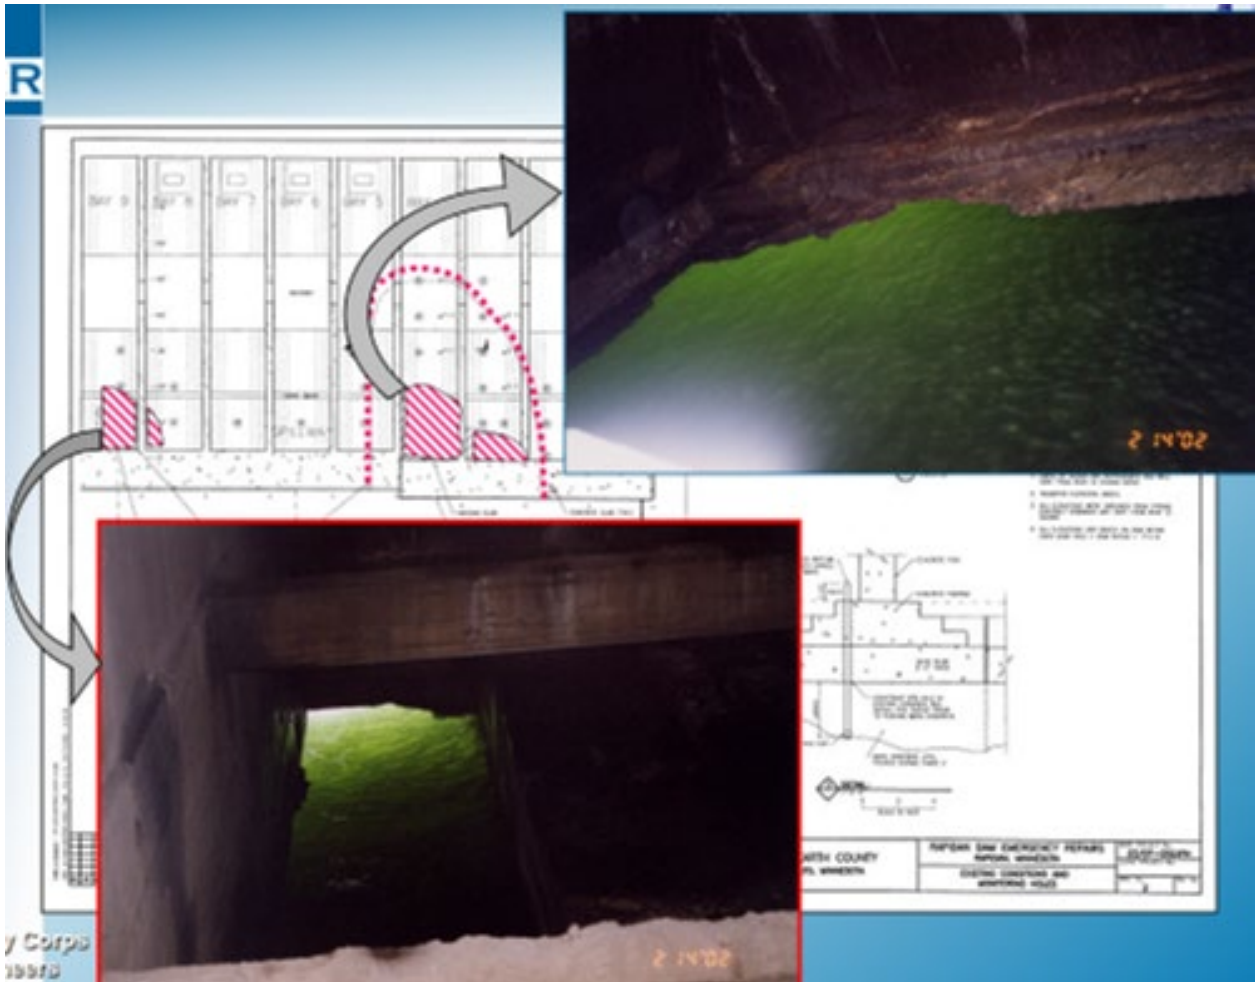
Have you ever inspected a dam and wanted to make a quick exit? This was the case for Barr Engineering Co. (Barr) engineers in February 2002, when an inspection of the Rapidan Dam revealed severe structural issues, including a large scour hole under the dam's buttresses measuring more than 18 ft. deep and extending more than 30 ft. upstream of the dam's toe (Figure 3). Intense spring flow conditions led to the failure of the downstream apron, causing erosion of the underlying soft sandstone bedrock and compromising the structural integrity of the dam. This discovery indicated that the dam was on the brink of failure, with its buttresses cantilevered over open water instead of resting on bedrock. Immediate action was necessary to prevent a catastrophic collapse, especially with spring rains approaching. The inspection was limited due to safety concerns, but stability analyses confirmed the dam's precarious state.

Figure 3 Voids in concrete base that should be founded on bedrock (Photo Credit: Barr Engineering Co.)

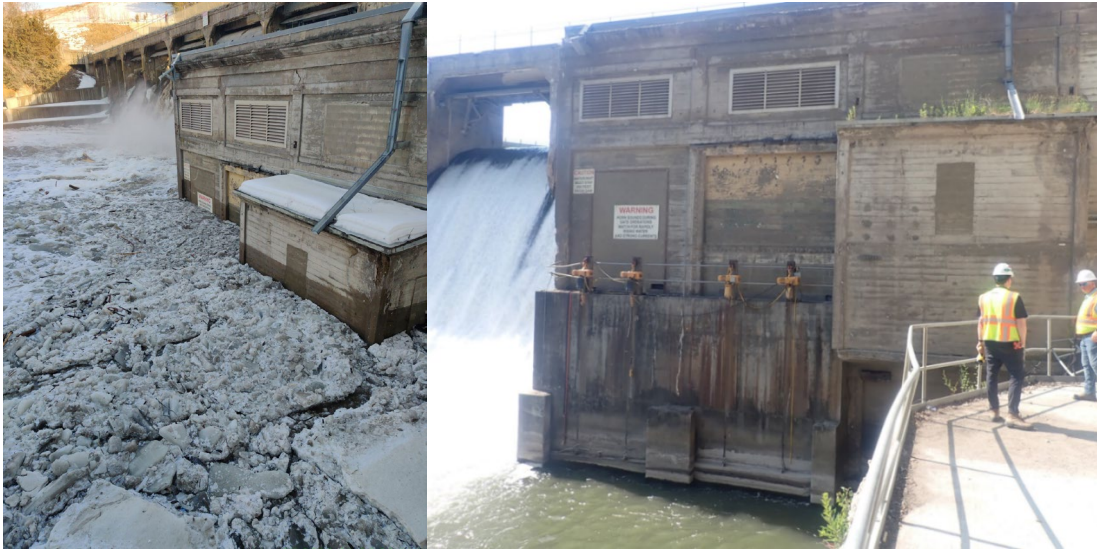
Spring flooding in 2019 damaged the downstream apron, the Tainter gates, and the powerhouse, and power generation was halted. The damaged Tainter gates were not operational and were placed in the fully open position. In the winter of 2019-2020, a large ice jam downstream of the dam caused the tailwater to rise and flood the powerhouse up to 14.7 ft. above the operating floor, damaging the turbines and their electrical controls (Figure 4). The dam has not produced power since 2019. The County was in the process of surrendering its FERC exemption when the 2024 breach occurred.

Figure 4 Comparison: Downstream ice buildup (left), January 18, 2020 (note white signs on powerhouse for scale of ice dam height) vs. normal tail water (right) [Photo Credit: Blue Earth County (left), Barr Engineering Co. (right)]

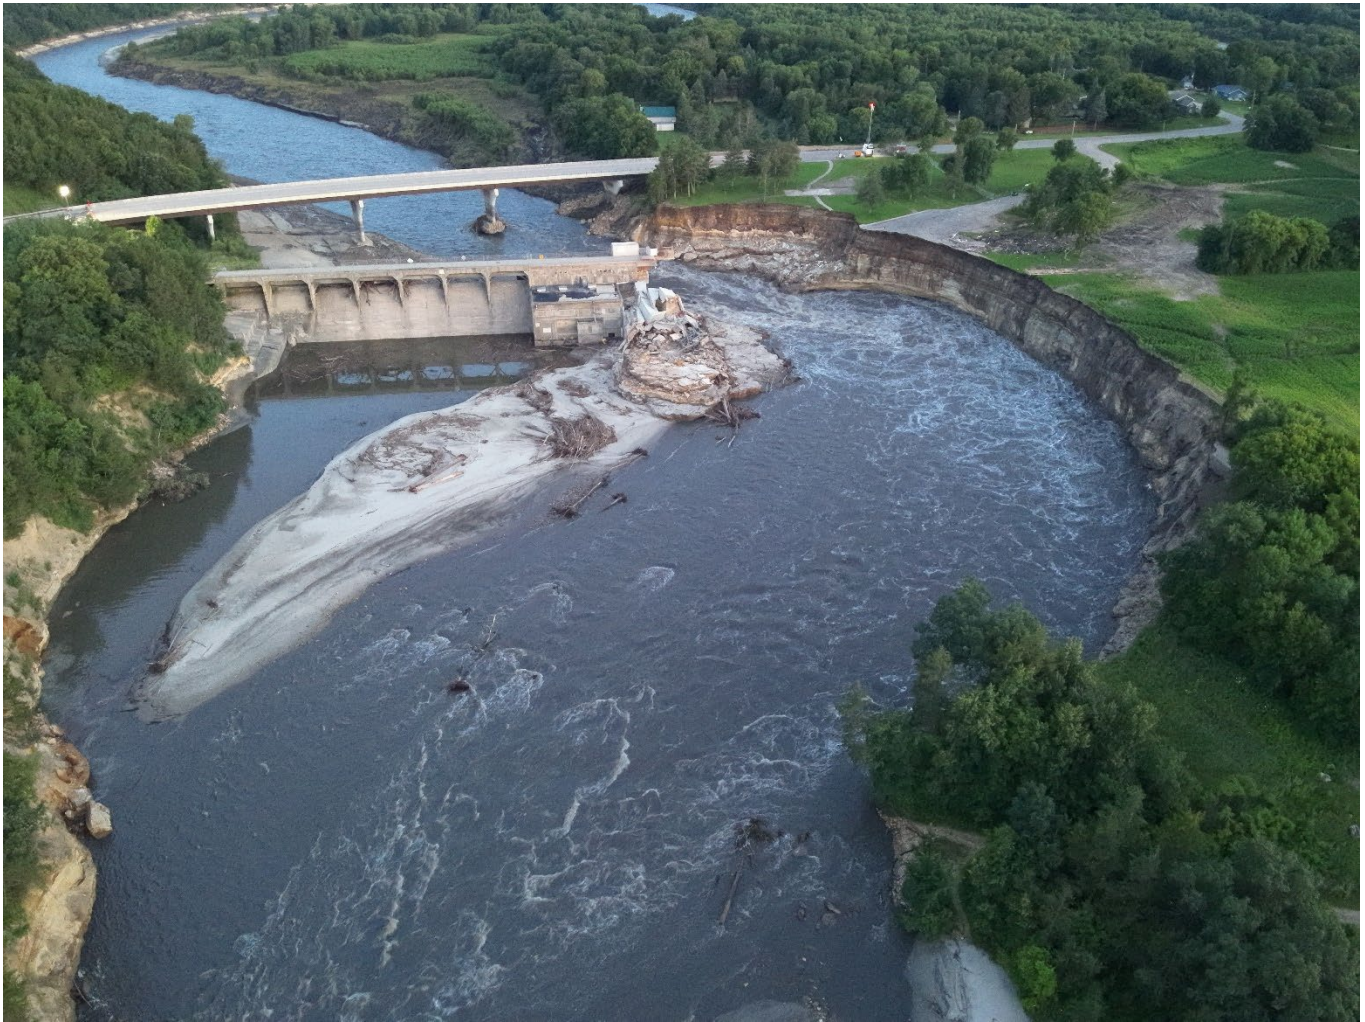
Despite emergency repair efforts in 2002 and subsequent projects, the Rapidan Dam encountered another significant challenge in June 2024 due to severe flooding (Figure 5). Historic rainfall caused the Blue Earth River to swell, and debris accumulation at the gates led to water surging over the dam, leading to a complete failure of its west abutment. This failure resulted in riverbank erosion, the collapse of a nearby home, damage to the dam and powerhouse, and the destruction of an Xcel Energy substation, causing outages for approximately 600 households.

Figure 5 Rapidan Dam west abutment breached following June 2024 historic rain (Photo Credit: Blue Earth County Sheriff's Office)

The failure of the Rapidan Dam's west abutment was primarily caused by a combination of factors. Recent bouts of heavy rain significantly increased the flow of the Blue Earth River, which collected trees, logs, and woody debris along the Blue Earth River floodplain. This debris accumulated on the front face of the dam and on the Co. Road 9 bridge piers located upstream of the dam. Anecdotally, it appears that a mass of woody debris broke free from the bridge piers, adding to the debris along the dam and partially blocking the gate bays, despite all five gates being fully open. The gate capacity was significantly reduced, causing the reservoir elevation to increase until water began flowing over the dam and west abutment area, breaching the west abutment and eroding the downstream slope. This increased water flow led to rapid erosion around the dam's abutment, undermining its structural integrity. When the west abutment failed, a portion of the sediment accumulated behind the dam was released downstream, exacerbating the erosion and impacting the channel. Figure 6 shows several dryer years and lower flows that may have contributed to an increased load of woody debris along the Blue Earth River floodplain, prior to the June 2024 event. Typically, much of the debris would have been periodically swept downstream during precipitation events throughout the year.
