# Memorandum

**To:** Mr. Paul Dunlap, California Department of Water Resources  
**From:** Oroville Dam Spillway Incident Independent Forensic Team  
**Date:** September 5, 2017  
**Re:** Interim Status Memorandum

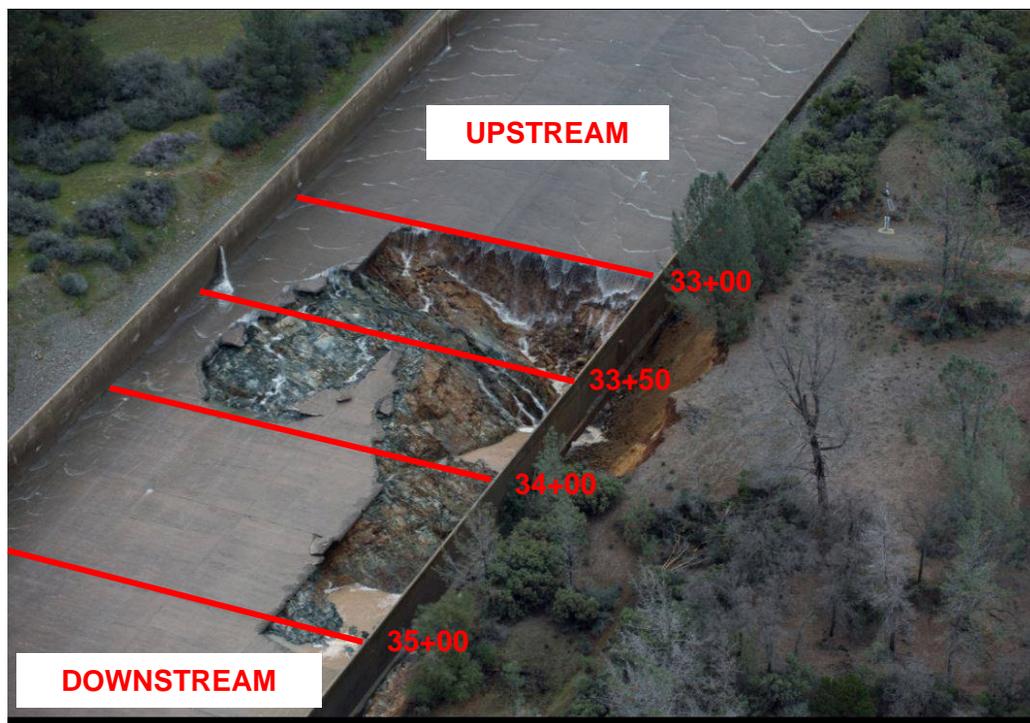
***Update on Initiating Event of Service Spillway Chute Failure*** – The IFT believes that the service spillway chute failure most likely initiated by the uplift and removal of a section of the slab in the chute downstream of Station 33+50 at shortly after 10:00 am on February 7. Once the initial section of the chute slab was removed, the underlying moderately to highly weathered rock and soil-like material beneath the slab in this location was directly exposed to high-velocity spillway flow. The high-velocity flow rapidly eroded the foundation materials at this location, removed additional chute slab sections in both upstream and downstream directions, and quickly created the erosion hole that was observed by 12:30 pm on February 7, as flows diminished following spillway gate closure – see photo below. These findings are based on eyewitness accounts, and photo and video records.

Since all physical evidence at the point where the failure initiated was destroyed, it will never be possible to confirm exactly where the initiating event occurred. Others have suggested that the uplift initiated at Station 33+00 (see photo above). However, the IFT has concluded that, although there may have been water injection along the Station 33+00 joint, that was almost certainly not the location of the initial failure. Had the failure initiated along that joint, the concrete keys at the joint would have been damaged, and this was not observed when the spillway gates were closed, and the eroded hole was inspected on February 8 by a climb team engaged by DWR. The slab section downstream of the joint at that location could not have lifted without shearing the concrete key in the upstream slab section, and this condition was not observed in the photos and videos taken by the climb team, which were carefully reviewed by the IFT.
