Lightning Strikes Twice at Rapidan Dam

JIM HERBERT, P.E., VICE PRESIDENT/SENIOR CIVIL ENGINEER, BARR ENGINEERING CO.; AND JOE HJERPE, P.E., SENIOR CIVIL ENGINEER, BARR ENGINEERING CO.; TOM MACDONALD, VICE PRESIDENT/SENIOR WATER RESOURCES ENGINEER, BARR ENGINEERING CO. RYAN THILGES, P.E., COUNTY ENGINEER/PUBLIC WORKS DIRECTOR, BLUE EARTH COUNTY

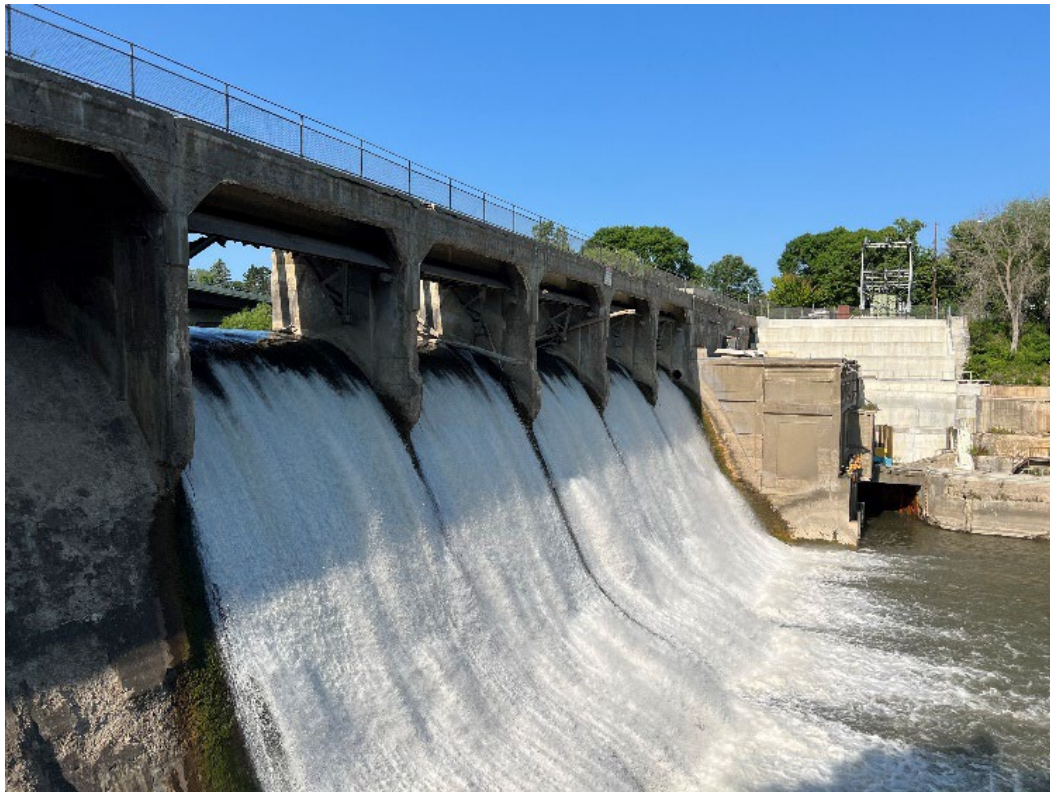
Figure 4 Rapidan Dam (Photo Credit: Barr Engineering Co.)

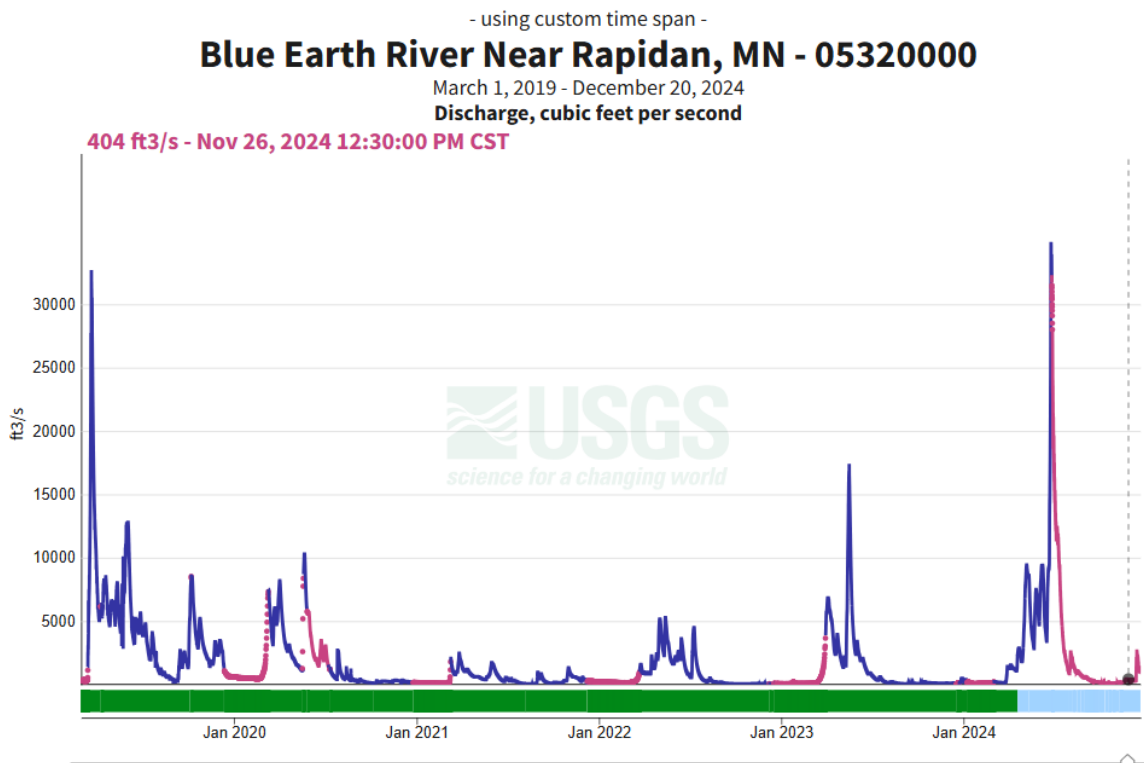
The failure of the Rapidan Dam's west abutment was primarily caused by a combination of factors. Recent bouts of heavy rain significantly increased the flow of the Blue Earth River, which collected trees, logs, and woody debris along the Blue Earth River floodplain. This debris accumulated on the front face of the dam and on the Co. Road 9 bridge piers located upstream of the dam. Anecdotally, it appears that a mass of woody debris broke free from the bridge piers, adding to the debris along the dam and partially blocking the gate bays, despite all five gates being fully open. The gate capacity was significantly reduced, causing the reservoir elevation to increase until water began flowing over the dam and west abutment area, breaching the west abutment and eroding the downstream slope. This increased water flow led to rapid erosion around the dam's abutment, undermining its structural integrity. When the west abutment failed, a portion of the sediment accumulated behind the dam was released downstream, exacerbating the erosion and impacting the channel. Figure 6 shows several dryer years and lower flows that may have contributed to an increased load of woody debris along the Blue Earth River floodplain, prior to the June 2024 event. Typically, much of the debris would have been periodically swept downstream during precipitation events throughout the year.

Figure 7 USGS Gage Data from March 2019 through December 2024
