Hidden Dangers and Public Safety at Low-head Dams

BRUCE A. TSCHANTZ, PE

KENNETH R. WRIGHT, PE

ABSTRACT

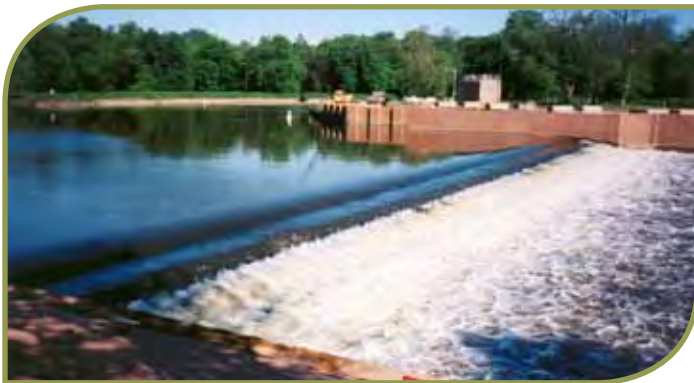
Figure 7. Island Farm Weir stepped spillway modification.

The Island Farm Weir was modified in 1998 after four drownings and three near-drownings in only three years following its construction. The successful retrofit consisted of providing a series of steps on the downstream face (Figure 7) to dissipate energy and to eliminate the opportunity for a submerged jump and reverse roller to form below the dam structure.

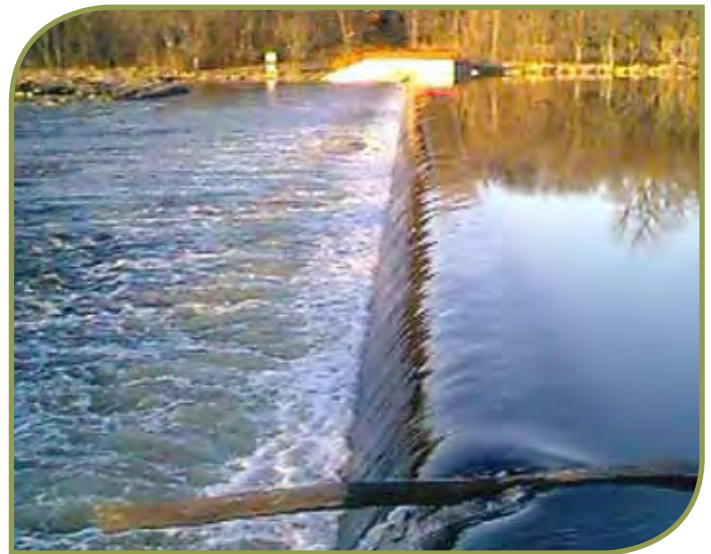
Figure 8. Yorkville Dam on the Fox River.

While accidents and drownings at low-head dams are reported regularly in the local and national media, little statistical data is available to assess the full national extent of the problem. Minnesota's Boat and Water Safety Section of the Department of Natural Resources reports 52 deaths and 50 injured or rescued people at low-head dams in that state between 1974 and 2002 (Minn., 2003). In Illinois, the Fox River has a notoriously dangerous segment of 15 dams in the 115-mile reach, just west of Chicago, between Wisconsin and its mouth at the Illinois River. At the 7-foot high Yorkville Dam (Figure 8), at least 12 people are reported to have drowned since it
