U.S. Fish & Wildlife Service Low Hazard Dams

**Standing
Operating
Procedures**

All USFWS Refuges

UNITED STATES DEPARTMENT OF THE INTERIOR
FISH & WILDLIFE SERVICE
All REGIONS

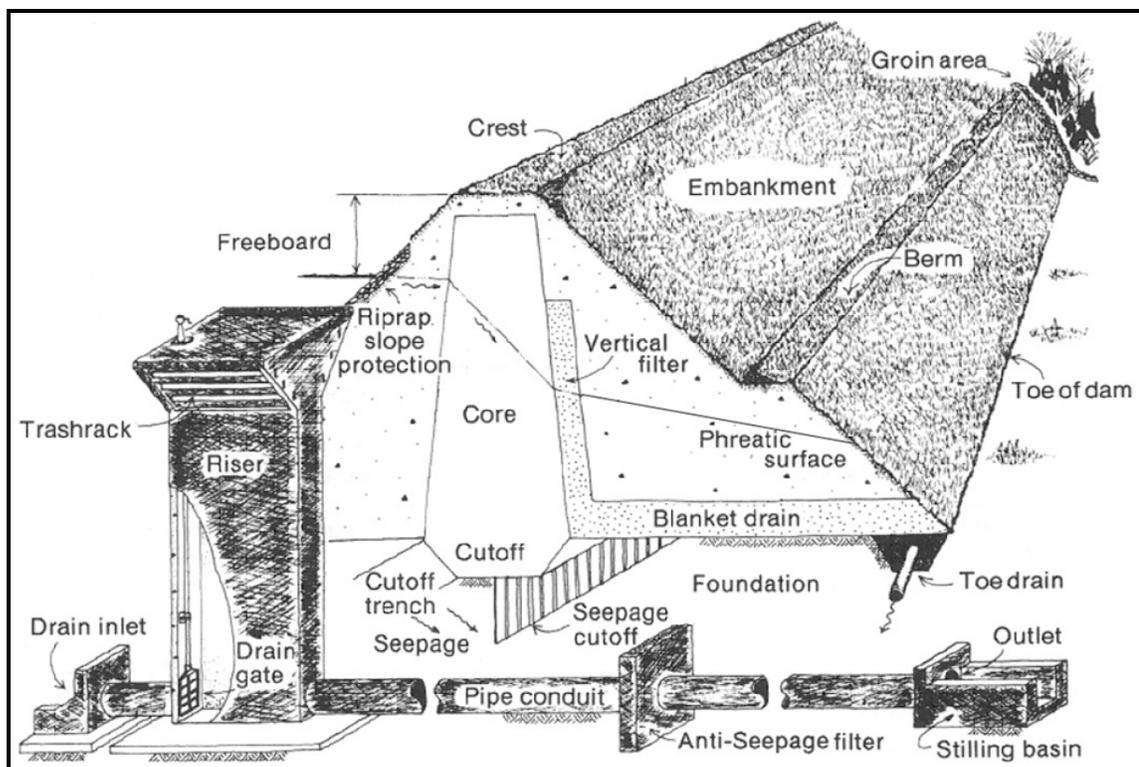
Figure 1-1: Typical Features of an Embankment Dam
(see glossary in Appendix A for term definitions)

The basic features common to most dams are illustrated in Figure 1-1, and include the dam structure, service or principal spillway(s), emergency spillway, and outlet works. A glossary of common terms used to describe dam features is provided in Appendix A. A brief discussion of basic dam features is provided below.

Most embankment dams have the general configuration shown in Figure 1-1. The upstream and downstream slopes of embankment dams are typically 2H:1V (horizontal to vertical) or flatter. Their capacity for water retention is due to the low permeability of the entire mass (in the case of a homogeneous embankment) or of a zone of low-permeability material (in the case of a zoned embankment dam).

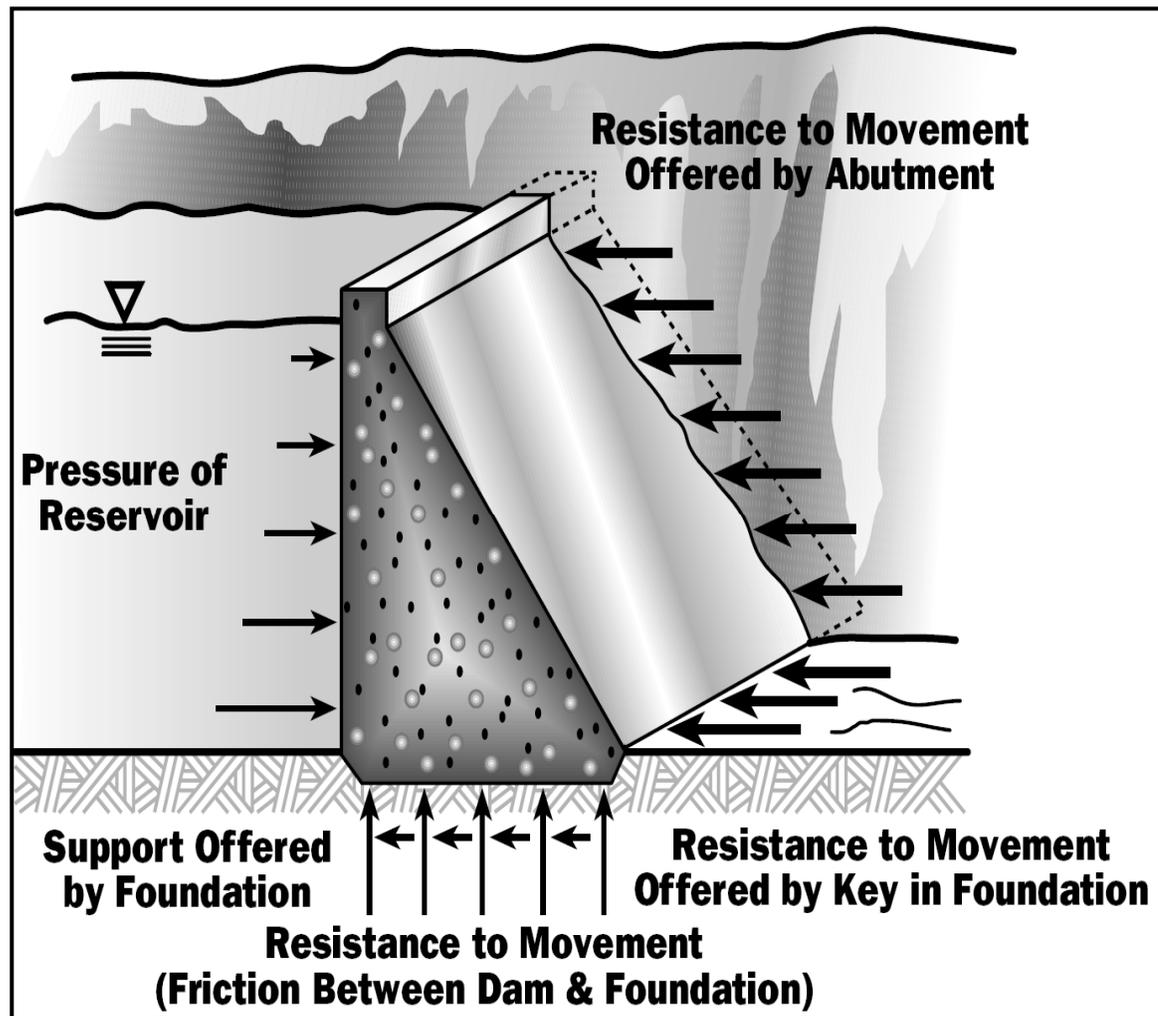
Figure 1-2: Typical Concrete Gravity Dam Section

Concrete dams may be categorized into gravity, arch and buttress dams according to the designs used to resist the stresses from the reservoir water pressure. A concrete gravity dam (shown in Figure 1-2) is the most common and relies entirely on its mass or weight for stability. A buttress dam is a specific type of concrete dam in which the destabilizing forces are transmitted to the dam foundation through a series of vertical or sloping buttress walls. Concrete arch dams are thin concrete curved or arched sections that transmit the destabilizing forces laterally into the rock abutments. Buttress and arch dams usually require significantly less concrete to build than a gravity dam.

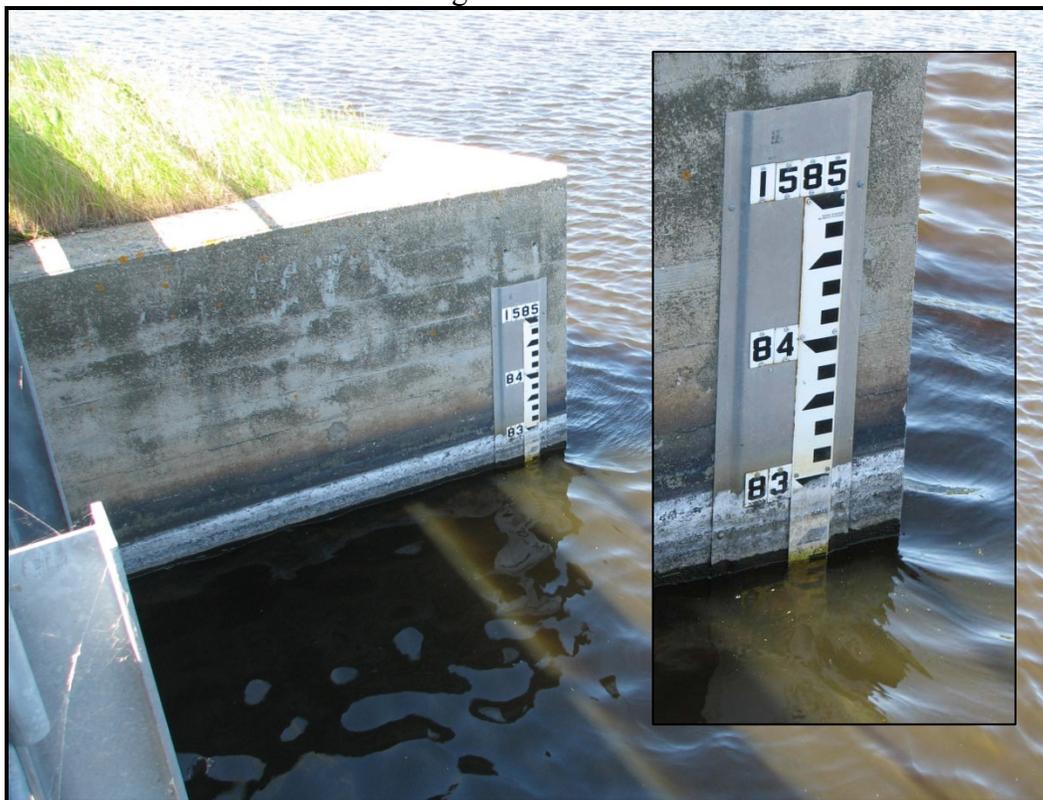
Figure 3-1: Reservoir Staff Gage

surface on the staff gage is difficult due to windy conditions, the average water surface elevation observed over several minutes should be recorded as the reservoir elevation. A note should be recorded in the comment section that the weather conditions were windy at the time of the instrument reading.

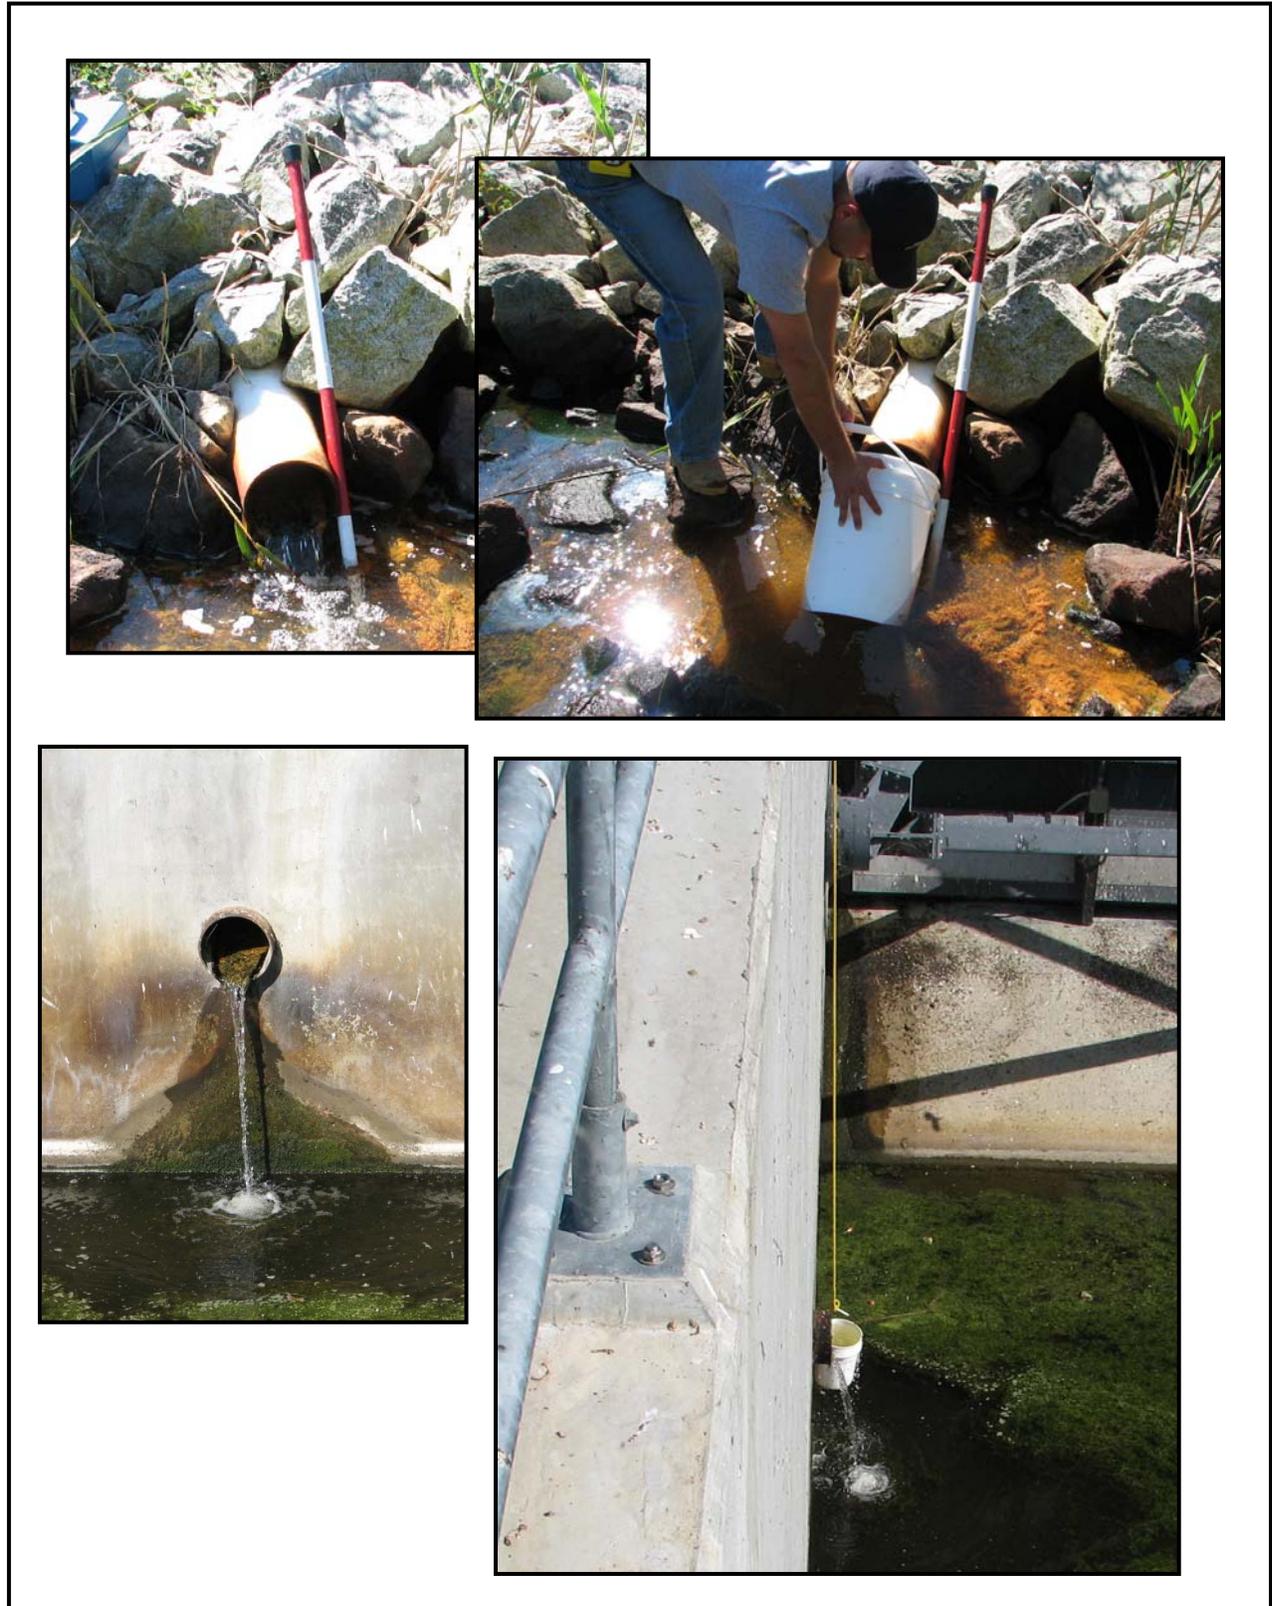
Figure 3-2: Typical Flow Measurement Techniques at Drain Outfalls

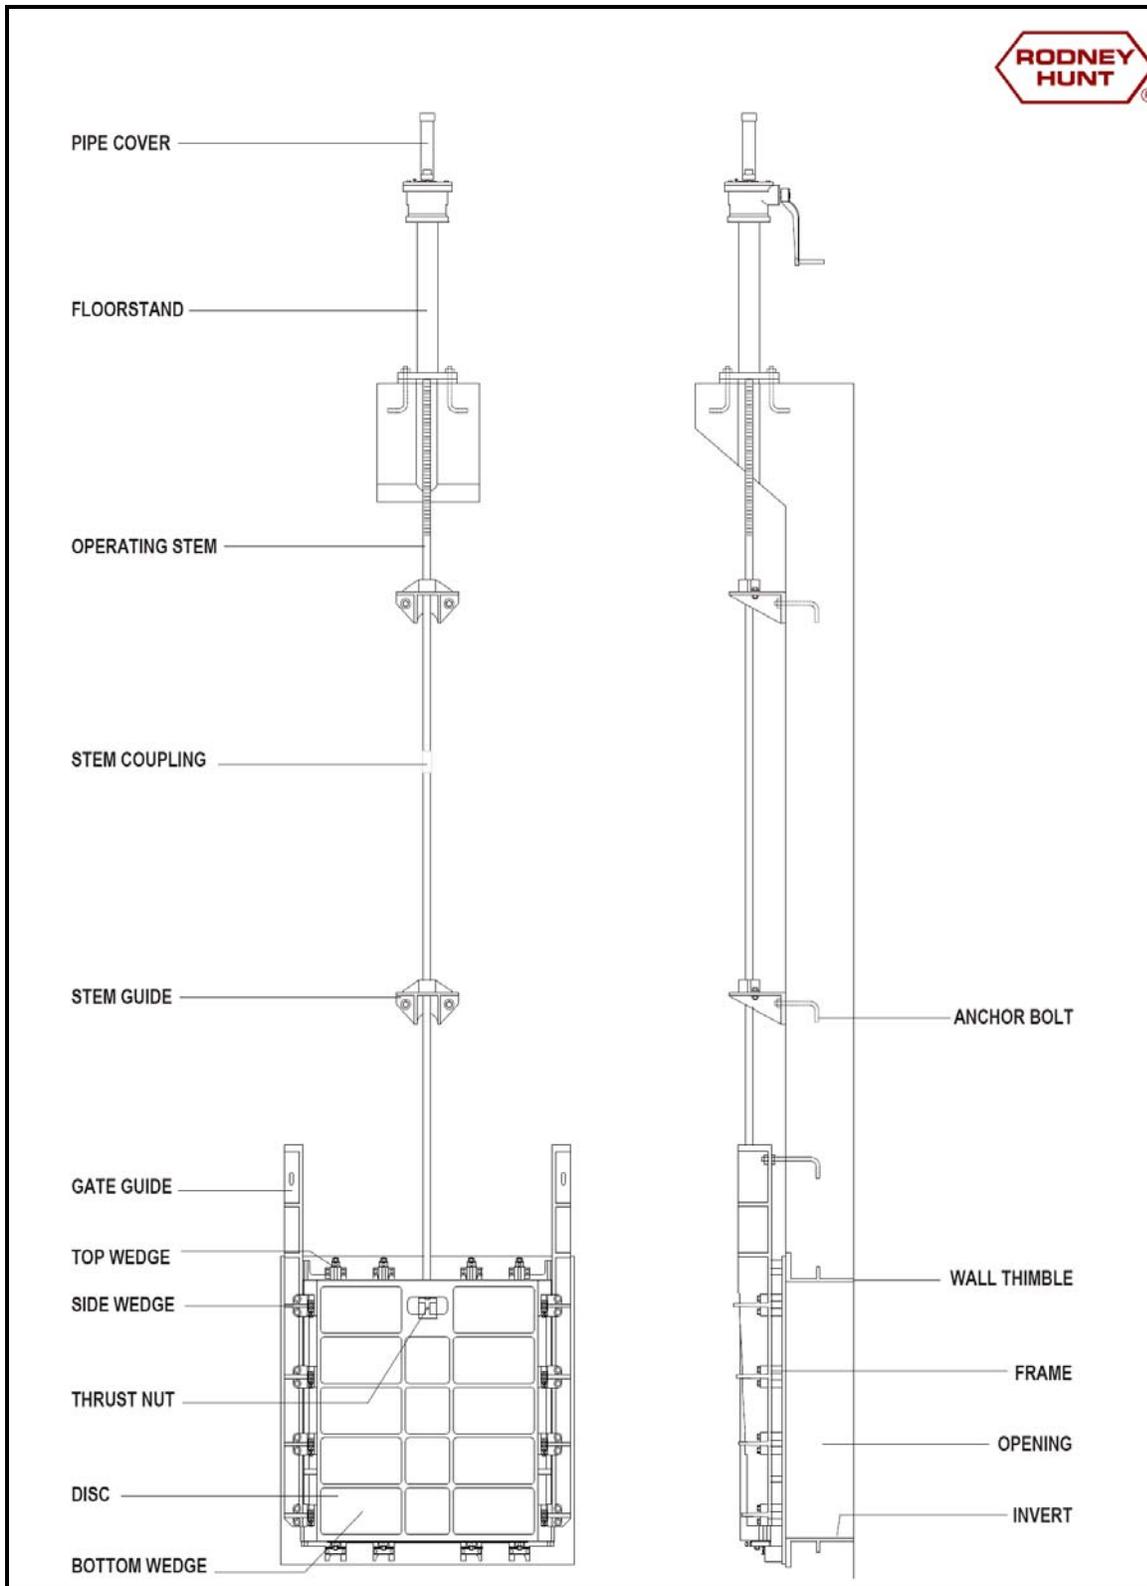
Figure 5-1: Typical Sluice Gate Configuration
 (Source: Rodney Hunt Gates and Valves)

To assure good operation and maintenance of sluice gates, all gates should be exercised and inspected for the condition of all gate components as part of the normal dam and reservoir Operations Schedule (Table 4-1). The recommended procedure to ensure the smooth operation of outlet gates is to operate all gates through their full range at least once a year and preferably more often. Some manufacturers recommend operating gates as often as four times a year. Because operating gates under full reservoir pressure can result in large outlet discharges, schedule gate testing during periods of low storage, if possible, or else operate them during periods of low stream flow. If large releases are expected, only have the outlets tested after coordinating releases with the local floodplain administrator and other dam owners located downstream and after notifying downstream residents and water users.

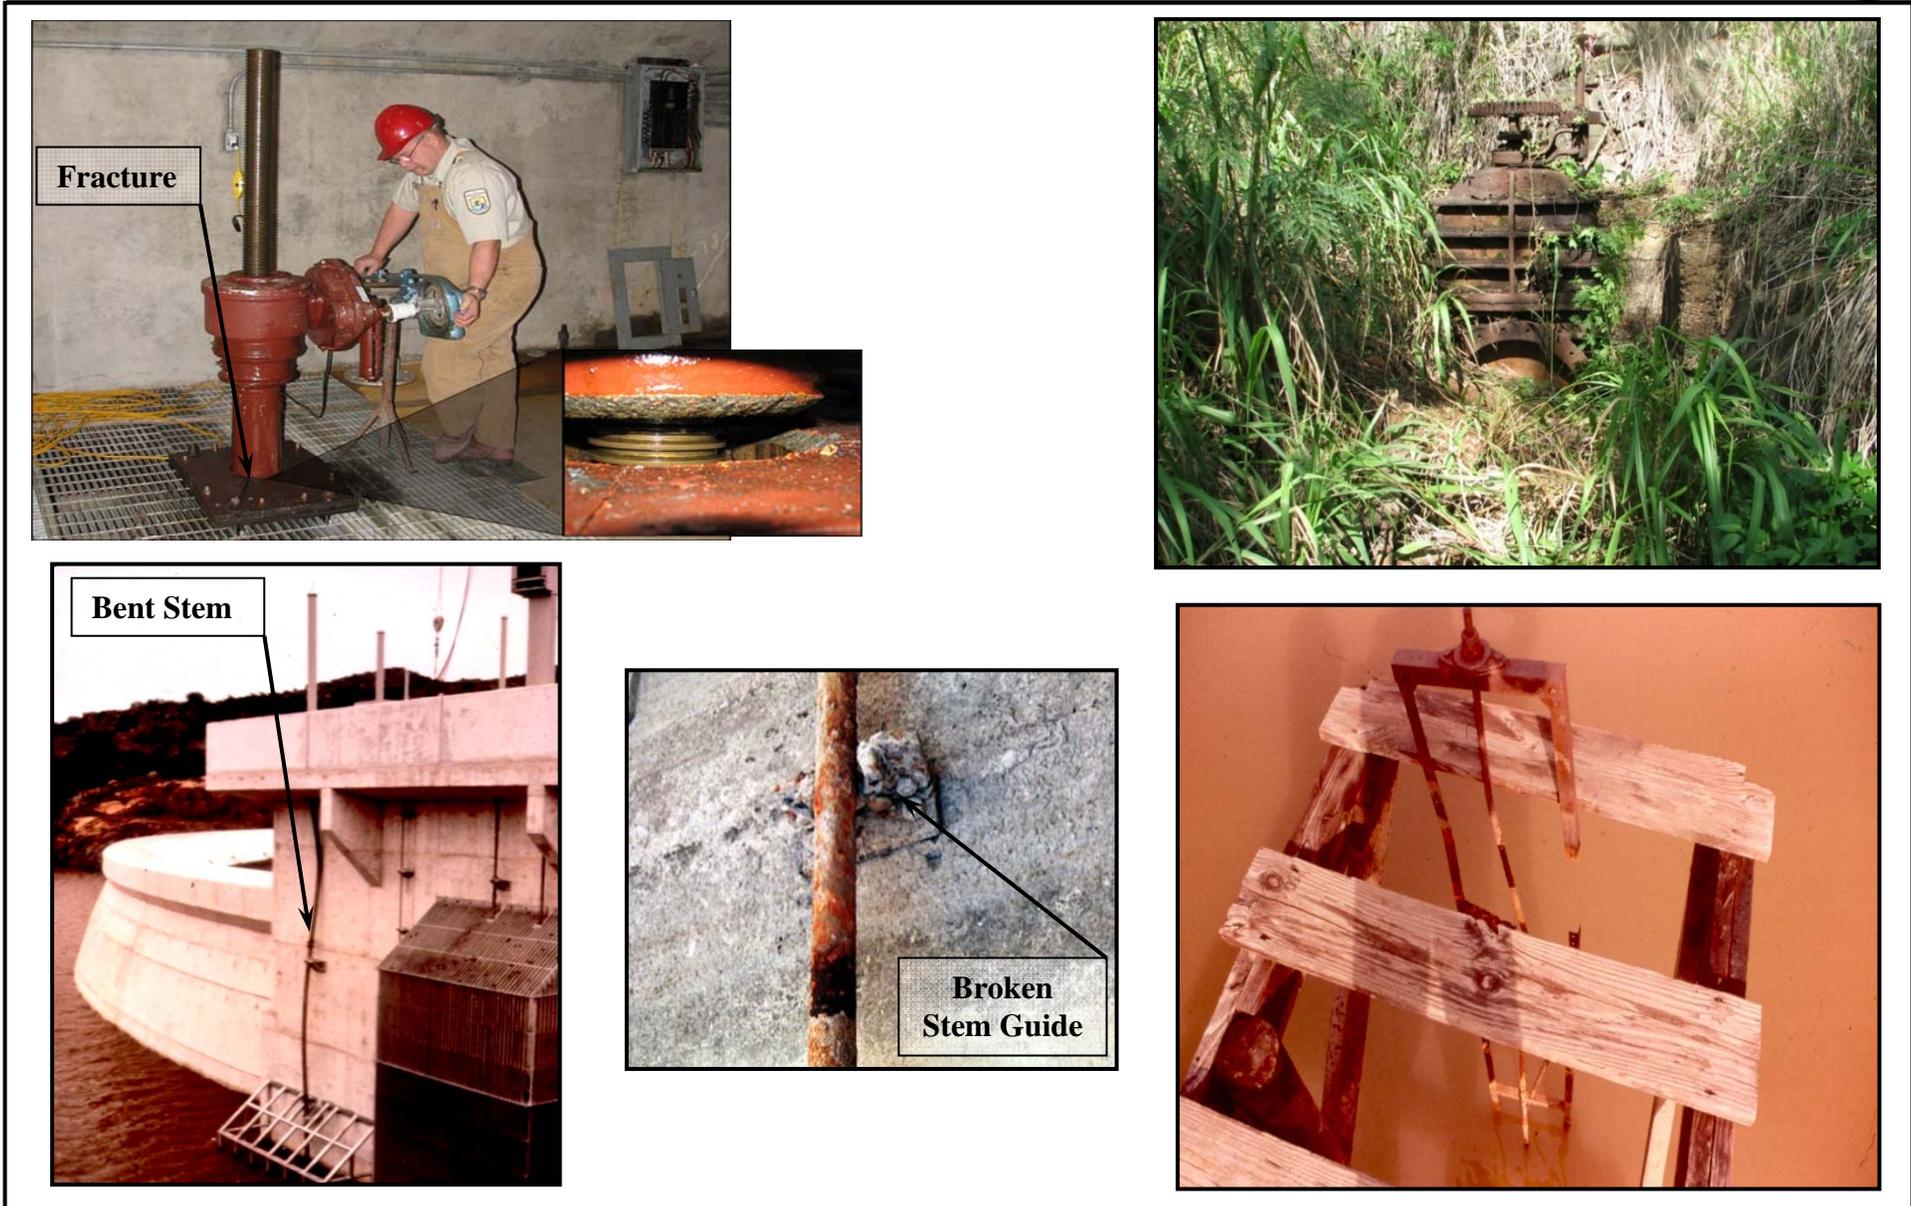
Figure 5-2: Examples of Typical Outlet Works Gate and Valve Operation and Maintenance Problems

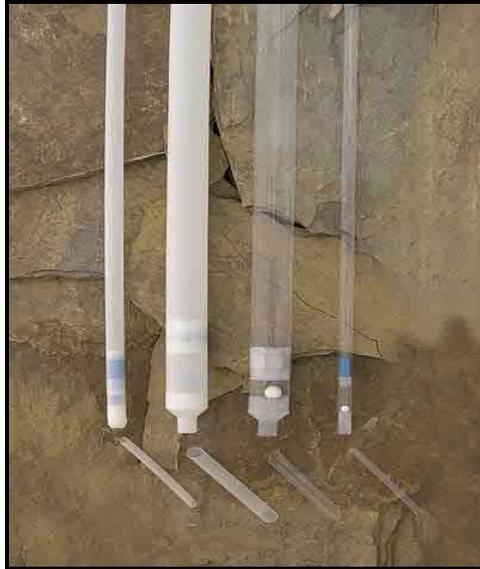
Figure 5-3: Photo of Piezometer Bailers

Sediment sometimes builds up within the PVC pipe of a piezometer. This can cause inaccurate readings. To remove the sediment, gently agitate the sediment with a pipe or wire that is longer than the piezometer is deep. Be careful not to damage the piezometer screen or loosen the joints of the piezometer pipe. Then bail the water and sediment with an appropriately sized well bailer. A bailer is a cylindrical tube fitted with a valve at the bottom which is used to remove fluid from a well. Fill the piezometer with water and repeat until the bailed water is relatively clear, or the pipe can be lowered to the bottom of the piezometer without “feeling” sediment. Figure 5-3 illustrates a bailer.

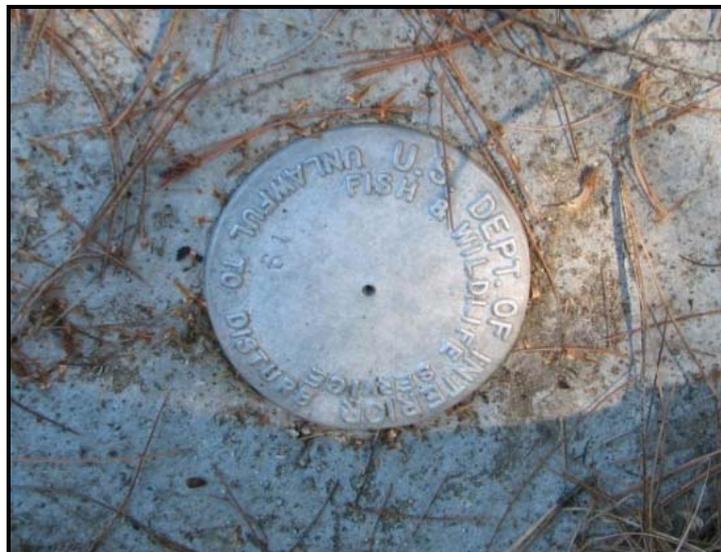
Figure 5-4: Typical USFWS Survey Monument

The brass cap survey monuments should be protected from damage, not covered or moved. If they become damaged or stolen they should be replaced with the assistance of the RDSO. A licensed surveyor should assist in the replacement of the survey monuments. Figure 5-4 depicts a typical survey monument.

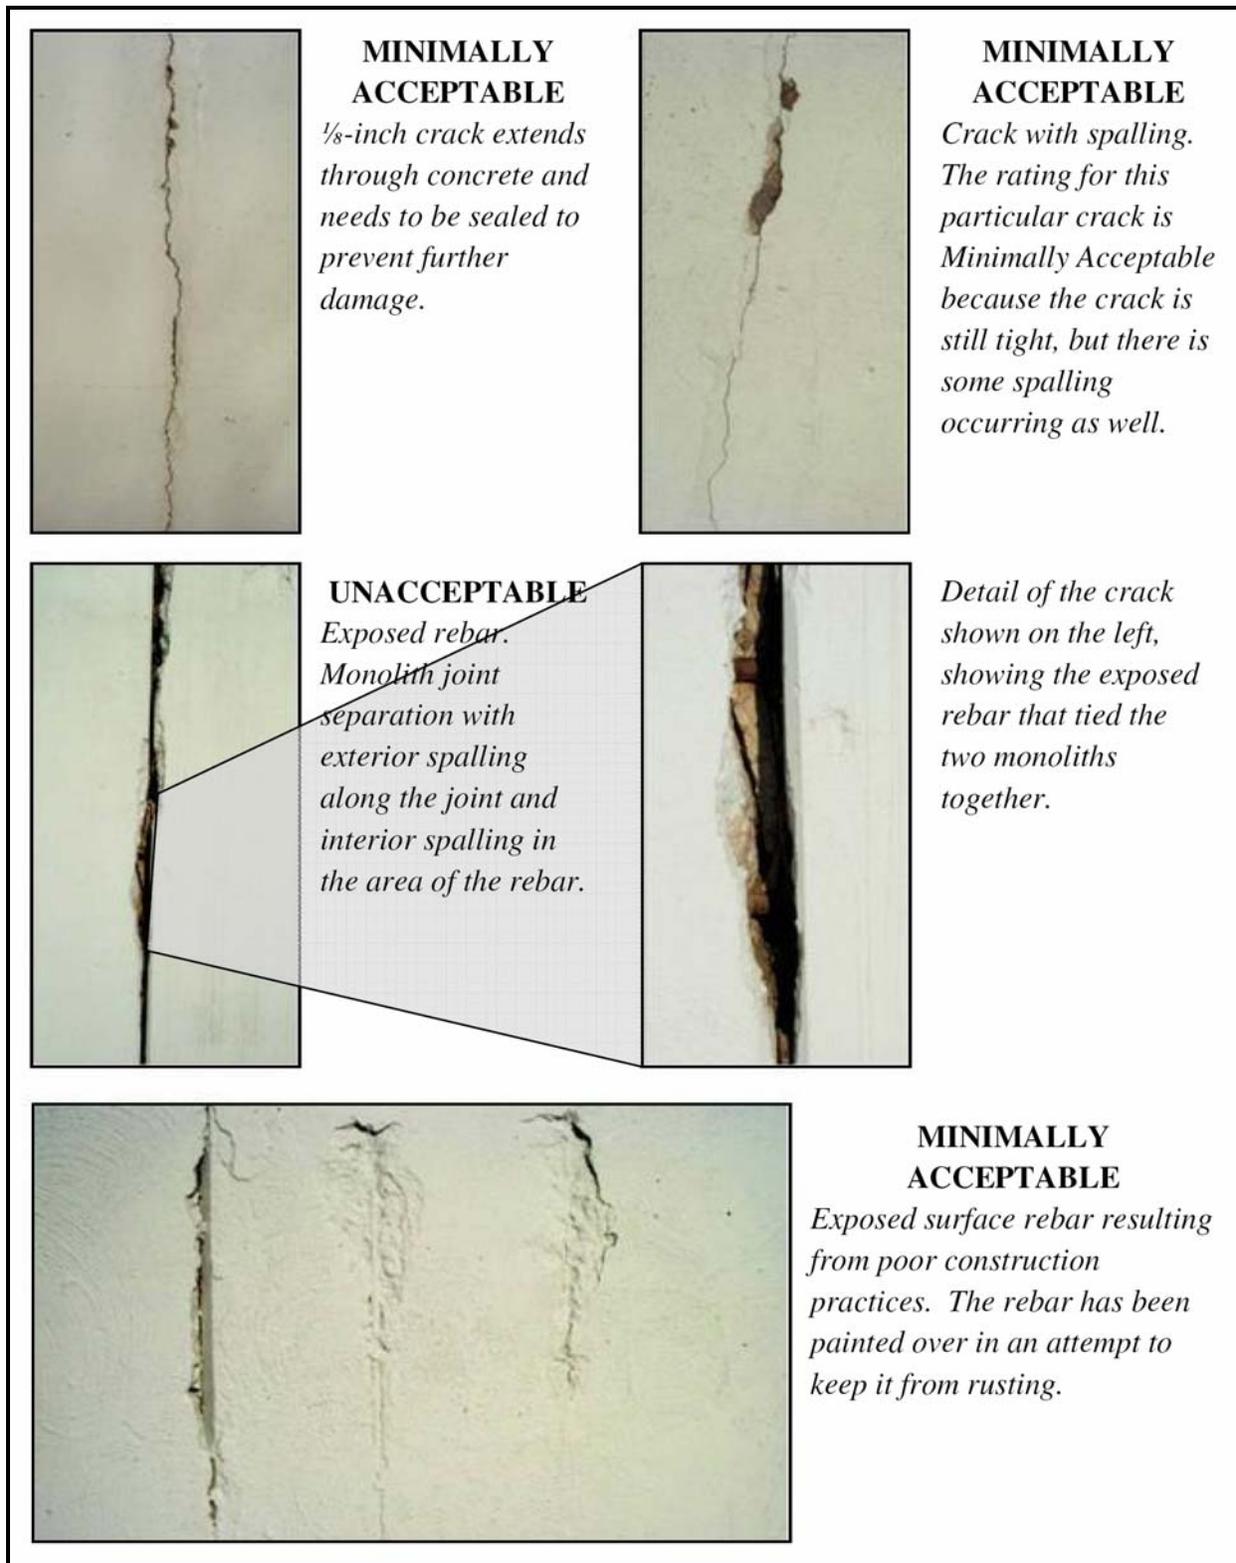
MINIMALLY ACCEPTABLE

1/8-inch crack extends through concrete and needs to be sealed to prevent further damage.

Visible cracking, scaling, or spalling are signs of concrete movement and stresses within the concrete. Cracks in concrete walls that aren't repaired are subject to freeze/thaw damage, which widens the gap and leads to additional spalling of the concrete. When examining any concrete structures, spalling, scaling, or cracking should be very minimal. Figure 5-5 shows various degrees of cracking and spalling.

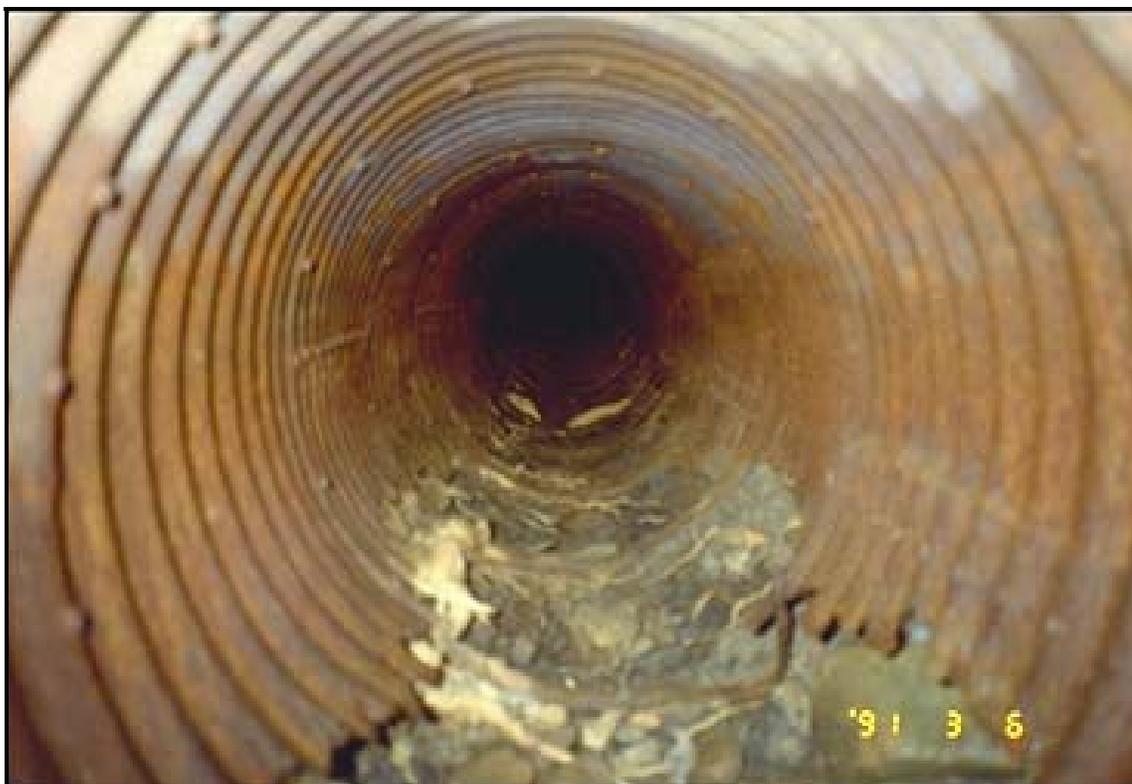
Figure 5-6: Photo of Inside of Corrugated Metal Pipe Showing Corrosion and Deterioration

Corrosion is a common problem of pipe spillways and other conduits made of metal. Exposure to moisture, acid conditions, or salt will accelerate the corrosion process. In these areas, pipe made of non-corrosive materials such as reinforced concrete or plastic should be used. **Corrugated galvanized steel pipes should not be used to replace existing conduits or for new conduits in FWS dams.**

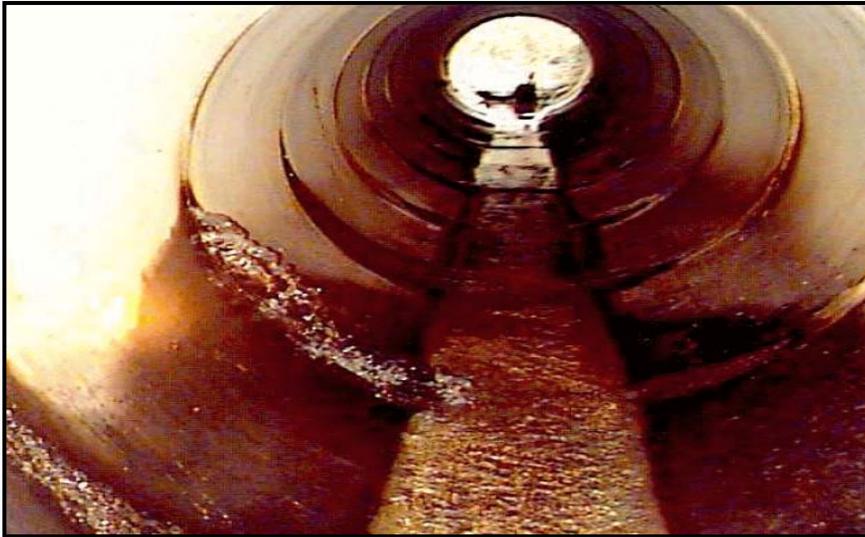
Concrete conduit with severely leaking joints

Figure 5-7: Examples of Concrete Conduit Defects

Figures 5-7 and 5-8 show various defects of concrete and metal conduits.

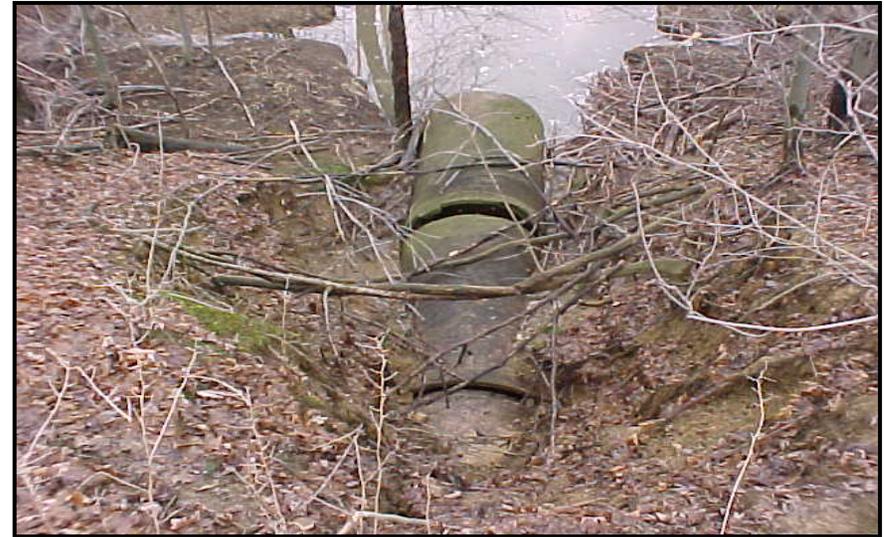
Concrete conduit with separated joints

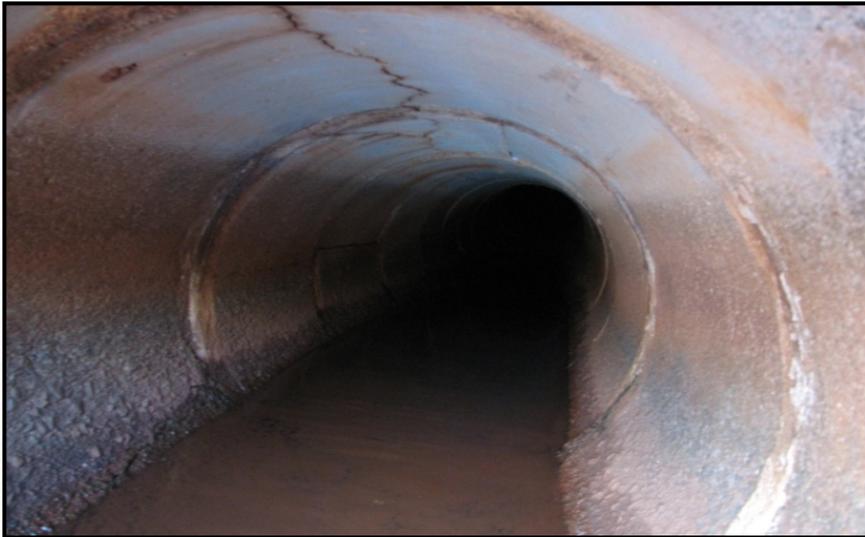
Concrete conduit with crack along top of pipe

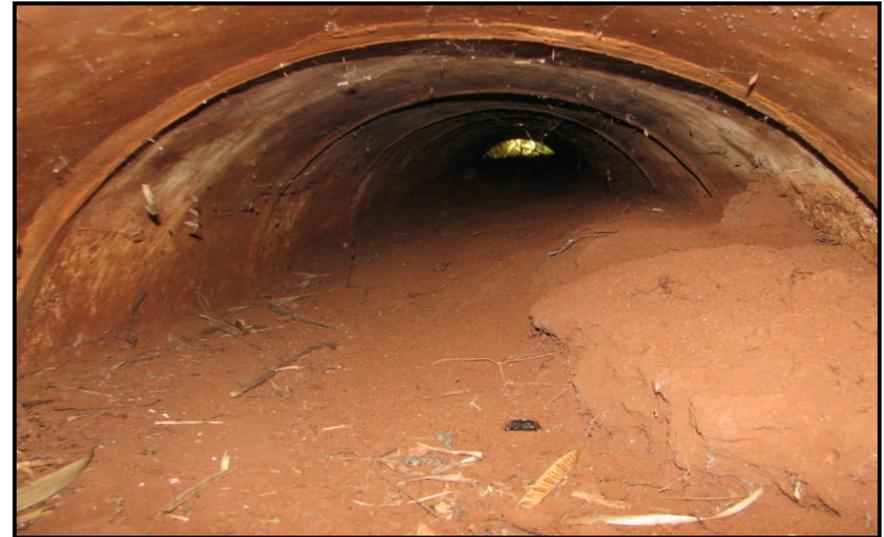
Concrete conduit filled with sediment

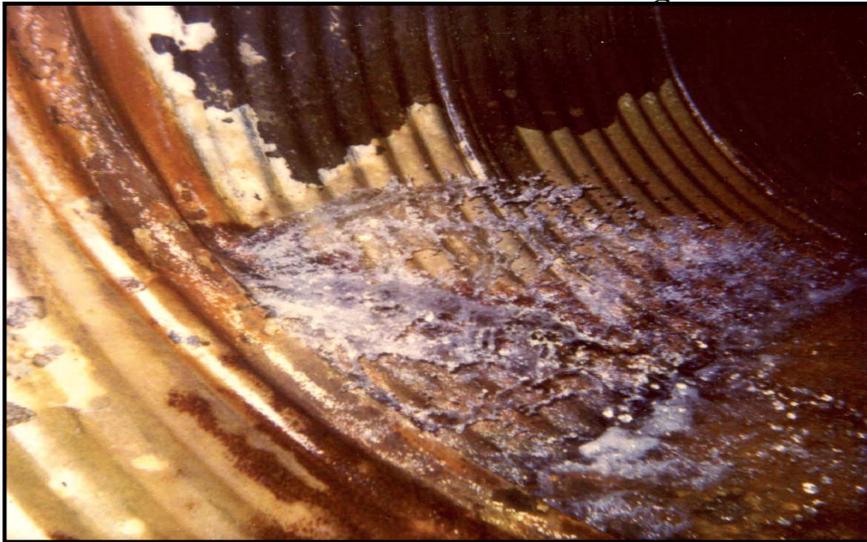
Metal conduit corroded with severely leaking joints

Figure 5-8: Examples of Metal Conduit Defects

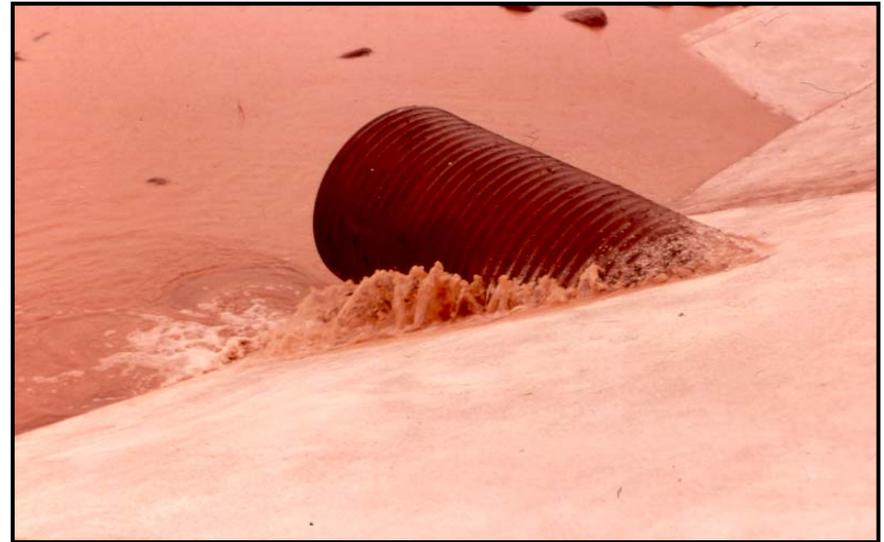
Metal conduit with seepage along exterior

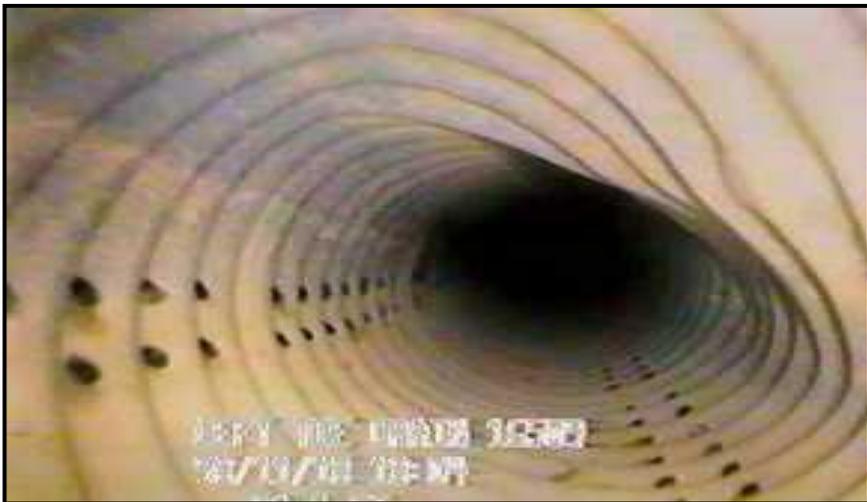
Deformed corrugated metal conduit

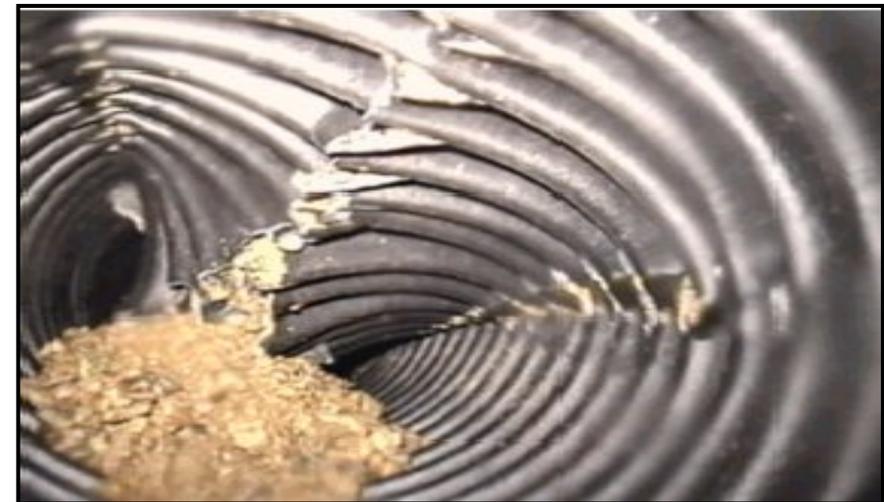
Deformed and broken corrugated metal conduit

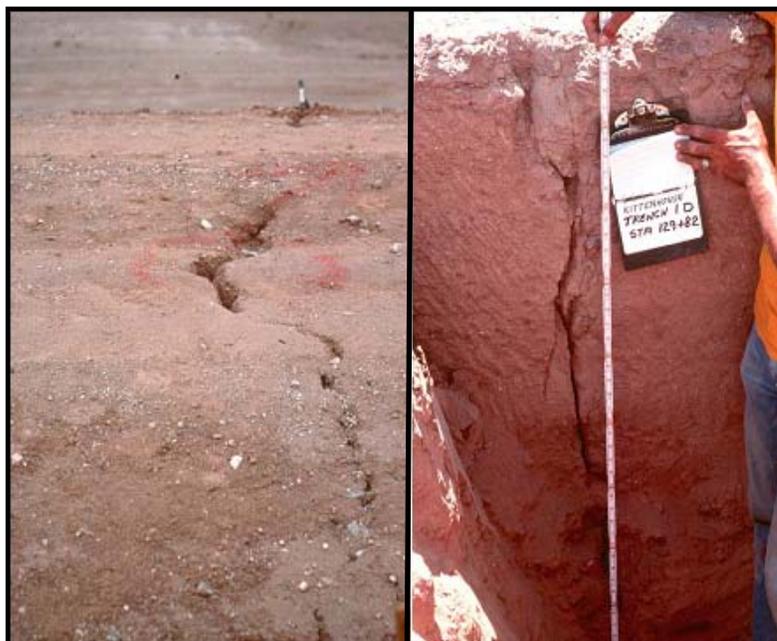
Figure 5-9: Photos Showing Cracks in an Embankment Dam

Occasionally minor cracks will form in an earthen dam because of surface drying. These are called *desiccation* (drying) cracks and should not be confused with *structural* or *settlement* cracks. Drying cracks are usually parallel to the main axis of the dam, typically near the upstream or downstream shoulders of the crest. These cracks often run intermittently along the length of the dam and may be up to four feet deep.

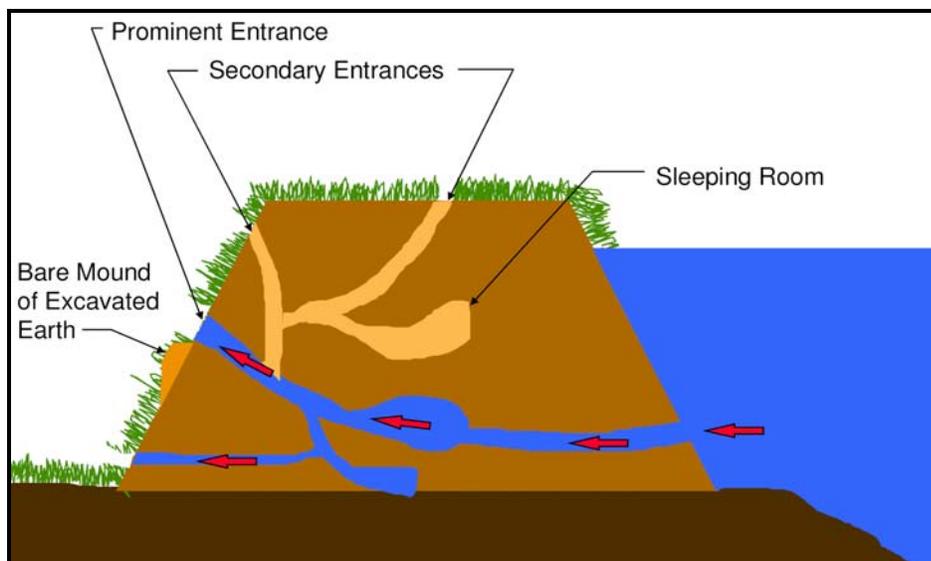
Figure 5-10: Schematic of Animal Burrows In Embankment Illustrating Potential for Developing a Piping Failure

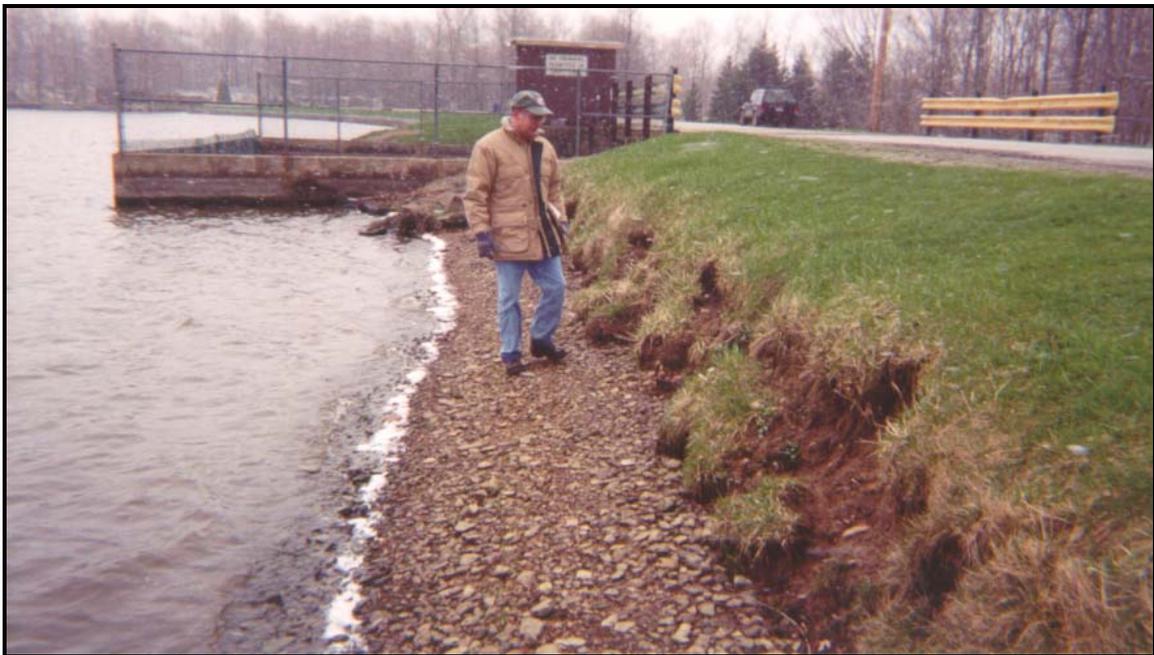
Figure 5-11: Example of Wave Erosion and Beaching

An erosion problem called *benching* can develop on the upstream slope of a dam. Waves caused by high winds can erode the exposed face of an embankment by repeatedly striking the surface just above the pool elevation, rushing up the slope, then tumbling back into the pool. This action erodes material from the face of the embankment and displaces it down the slope, creating a “bench.” Erosion of unprotected soil can be rapid and, during a severe storm, could erode the dam. Figure 5-11 illustrates wave erosion.

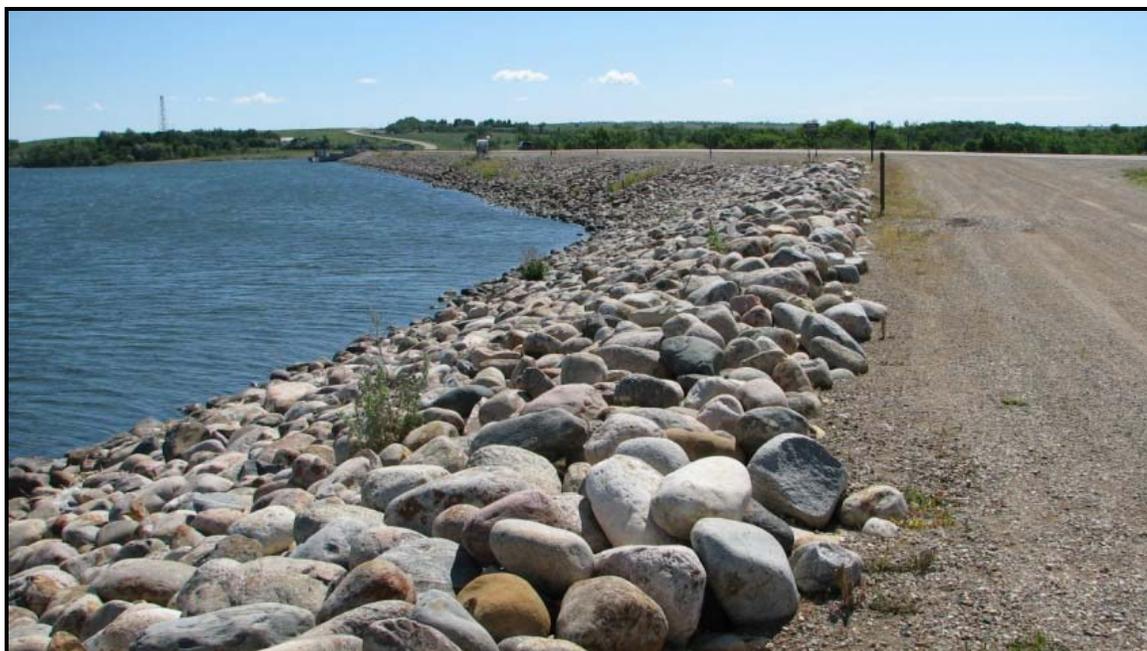
Figure 5-12: Riprap Erosion Protection on Upstream Embankment Slope

The upstream face of a dam is commonly protected against wave erosion and resultant benching by armoring with a layer of riprap on bedding material. Materials such as bituminous or concrete facing, bricks, or concrete blocks have also been used to armor upstream slopes. Protective benches can also be built into the upstream slope of small dams by placing a berm (8–10 feet wide) along the upstream face a short distance below the normal pool level, supplying a surface on which wave energy can dissipate.

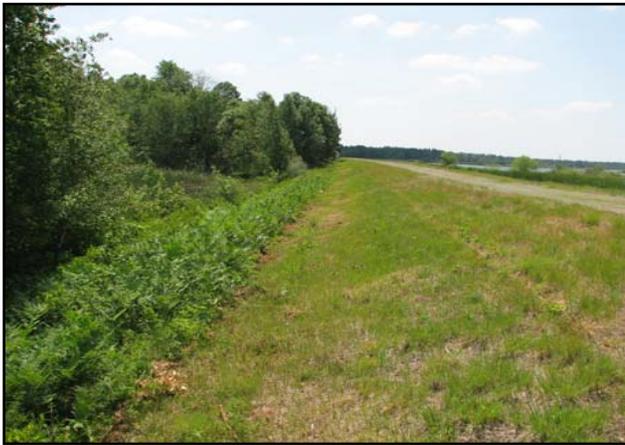
Most of downstream slope is mowed but trees and tall grass remain on slope and at toe of slope.

Figure 5-13: Examples of Unacceptable Control of Vegetation

Figures 5-13 and 5-14 illustrate unacceptable and acceptable vegetation control on a dam, respectively.

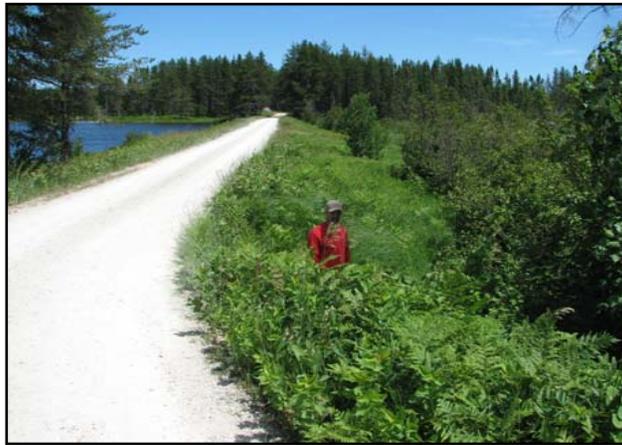
Downstream slope with trees growing on slopes and waist-high grass making visual inspection nearly impossible

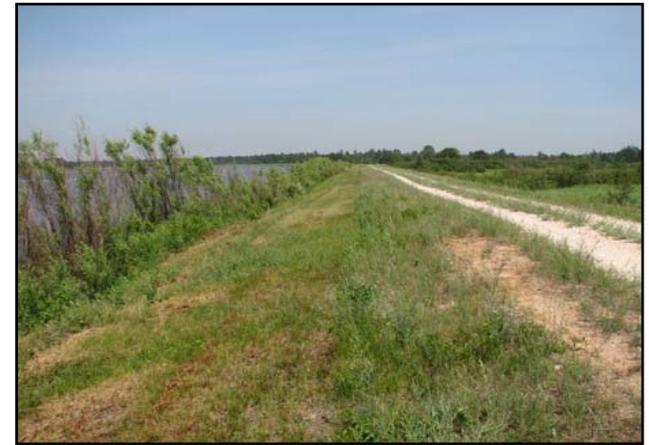
Upstream slope is mowed, but trees and tall grass growing along toe of slope above normal pool reservoir.

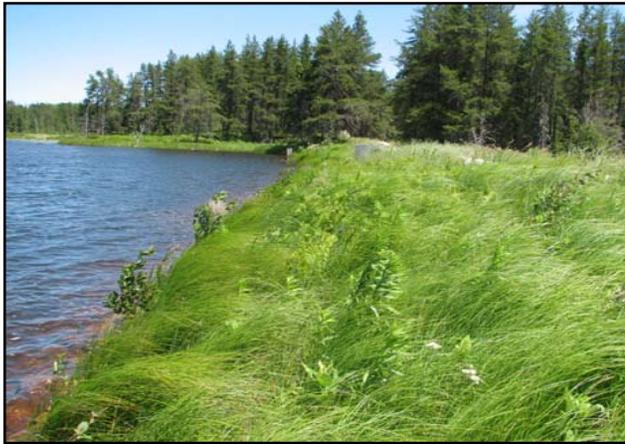
Upstream slope with waist-high grass making visual inspection nearly impossible.

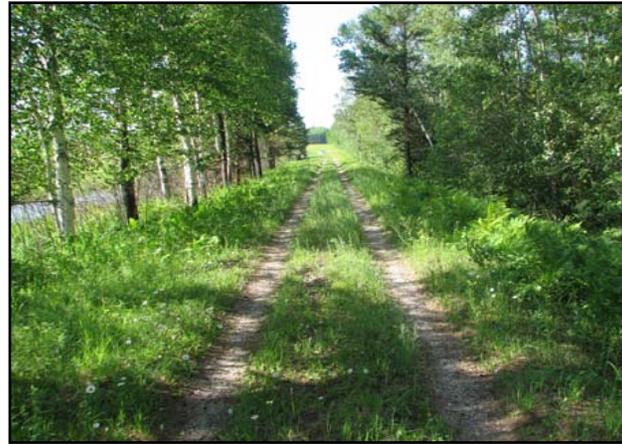
Mature trees growing on slopes and knee-high grass, making visual inspection difficult.

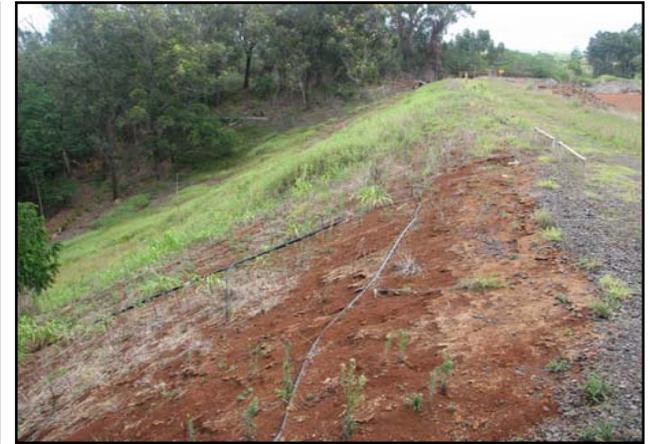
Missing vegetation on slope.
