U.S. Fish & Wildlife Service Low Hazard Dams

**Standing
Operating
Procedures**

All USFWS Refuges

UNITED STATES DEPARTMENT OF THE INTERIOR
FISH & WILDLIFE SERVICE
All REGIONS

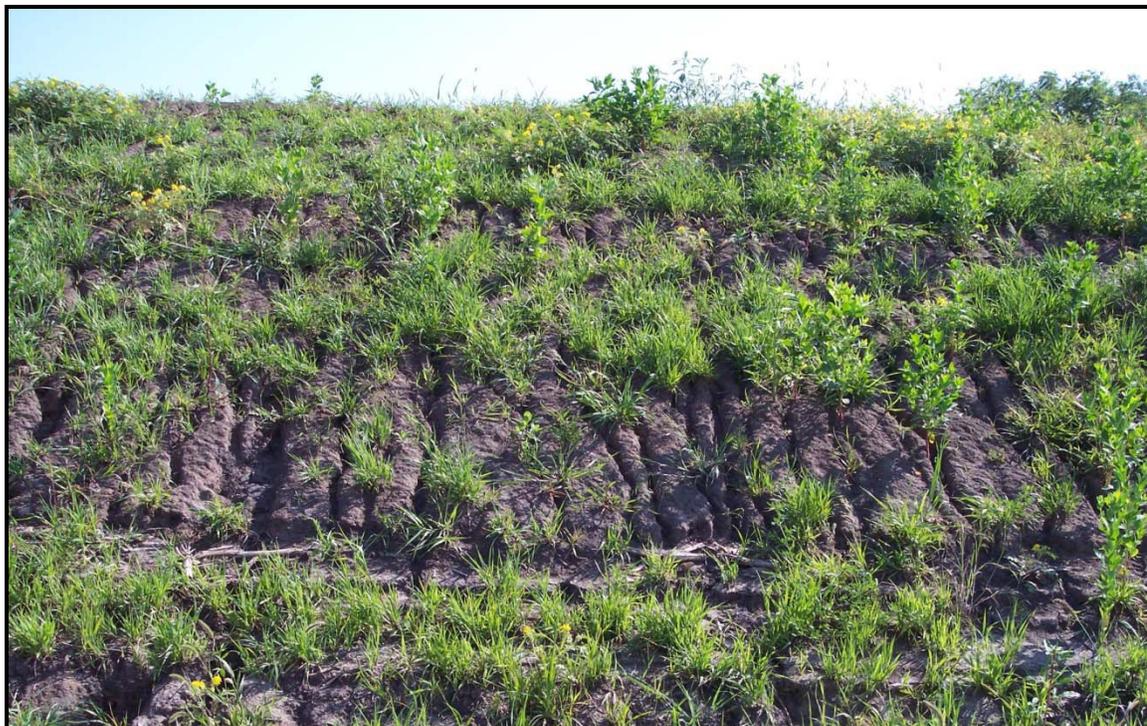
Figure 5-15: Sparse Vegetation and Erosion of Downstream Embankment Slope

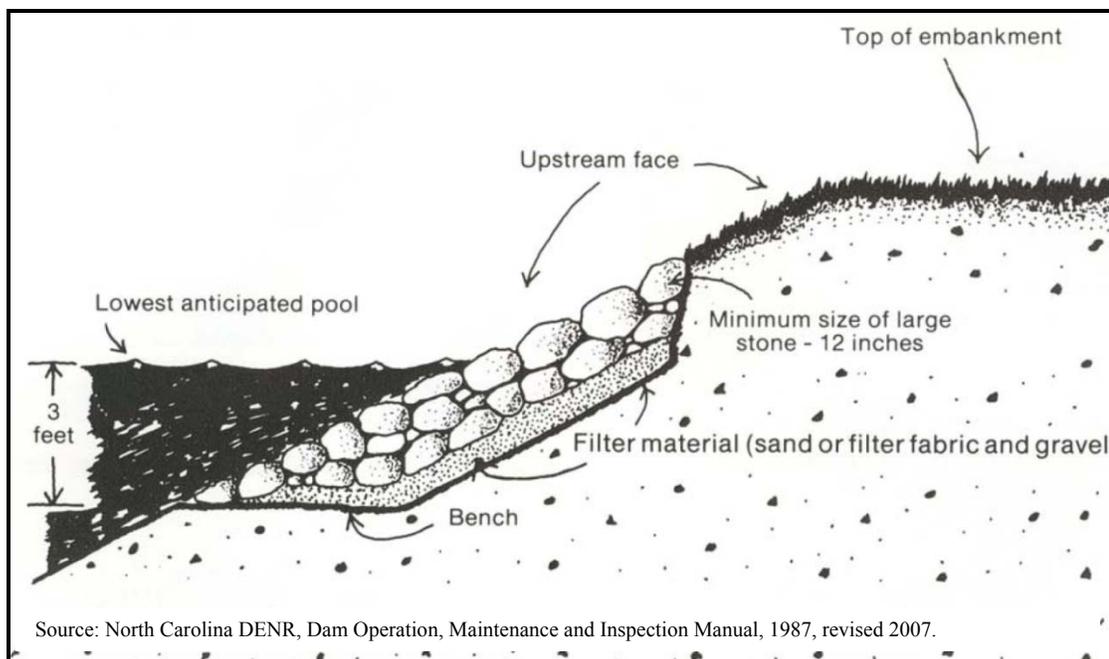
Figure 5-16: Typical Beaching Protection Detail for the Upstream Slope of an Embankment Dam

The layer should extend a minimum of 3 feet below the lowest anticipated pool level. Otherwise, wave action during periods when the reservoir level is drawn down can undermine and destroy the protective layer. Figure 5-16 illustrates the proper configuration to minimize or eliminate beaching.

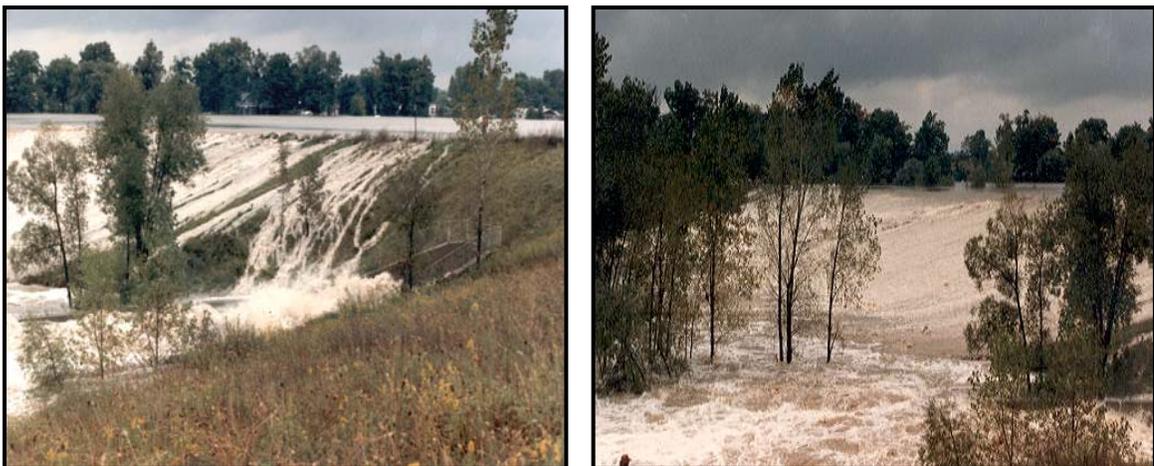
Figure 6-1: Dam Overtopping During a Flood

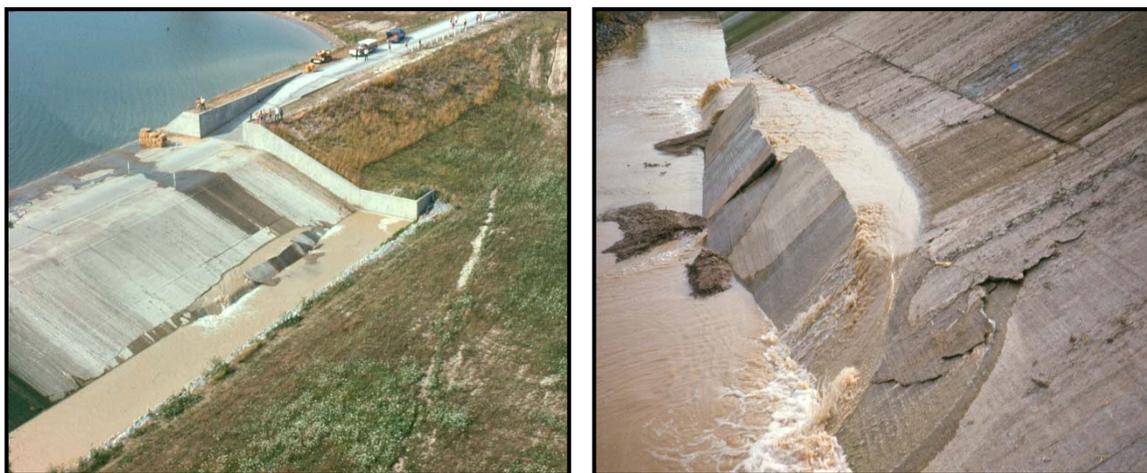
Figure 6-2: Structural Failure of a Concrete Spillway from Uncontrolled Seepage and Uplift Pressures Developing Under the Structure

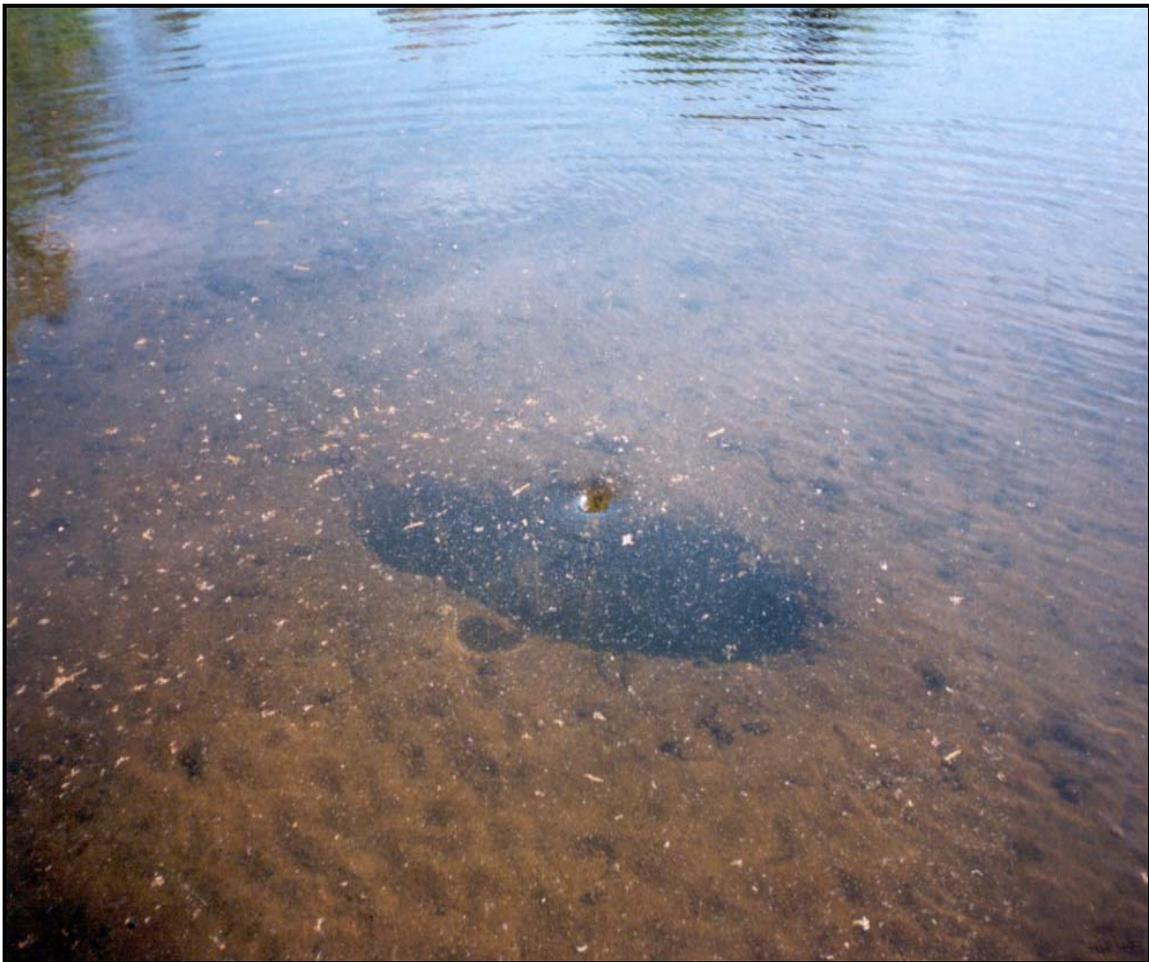
Figure 6-3: Photo of a Small Whirlpool and Sinkhole on Upstream Slope Below Reservoir Level

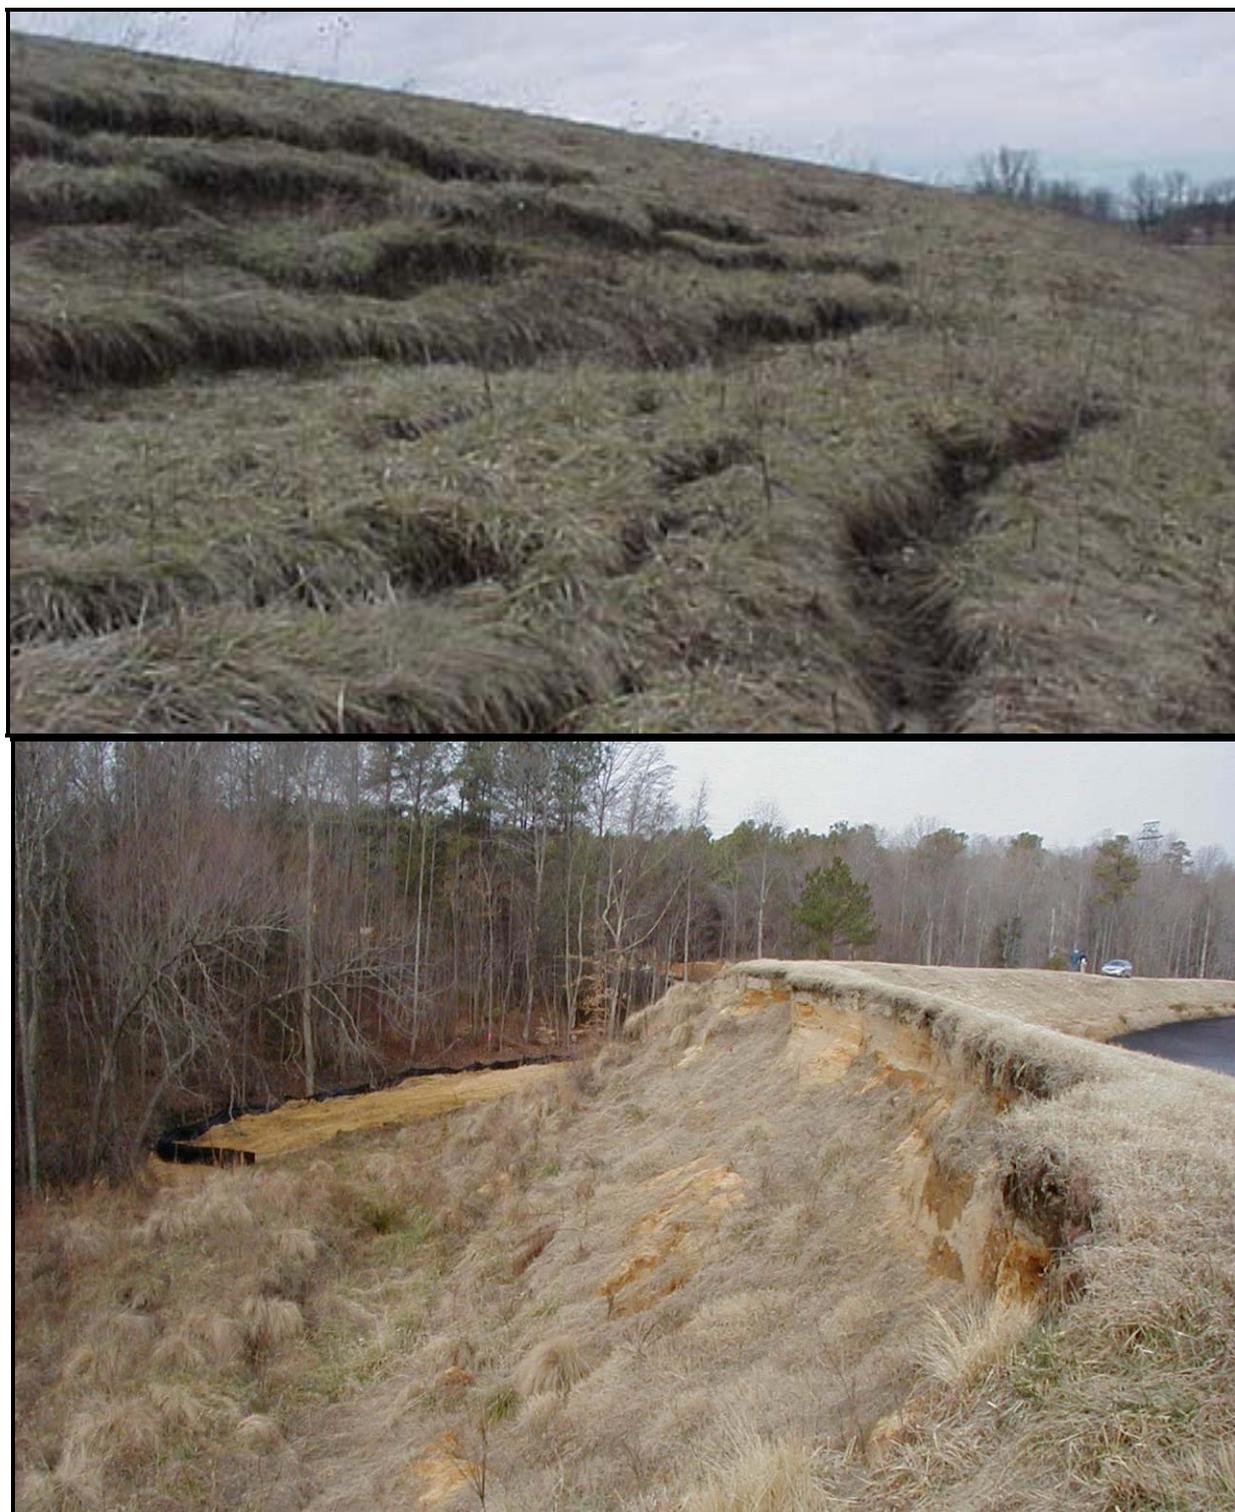
Figure 6-4: Photos Showing Examples of Downstream Slope Instability and slides on Embankment Dams

In this case, seepage water flows under the dam without following a well-defined path, and results in one or more boils outcropping at or near the downstream toe. The flow from these boils tends to undercut and ravel the downstream toe, resulting in sloughing of the downstream slope. Sloughing is the movement of small amounts of soils from the embankment slopes. Sloughing may also occur if the dam embankment becomes saturated as a result of prolonged high reservoir stages (see Figure 6-4).

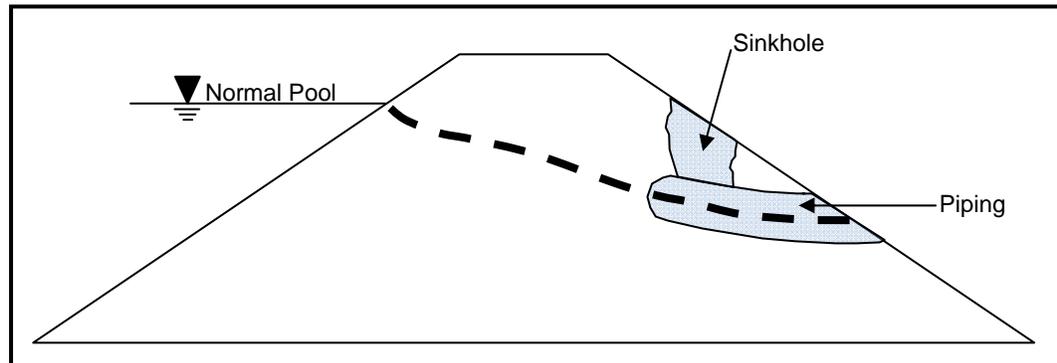
Figure 6-5: Depiction of Piping In An Embankment

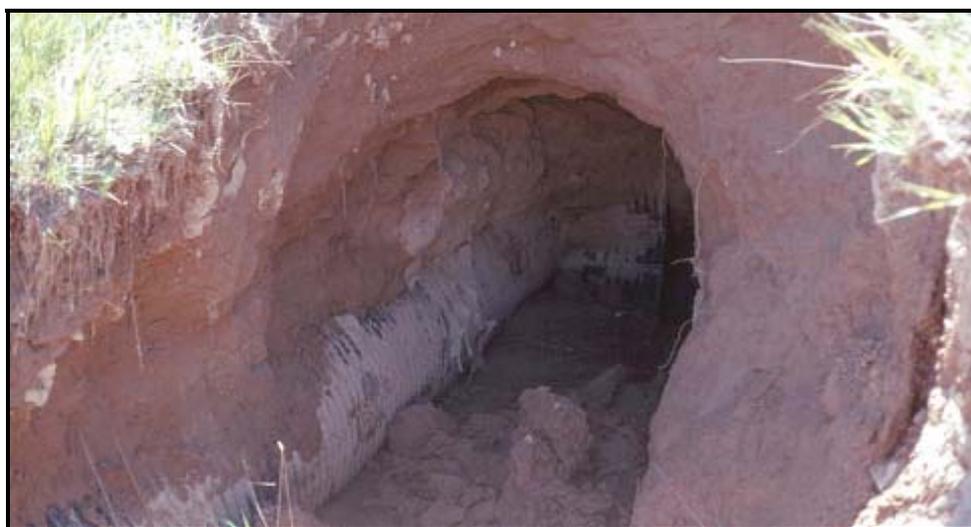
Figure 6-6: Photo Showing Example of a Piping Failure Along an Outlet Conduit

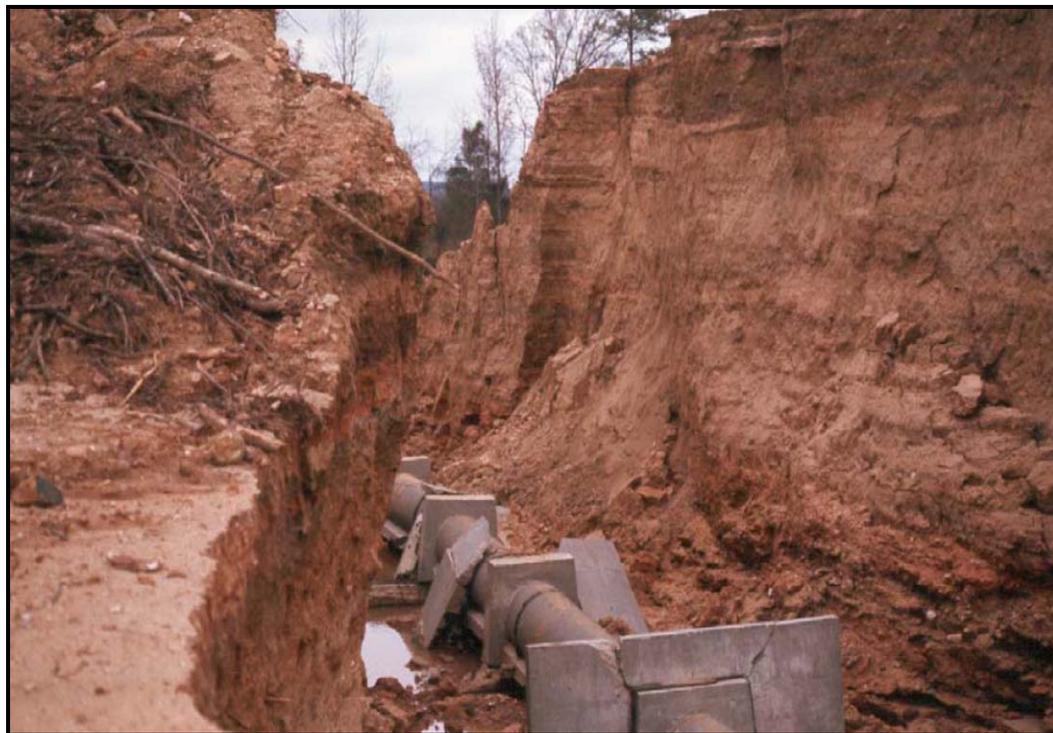
Figure 6-7: Photo Showing Example of Piping Failure Along an Outlet Conduit

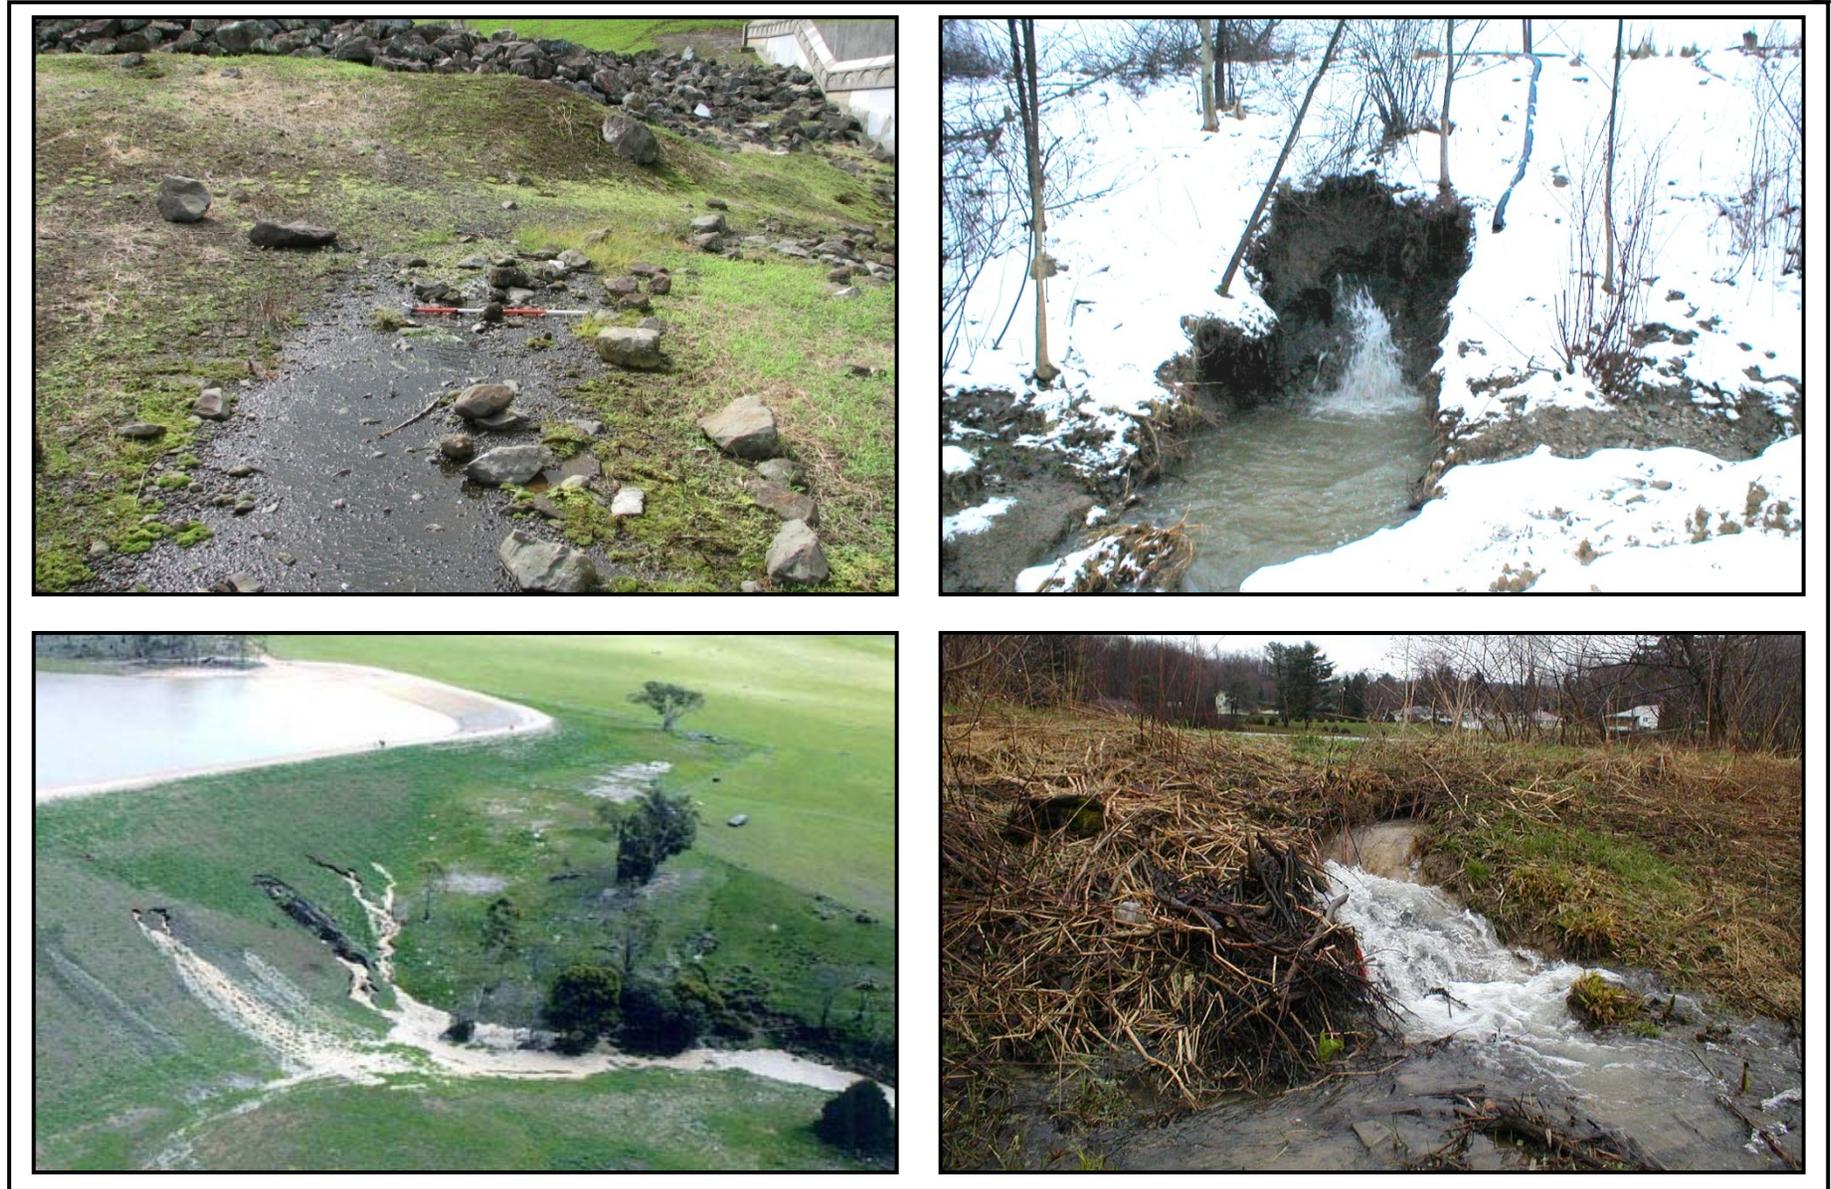
Figure 6-8: Examples of Uncontrolled Seepage on Downstream Slopes of Embankment Dams

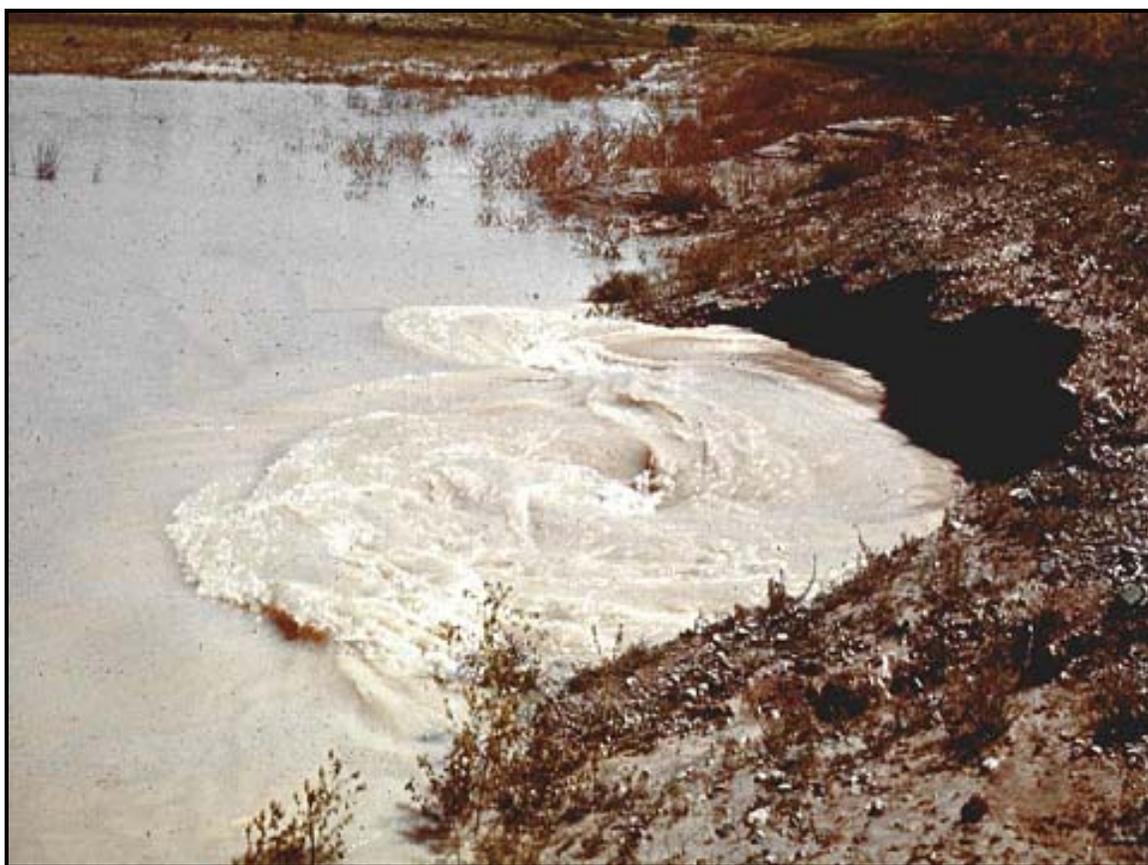
Figure 6-9: Photo of a Whirlpool on the Upstream Slope of an Embankment Dam

<p>Some part of the foundation material is supplying a flow path. This could be caused by a sand or gravel layer in the foundation. Increased flows can lead to erosion of the foundation and failure of the dam. See Figures 6-9 thru 6-13 for examples.</p>	<ol style="list-style-type: none"> 1. Examine the boil for transportation of foundation materials. 2. If soil particles are moving downstream, sandbags or earth should be used to create a dike around the boil. The pressures created by the water level with the dike may control flow velocities and temporarily prevent further erosion. 3. If erosion is becoming greater, the reservoir level should be lowered. 4. A qualified engineer should inspect the condition and recommend further actions. <p>RDSO NOTIFICATION REQUIRED</p>

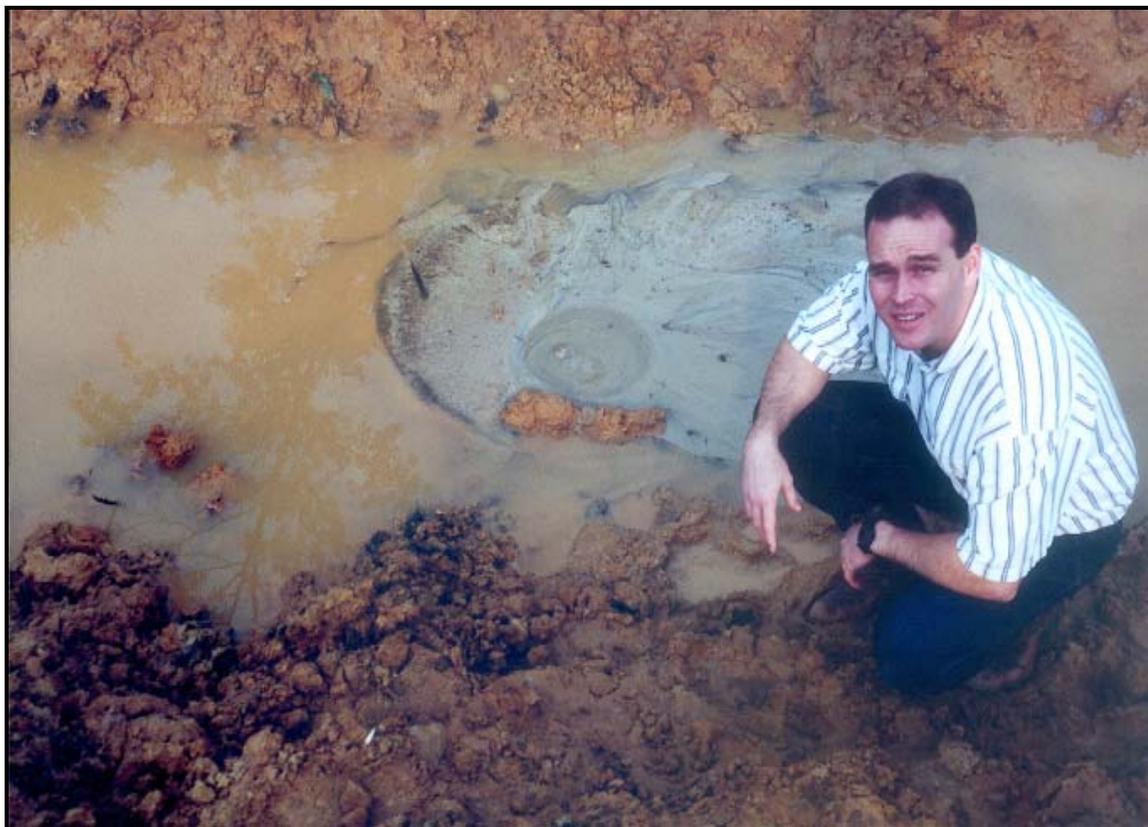
Figure 6-10: Sandboil at the Toe of an Embankment Dam

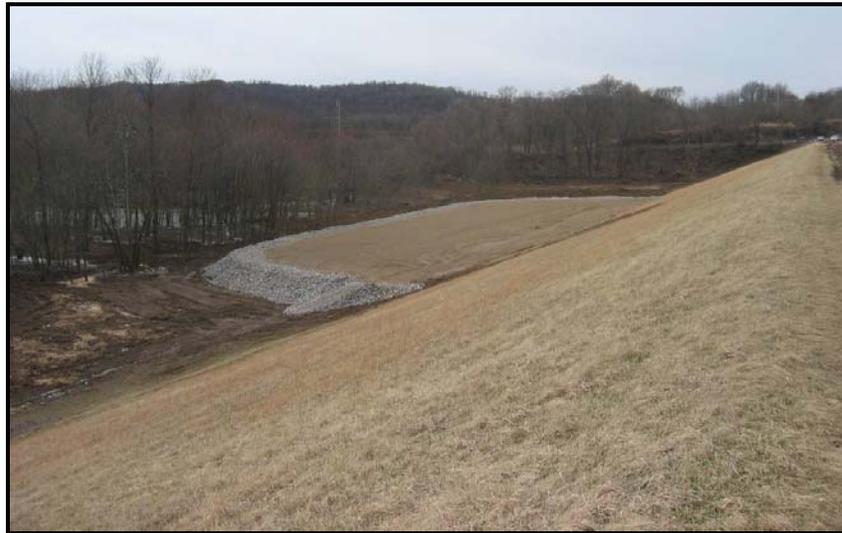
Figure 6-11: Filtered Drainage Berm at Toe of an Embankment Dam

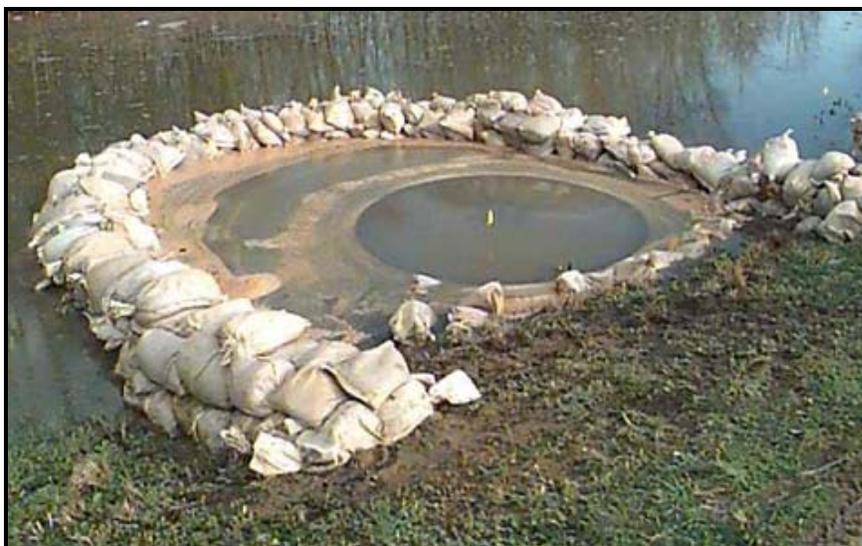
Figure 6-12: Sandbag Ring Levee Around a Boil at the Downstream Toe of an Embankment Dam

If a ring dike is constructed around the boil, it should not be built too high or it can develop new boils outside of the affected area. The primary objective is to prevent the loss of embankment material with the seepage. The purpose of the ring is to raise a head of water over the boil to counterbalance the upward pressure of the seepage flow. The height of the water column is adjusted so that the water exiting the boil runs clear and no longer removes soil from the dam foundation. It is important that the flow of water is not stopped completely, as this may cause additional boils to break out nearby. Treated areas should be kept under constant surveillance until the water recedes. Sandbag rings are the most common method of constructing ring dikes, however concrete well rings, short pieces of large diameter pipe, earth berms, sheet piling, etc., can also be used. A sandbag ring levee around a boil is illustrated in Figures 6-12 and 6-13.

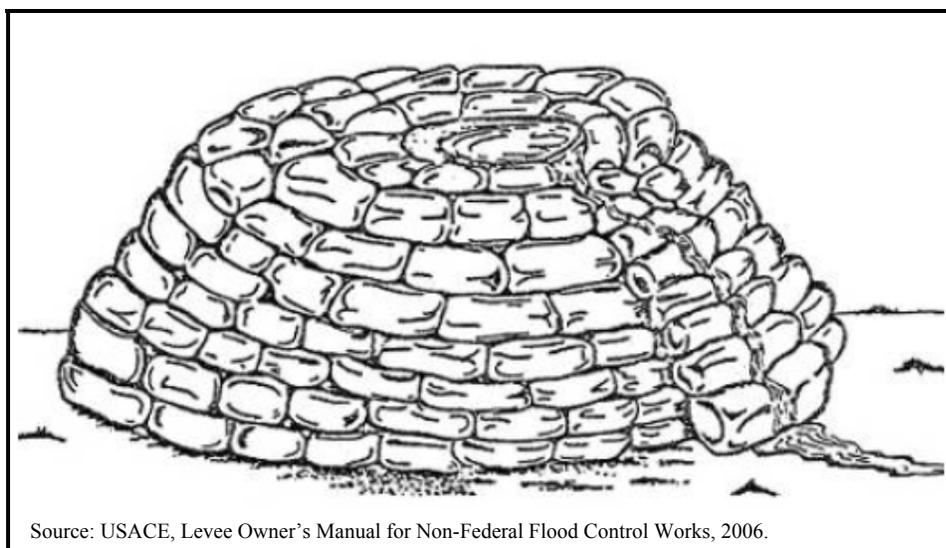
Figure 6-13: Sketch of a Typical Ring Levee with Spillway

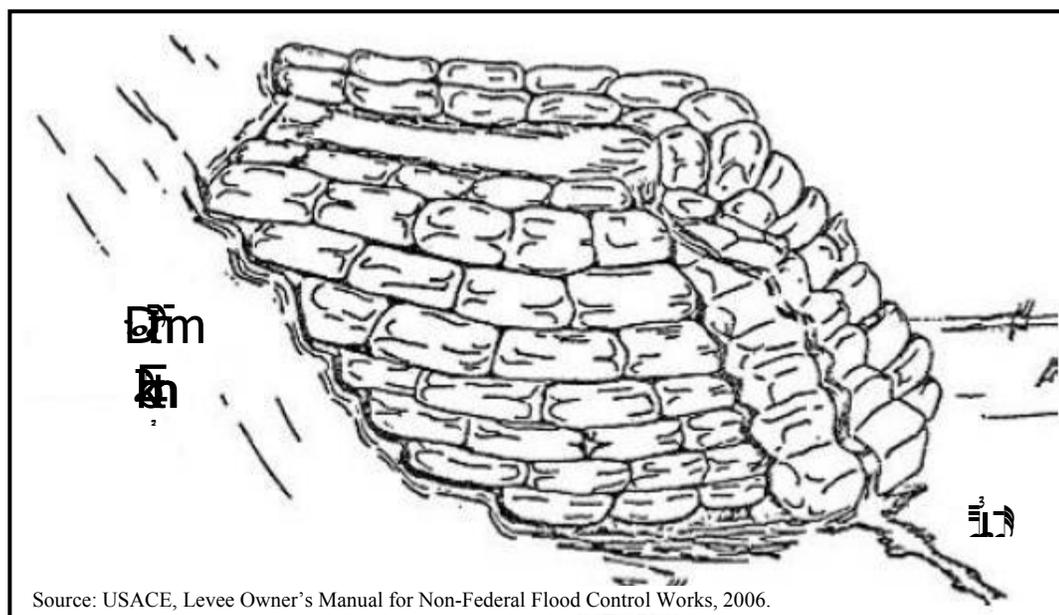
Figure 6-14: Sketch of Ring Levee Tied to the Downstream Slope of the Dam

toe, the sandbag ring may be tied into the downstream slope of the dam, as shown in Figure 6-14.

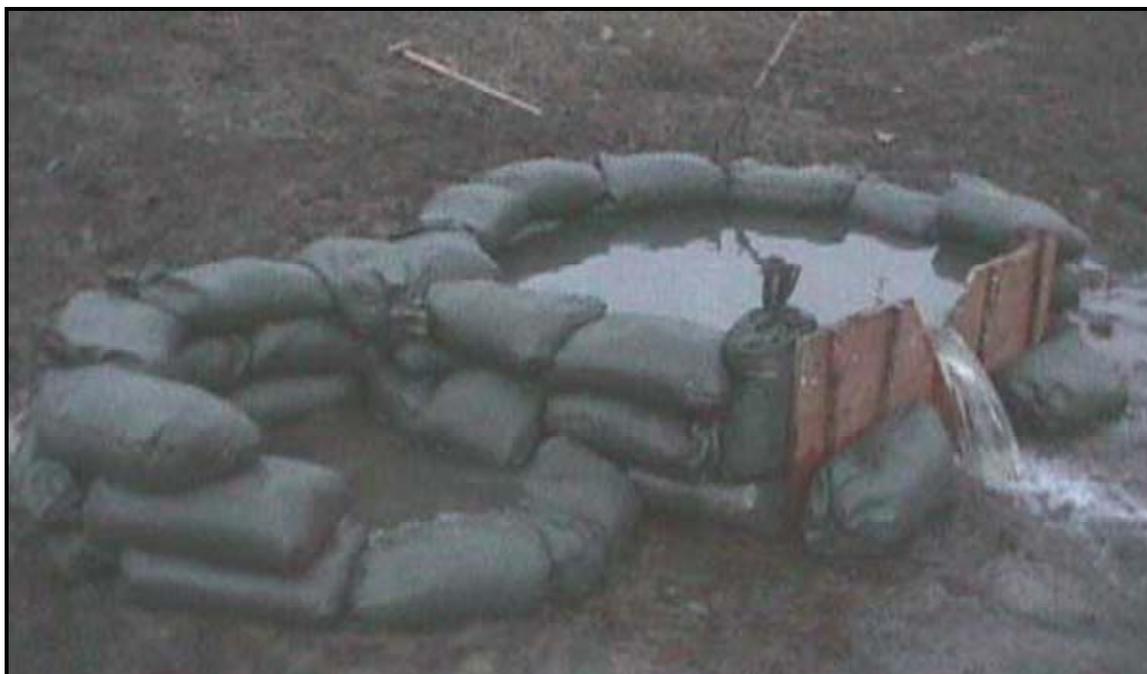
Figure 6-15: Photo of Sandbag Levee with V-notch Weir Outlet to Monitor Changes in Seepage

A spillway or exit channel should be constructed on the top of the sack ring so that the level of the water in the ring dam can be adjusted, and the overflow water can be carried a safe distance from the boil, away from the direction of the dam. Because the height of the water is the critical factor in adjusting the rate of flow through the boil, the spillway will require constant monitoring and adjustment once the sandbag ring dam is filled with water. This spillway is normally constructed of sandbags, but alternately, a V-shaped drain can be constructed of two boards (See Figure 6-15); or PVC pipe, plastic sheeting, or other materials may be helpful in building the spillway.

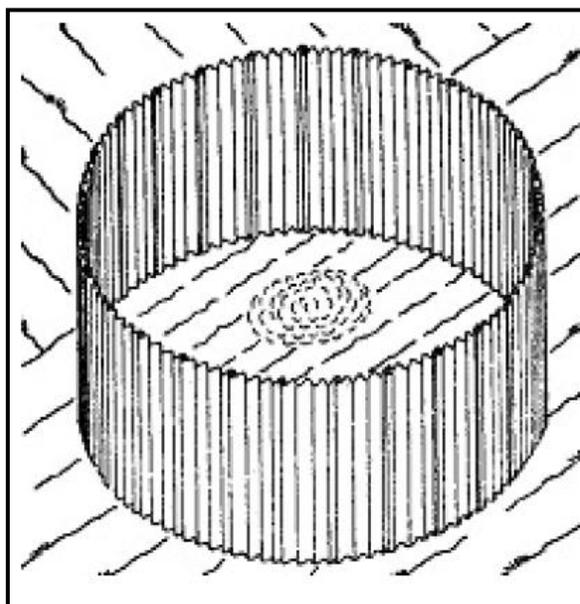
Figure 6-16: Illustration of a Ring of Corrugated Sheet Steel Piling to Encircle a Boil

An alternate method of ringing sandboils is by use of corrugated sheet-steel piling, as shown in Figure 6-16. The area is cleared of debris, and the piling is driven about 1½ feet into the ground around the boil. This method accomplishes the same task faster than sandbagging, but is limited in use by the availability of material, equipment, and the location and foundation condition of boils. Expedient methods can be improvised in other ways, to include using sections of corrugated metal piping. Special care must be taken with the design of these structures to make sure there is a reliable means for adjusting the water level, so the water column doesn't completely stop the flow of water through the boil.

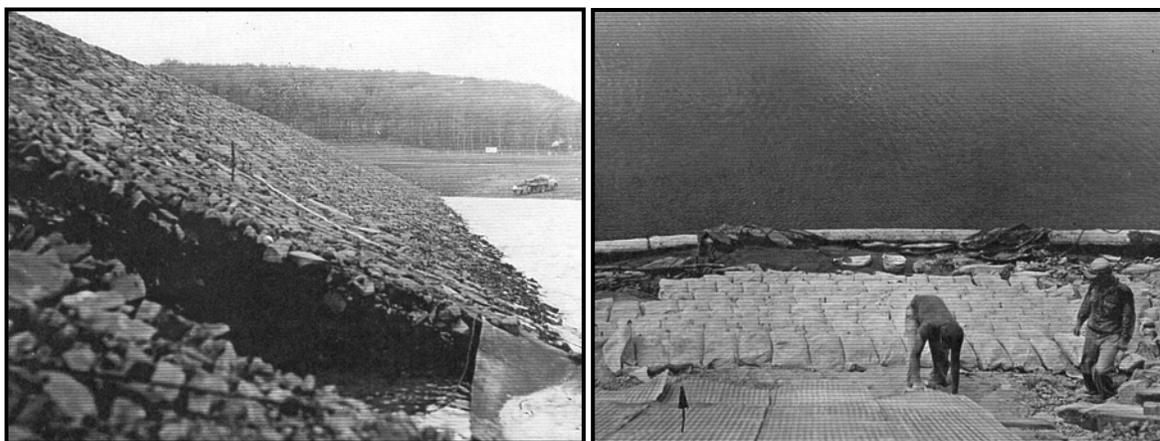
Figure 6-17: Sinkhole in Upstream Slope of a Dam at Waterline (left); Temporary Repaired Sinkhole w/Gravel, Geotextile and Sandbags (right)

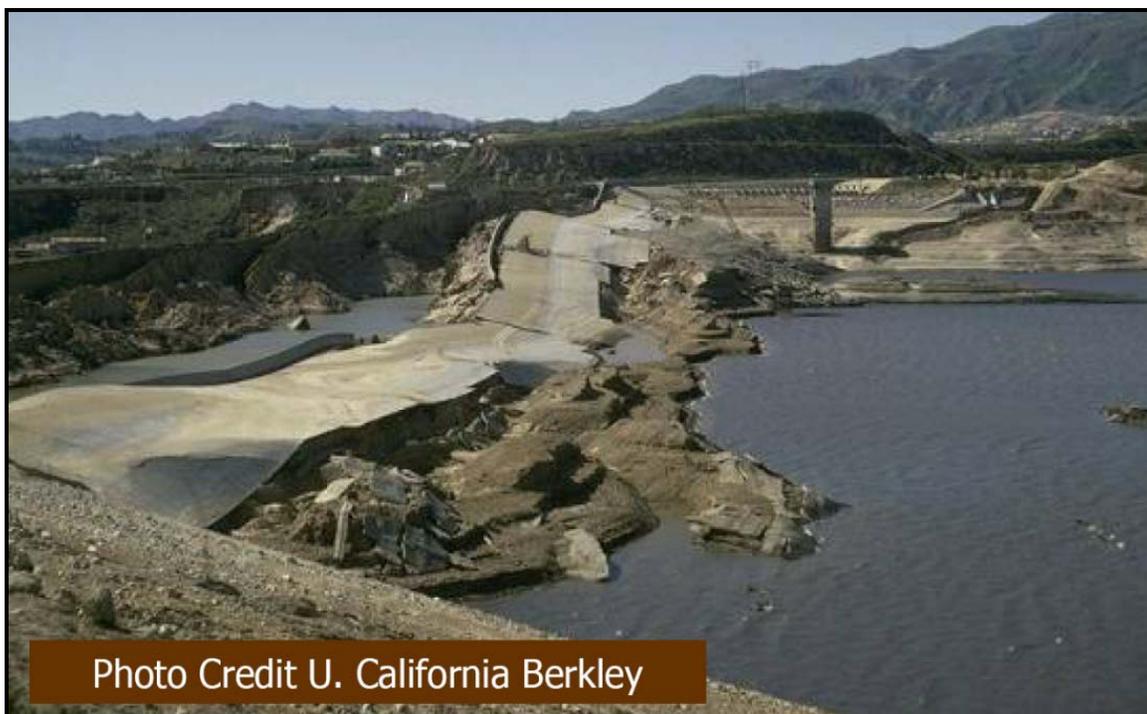
Figure 6-18: Example of a Deformed Embankment Caused by an Earthquake

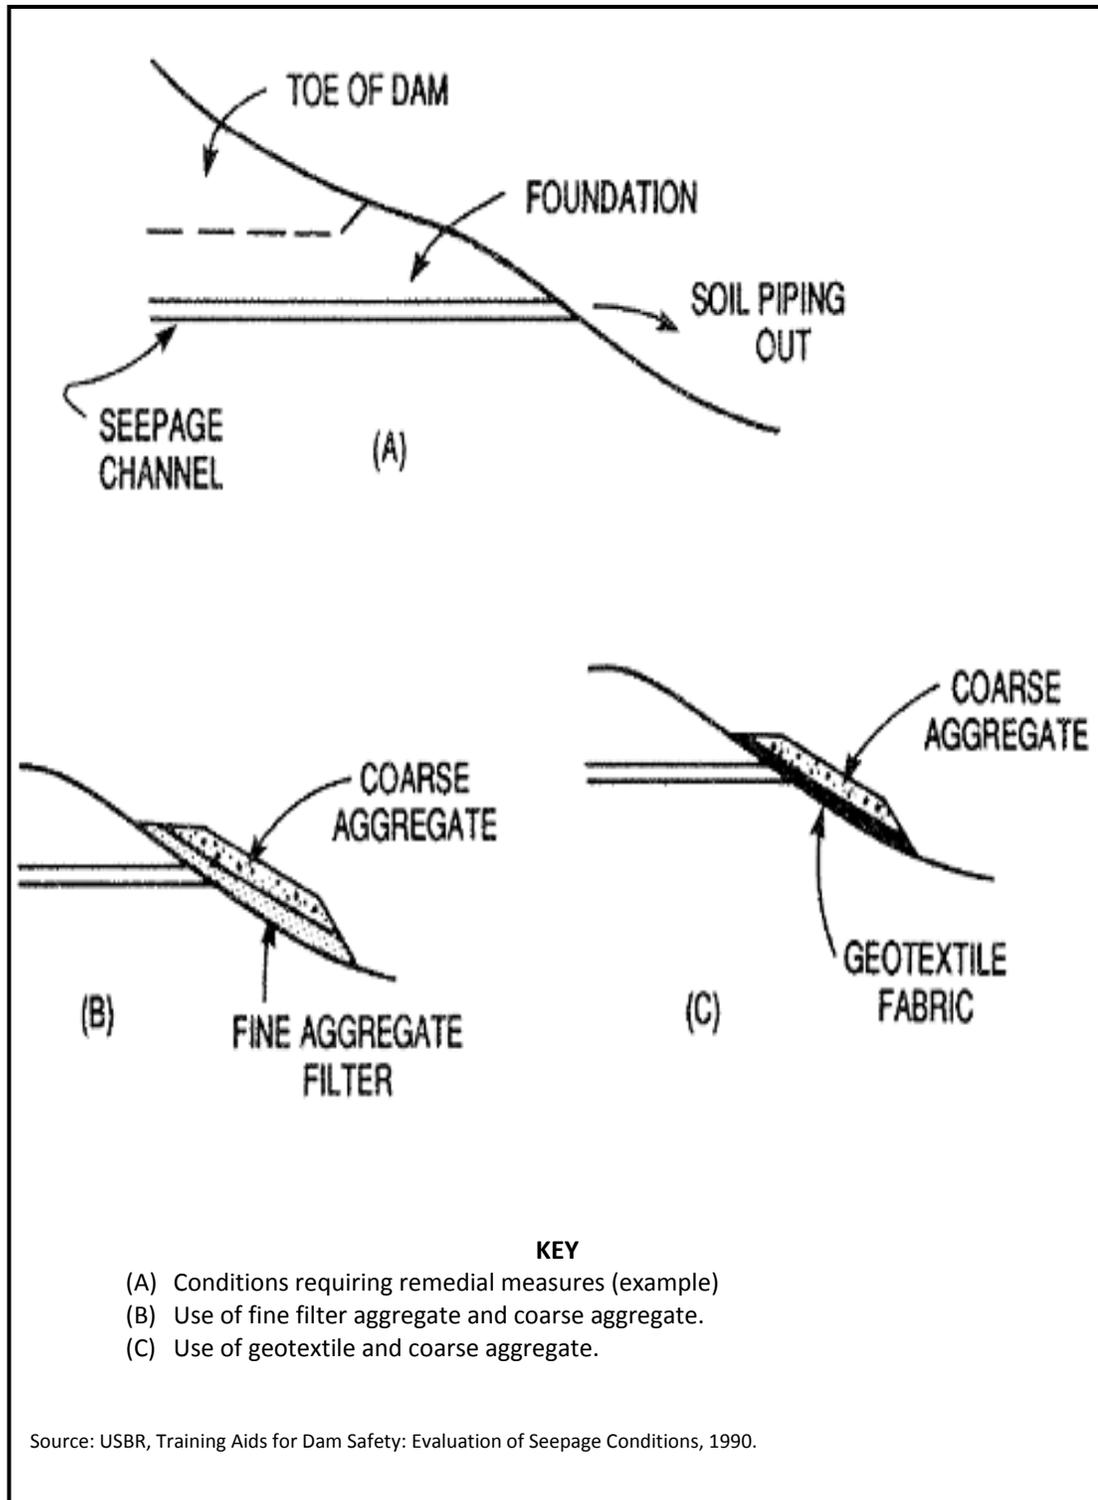
Figure 6-19: Emergency Filter Installation to Temporarily Control Piping on the Downstream Slope of an Embankment Dam

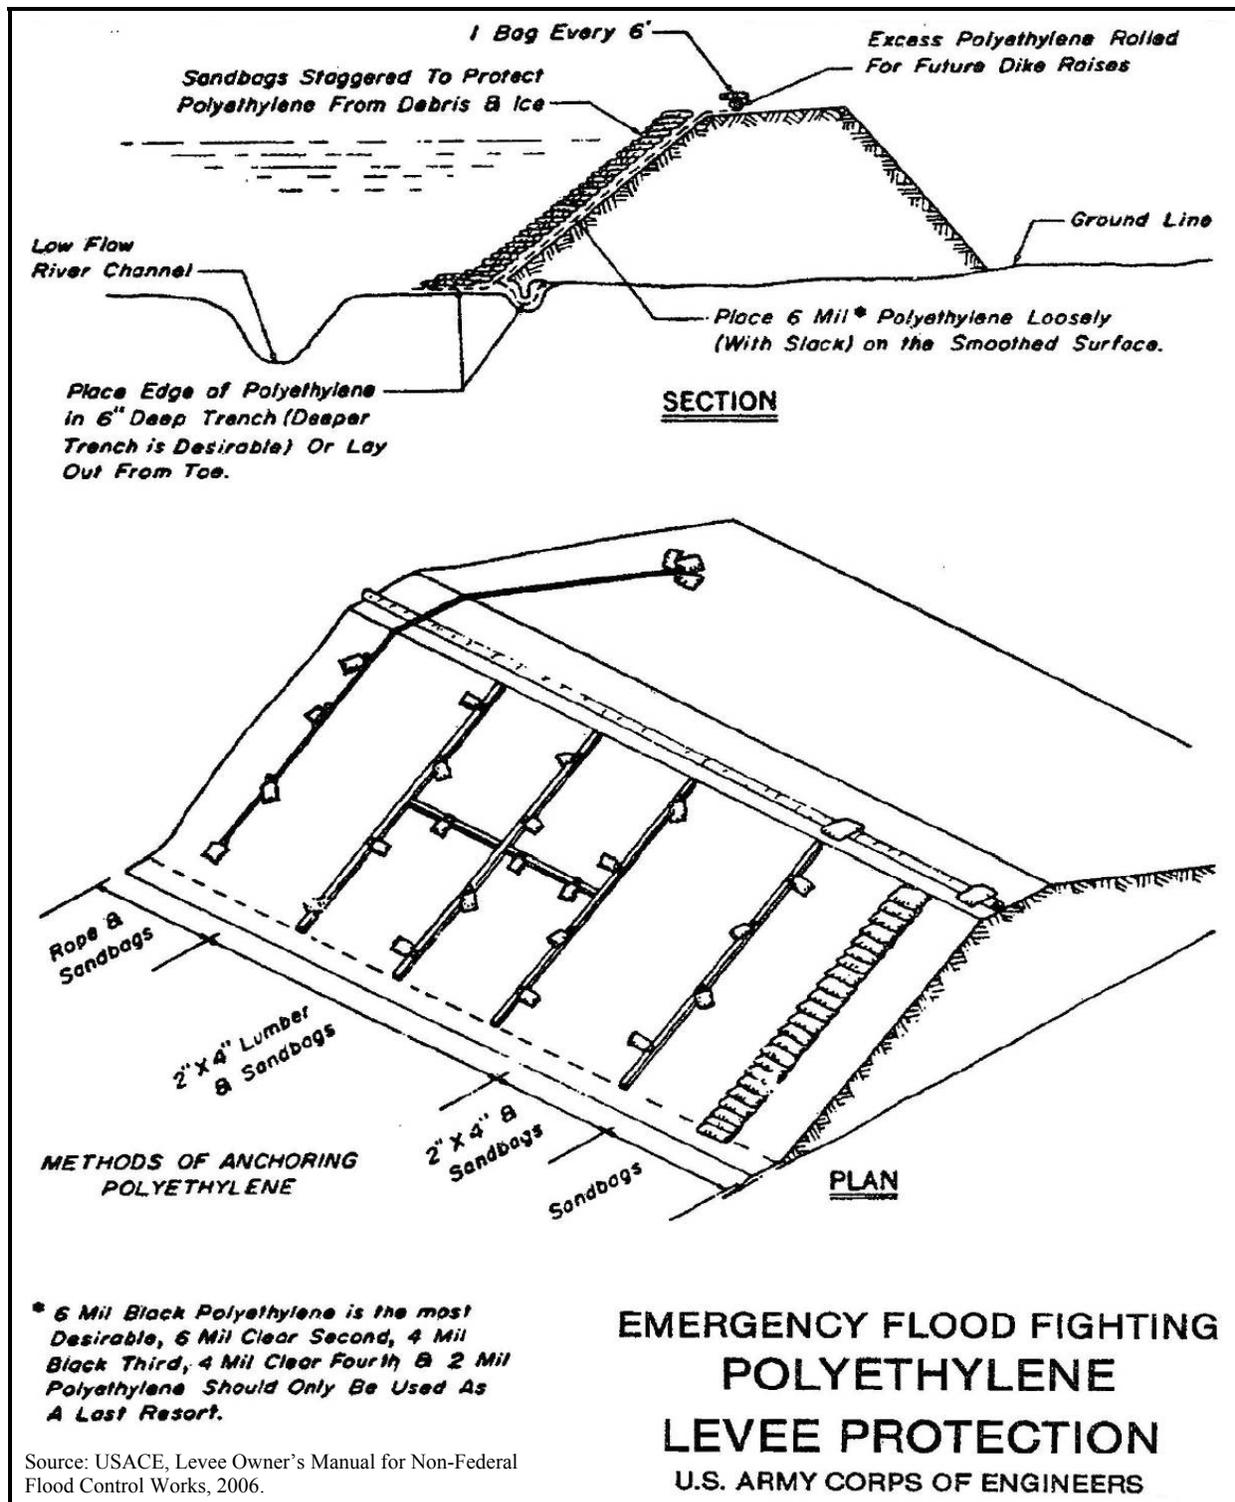
Figure 6-21: Placement of Polyethylene Slope Protection for Wave Erosion Protection In The Dry

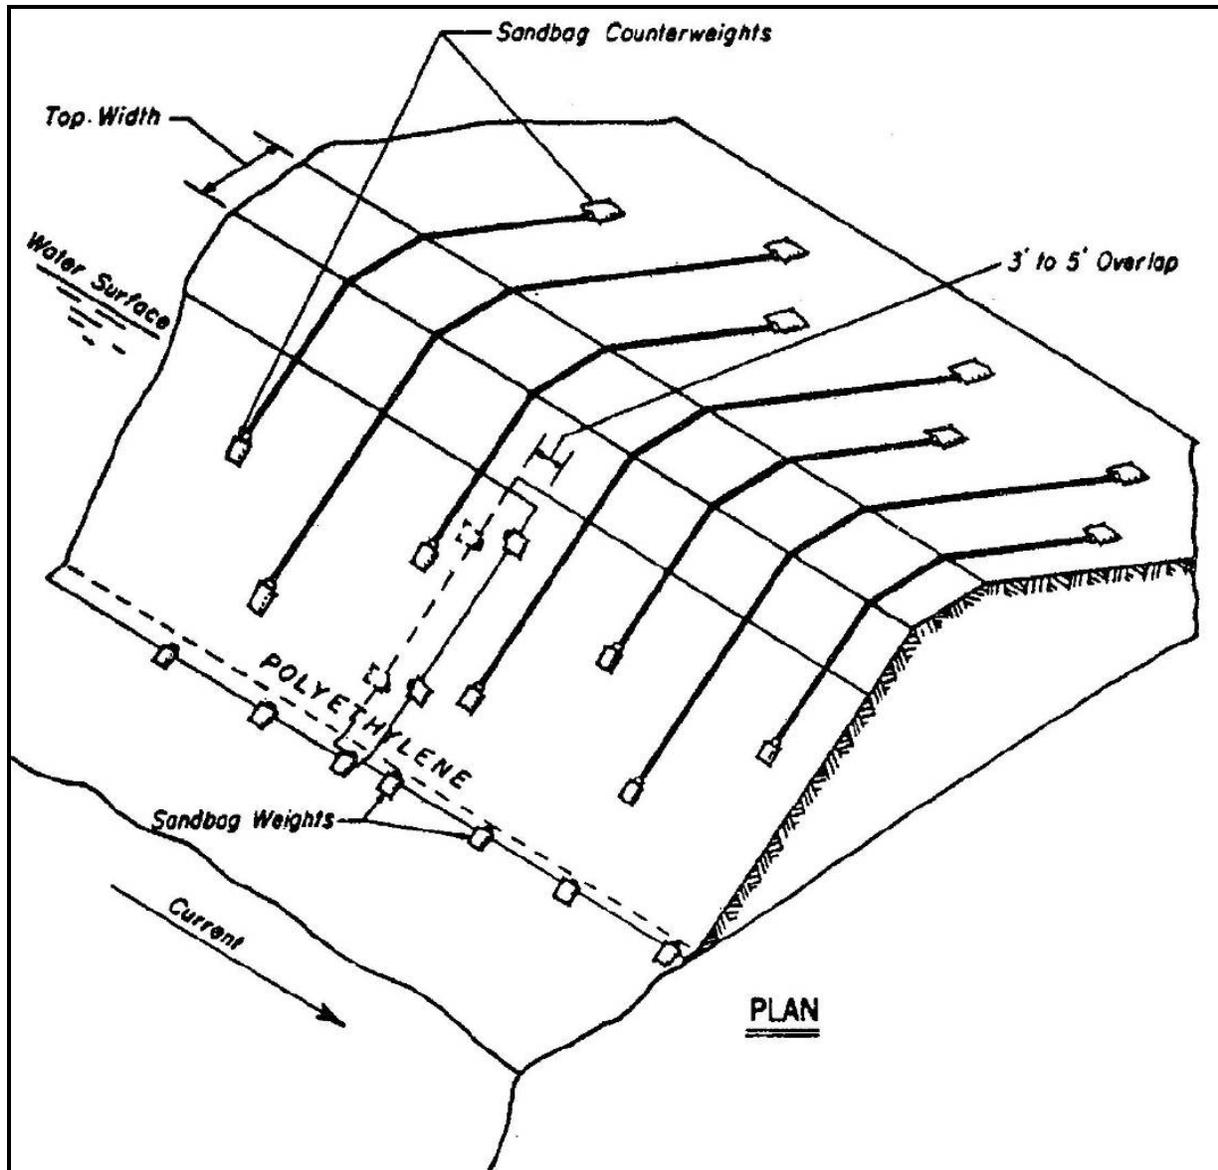
Figure 6-22: Placement of Polyethylene Sheeting For Wave Erosion Protection In The Wet

**EMERGENCY FLOOD FIGHTING
PLACEMENT OF
POLYETHYLENE
SHEETING IN THE WET
U.S. ARMY CORPS OF ENGINEERS**

Source: USACE, Levee Owner's Manual for Non-Federal Flood Control Works, 2006.

In many situations during high water, polyethylene sheeting and sandbags placed in the wet must provide the emergency protection. Wet placement may also be required to replace or maintain damaged polyethylene sheeting or polyethylene sheeting displaced by current action. Figure 6-22 shows a typical section of dam covered in the wet. Sandbag anchors are formed at the bottom edge and ends of the polyethylene sheeting by bunching the polyethylene sheeting around a fistful of sand or rock, and tying the sandbags to this fist-sized ball. Counterweights consisting of two or more sandbags connected by a length of ¼-inch rope are used to hold the center portion of the polyethylene sheeting down. The number of counterweights will depend on the uniformity of the dam slope and current velocity. Placement of the polyethylene sheeting consists of first casting out the polyethylene sheeting with the bottom weights and then adding counterweights to slowly sink the polyethylene sheeting into place. The polyethylene sheeting, in most cases, will continue to move down slope until the bottom edge reaches the toe of the slope. Sufficient counterweights should be added to insure that no air voids exist between the polyethylene sheeting and the dam face and to keep the polyethylene sheeting from flapping or being carried away in the current. For this reason, it is important to have enough counterweights prepared prior to the placement of the sheet.
