U.S. Fish & Wildlife Service Low Hazard Dams

**Standing
Operating
Procedures**

All USFWS Refuges

UNITED STATES DEPARTMENT OF THE INTERIOR
FISH & WILDLIFE SERVICE
All REGIONS

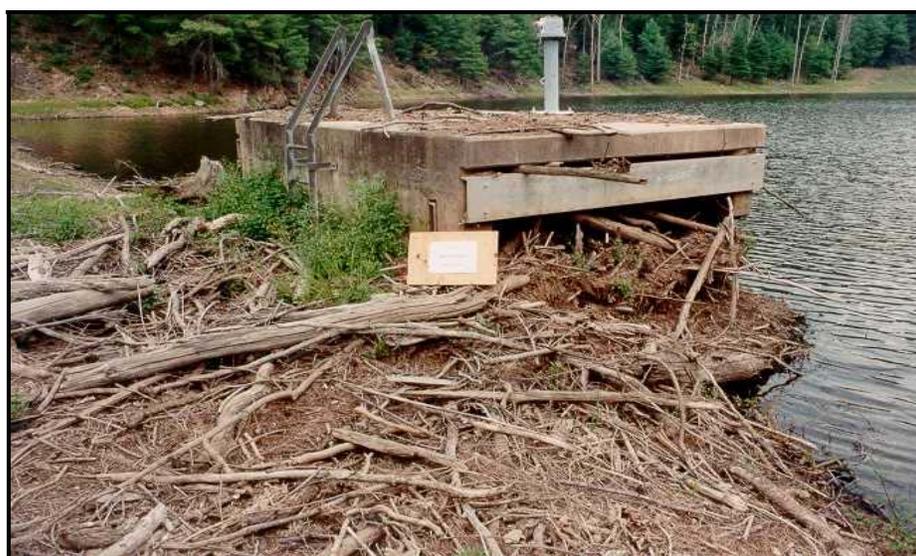
Figure 6-24: Debris Accumulation at Service Spillway Structure Can Obstruct Flow and Lead to Embankment Overtopping

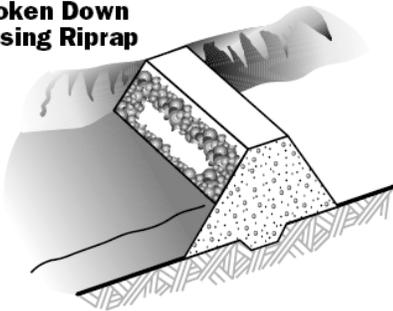
Broken Down Missing Riprap

Poor-quality riprap has deteriorated. Wave action or ice action has displaced riprap. Round and similar-sized rocks have rolled downhill. Wave action against these unprotected areas decreases embankment width.

Reestablish normal slope. Place bedding and competent riprap.

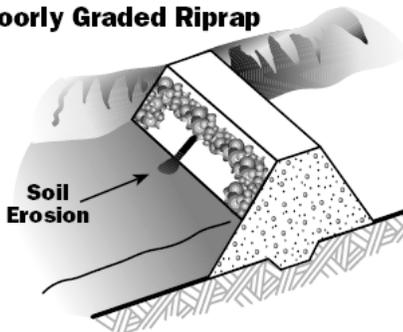
Erosion Behind Poorly Graded Riprap

Similar-sized rocks allow waves to pass between them and erode small gravel particles and soil. Soil is eroded away from behind the riprap. This allows riprap to settle, offering less protection and decreased embankment width.

Reestablish effective slope protection. Place bedding material.

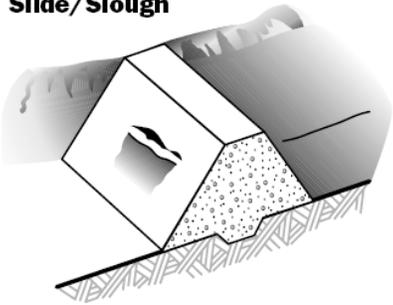
Problem	Probable Cause and Possible Consequences	Recommended Actions
<p>Slide/Slough</p>

<p>Lack loss of strength of embankment material. Loss of strength can be attributed to infiltration of water into the embankment or loss of support by the foundation. Massive slide cuts through crest or upstream slope reducing freeboard and cross-section. Structural collapse or overtopping can result</p>	<ol style="list-style-type: none"> 1. Measure extent and displacement of slide. If continued movement is seen, begin lowering water level until movement stops. 2. Have a qualified engineer inspect the condition and recommend further action. <p>RDSO NOTIFICATION REQUIRED</p>
<p>Transverse Cracking</p>

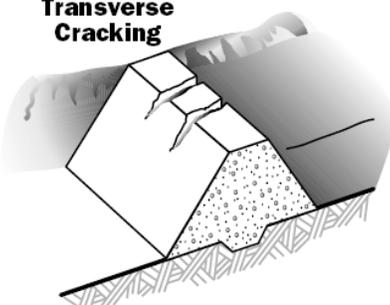
<ol style="list-style-type: none"> 1. Uneven movement between adjacent segments of the embankment. 2. Deformation caused by structural stressor instability. <p>1. Can provide a path for seepage through the embankment cross-section.</p> <ol style="list-style-type: none"> 2. Provides local area of low strength within embankment. Future structural movement, deformation or failure could begin. 3.. Provides entrance point for surface runoff to enter embankment 	<ol style="list-style-type: none"> 1. Inspect crack and carefully record crack location, length, depth, width and other pertinent physical features. Stake out limits of cracking. Engineer should determine cause of cracking and supervise all steps necessary to reduce danger to dam and correct condition. 2. Excavate slope along crack to a point below the bottom of the crack. Then, backfill excavation using competent material and correct construction techniques. This will seal the crack against seepage and surface runoff. This should be supervised by engineer. Continue to monitor crest routinely for evidence of future cracking. <p>RDSO NOTIFICATION REQUIRED</p>

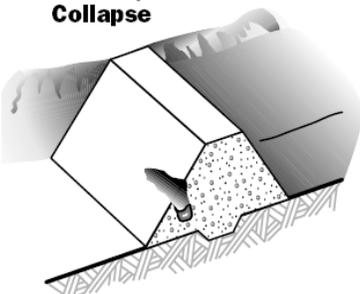
<p>Cave In/ Collapse</p>

<ol style="list-style-type: none"> 1. Lack of adequate compaction. 2. Rodent hole below. 3. Piping through embankment or foundation. 4. Presence of dispersive soils. <p>Indicates possible washout of embankment.</p>	<ol style="list-style-type: none"> 1. Inspect for and immediately repair rodent holes. Control rodents to prevent future damage. 2. Have a qualified engineer inspect the condition and recommend further action. <p>RDSO NOTIFICATION REQUIRED</p>

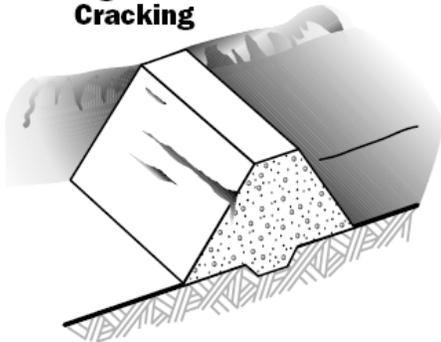
Longitudinal Cracking

1. Drying and shrinkage of surface material.
 2. Downstream movement or settlement of embankment.
1. Can be an early warning of a potential slide.
 2. Shrinkage cracks allow water to enter the embankment and freezing will further crack the embankment.
 3. Settlement or slide, showing loss of strength in embankment that can lead to failure.

1. If cracks are from drying, dress area with well-compacted material to keep surface water out and natural moisture in.
2. If cracks are extensive, a qualified engineer should inspect the condition and recommend further actions.

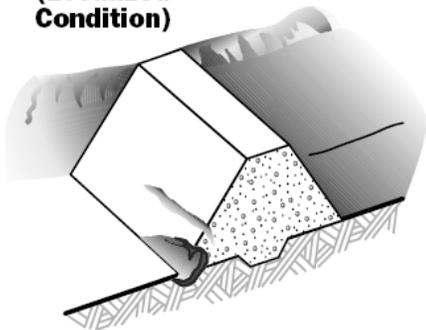
Slump (Localized Condition)

Preceded by erosion undercutting a portion of the slope. Can also be found on steep slopes. Can expose impervious zone to erosion and lead to additional slumps.

1. Inspect area for seepage.
2. Monitor for progressive failure.
3. Have a qualified engineer inspect the condition and recommend further action.

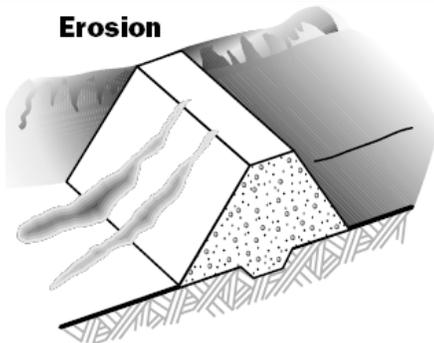
Water from intense rainstorms or snowmelt carries surface material down the slope, resulting in continuous troughs. Can be hazardous if allowed to continue. Erosion can lead to eventual deterioration of the downstream slope and failure of the structure.

1. The preferred method to protect eroded areas is rock or riprap.
2. Reestablishing protective grasses can be adequate if the problem is detected early.

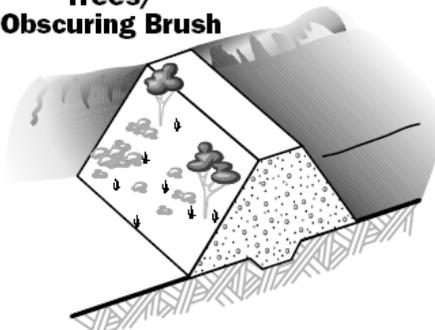
**Trees/
Obscuring Brush**

Natural vegetation in area. Large tree roots can create seepage paths. Large trees can blow over during storms and damage dam or cause breach. Bushes can obscure visual inspection and harbor rodents.

1. According to the FWS Tree Removal Guidelines (See Appendix F), any trees growing on the upstream slope that are less than 2 inches in diameter should be cut and treated. Trees growing on the downstream slope that are greater than 2 inches should be removed. Trees growing on the crest, downstream slope and 20 feet beyond the toe of the dam that are less than 6 inches in diameter should be cut and removed. Trees growing on the crest, downstream slope and 20 feet beyond the toe of the dam that are greater than 6 inches in diameter should be removed.
2. Control vegetation on the embankment that obscures visual inspection.

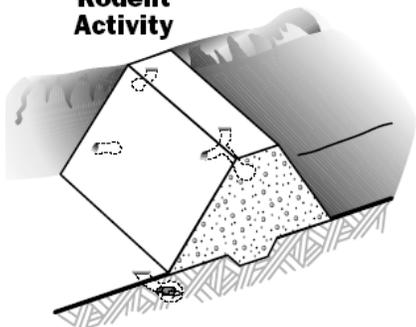
**Rodent
Activity**

Overabundance of rodents. Animal burrowing creates holes, tunnels, and caverns. Certain habitats, such as cattail-filled areas and trees close to the reservoir encourage these animals.

Can reduce length of seepage path and lead to piping failure. If tunnel runs through most of the dam, it can lead to collapse.

1. Control rodents to prevent more damage.
2. Backfill existing rodent holes.
3. Remove rodents. Determine exact location and extent of tunneling. Remove habitat and repair damages.

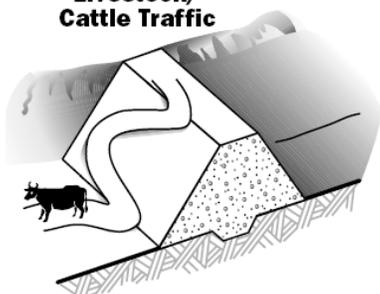
**Livestock/
Cattle Traffic**

Excessive travel by livestock especially harmful to slope when wet.

Creates areas bare of erosion protection and causes erosion channels. Allows water to stand. Area susceptible to drying cracks.

1. Fence livestock outside embankment area.
2. Repair erosion protection, i.e. riprap, grass.

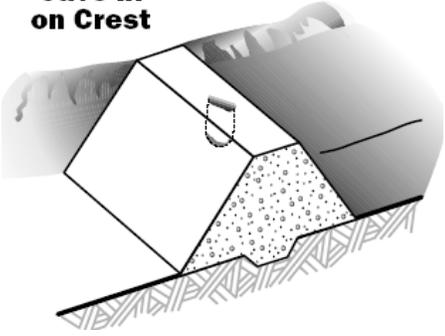
Problem	Probable Cause and Possible Consequences	Recommended Actions
<p>Cave-In on Crest</p>

<ol style="list-style-type: none"> 1. Rodent activity. 2. Hole in outlet conduit is causing erosion of embankment material. 3. Internal erosion or piping of embankment material by seepage. 4. Breakdown of dispersive clays within embankment by seepage waters. <ol style="list-style-type: none"> 1. Void within dam could cause localized caving, sloughing, instability or reduced embankment cross-section. 2. Entrance point for surface water. 	<ol style="list-style-type: none"> 1. Carefully inspect and record location and physical characteristics (depth, width, length) of cave-in. 2. Engineer should determine cause of cave-in and supervise all steps necessary to reduce threat to dam and correct condition. 3. Excavate cave-in, slope sides of excavation and backfill hole with competent material using proper construction techniques. This should be supervised by engineer. <p>RDSO NOTIFICATION REQUIRED</p>

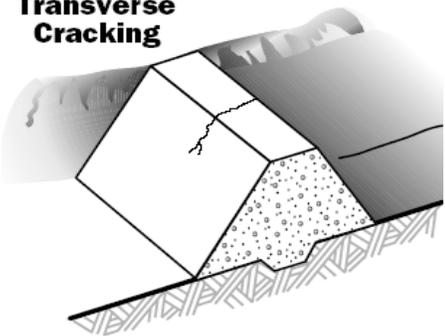
<p>Transverse Cracking</p>

<ol style="list-style-type: none"> 1. Uneven movement between adjacent segments of the embankment. 2. Deformation caused by structural stressor instability. <ol style="list-style-type: none"> 1. Can provide a path for seepage through the embankment cross-section. 2. Provides local area of low strength within embankment. Future structural movement, deformation or failure could begin. 3. Provides entrance point for surface runoff to enter embankment. 	<ol style="list-style-type: none"> 1. Inspect crack and carefully record crack location, length, depth, width and other pertinent physical features. Stake out limits of cracking. 2. Engineer should determine cause of cracking and supervise all steps necessary to reduce danger to dam and correct condition. 3. Excavate crest along crack to a point below the bottom of the crack. Then backfilling excavation using competent material and correct construction techniques. This will seal the crack against seepage and surface runoff. This should be supervised by engineer. 4. Continue to monitor crest routinely for evidence of future cracking. <p>RDSO NOTIFICATION REQUIRED</p>

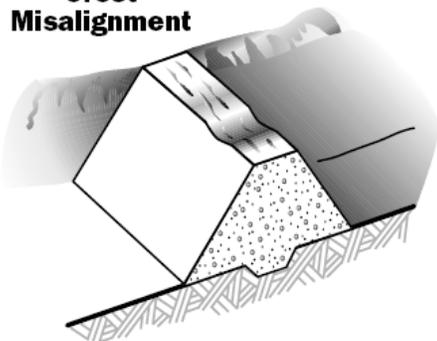
Crest Misalignment

1. Movement between adjacent parts of the structure.
 2. Uneven deflection of dam under loading by reservoir.
 3. Structural deformation or failure near area of misalignment.
-
1. Area of misalignment is usually accompanied by low area in crest which reduces freeboard.
 2. Can produce local areas of low embankment strength which may lead to failure.

1. Establish monuments across crest to determine exact amount, location, and extent of misalignment.
2. Engineer should determine cause of misalignment and supervise all steps necessary to reduce threat to dam and correct condition.
3. Following remedial action, monitor crest monuments according to a schedule to detect any movement.

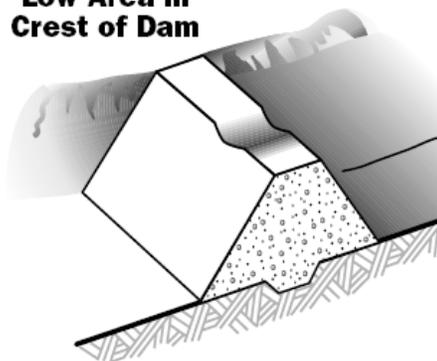
Low Area in Crest of Dam

1. Excessive settlement in the embankment or foundation directly beneath the low area in the crest.
2. Internal erosion of embankment material.
3. Foundation spreading to upstream and/or downstream direction.
4. Prolonged wind erosion of crest area.
5. Improper final grading following construction. Reduces freeboard available to pass flood flows safely through spillway.

1. Establish monuments along length of crest to determine exact amount, location, and extent of settlement in crest.
2. Engineer should determine cause of low area and supervise all steps necessary to reduce possible threat to the dam and correct condition.
3. Reestablish uniform crest elevation over crest length by filling in low area using proper construction techniques. This should be supervised by engineer.
4. Reestablish monuments across crest of dam and routinely monitor monuments to detect any settlement.

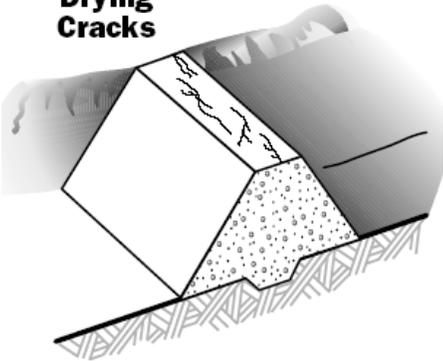
Problem	Probable Cause and Possible Consequences	Recommended Actions
<p>Drying Cracks</p>

<p>Material on the crest of dam expands and contracts with alternate wetting and drying of weather cycles. Drying cracks are usually short, shallow, narrow, and numerous. Point of entry for surface runoff and surface moisture, causing saturation of adjacent embankment areas. This saturation, and later drying of the dam, could cause further cracking.</p>	<ol style="list-style-type: none"> 1. Seal surface cracks with a tight, impervious material. 2. Routinely grade crest to proper drainage and fill cracks. 3. Cover crest with non-plastic material (not clay) to prevent large variations in moisture content.
<p>Obscuring Vegetation</p>

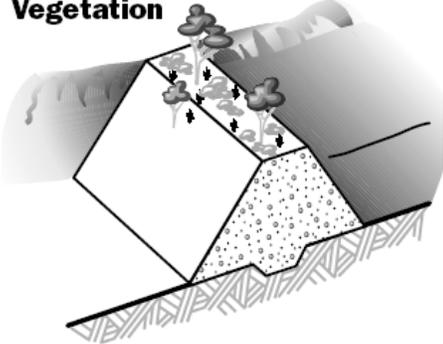
<p>Neglect of dam and lack of proper maintenance procedures.</p> <ol style="list-style-type: none"> 1. Obscures large parts of the dam, preventing adequate, accurate visual inspection of all parts of the dam. Problems which threaten the integrity of the dam can develop and remain undetected until they progress to a point that threatens the dam's safety. 2. Associated root systems develop and penetrate into the dam's cross section. When the vegetation dies, the decaying root systems can provide paths for seepage. This reduces the effective seepage path through the embankment and could lead to possible piping situations. 3. Prevents easy access to all parts of the dam for operation, maintenance and inspection. 4. Provides habitat for rodents. 5. Large trees can blow over during storms, resulting in damage and possible breach of the dam. 	<ol style="list-style-type: none"> 1. According to the FWS Tree Removal Guidelines (See Appendix F), any trees growing on the upstream slope that are less than 2 inches in diameter should be cut and treated. Trees growing on the downstream slope that are greater than 2 inches should be removed. Trees growing on the crest, downstream slope and 20 feet beyond the toe of the dam that are less than 6 inches in diameter should be cut and removed. Trees growing on the crest, downstream slope and 20 feet beyond the toe of the dam that are greater than 6 inches in diameter should be removed. Grass should be encouraged on all segments of the dam to prevent erosion by surface runoff. The void which results from removing the root system should be backfilled with well-competent, well-compacted material. 2. Future undesirable growth should be removed by cutting or spraying, as part of an annual maintenance program. 3. All cutting or debris resulting from the vegetative removal should be immediately taken from the dam and properly disposed of outside

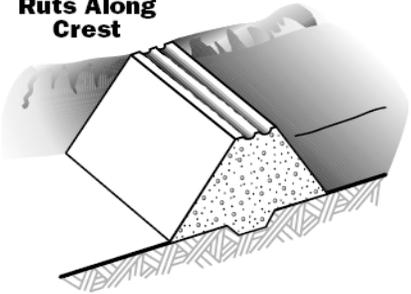
Problem	Probable Cause and Possible Consequences	Recommended Actions
<p>Ruts Along Crest</p>

<ol style="list-style-type: none"> 1. Inhibits easy access to all parts of crest. 2. Allows continued development of rutting. 3. Allows standing water to collect and saturate crest of dam. 4. Operating and maintenance vehicles can get stuck. 	<p>the reservoir basin. An engineer should be involved if the tree removal process poses a threat to the dam.</p> <ol style="list-style-type: none"> 1 Drain standing water from ruts. 2. Regrade and recompact crest to restore integrity and provide proper drainage to upstream slope. 3. Provide gravel or road base material to accommodate traffic. 4. Periodically maintain and regrade to prevent ruts reforming.
<p>Rodent Activity</p>

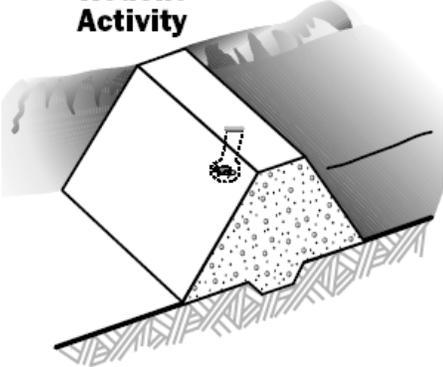
<p>Burrowing animals.</p> <ol style="list-style-type: none"> 1. Entrance point for surface runoff to enter dam. Could saturate adjacent portions of the dam. 2. Especially dangerous if hole penetrates dam below phreatic line. During periods of high storage, seepage path through the dam would be greatly reduced and a piping situation could develop. Tunnels can lead to collapse of crest and possible failure. 	<ol style="list-style-type: none"> 1. Completely backfill the hole with competent well-compacted material. 2. Initiate a rodent control program to reduce the burrowing animal population and to prevent future damage to the dam.

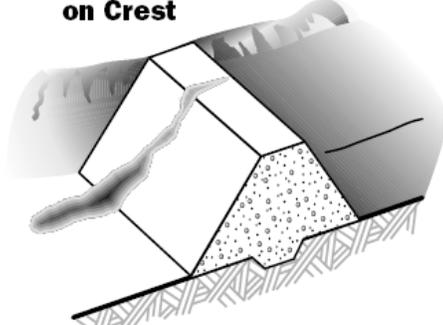
<p>Gully on Crest</p>

<ol style="list-style-type: none"> 1. Poor grading and improper drainage of crest. Improper drainage causes surface runoff to collect and drain off crest at low point in upstream or downstream shoulder. 2. Inadequate spillway capacity which has caused dam to overtop. <ol style="list-style-type: none"> 1. Can reduce available freeboard. 2. Reduces cross-sectional area of dam. 3. Inhibits access to all parts of the crest and dam. 4. Can result in a hazardous condition if due to overtopping. Heavy vehicle traffic without 	<ol style="list-style-type: none"> 1. Restore freeboard to dam by adding fill material to low area, using proper construction techniques. 2. Regrading crest to provide proper drainage of surface runoff. 3. If gully was caused by overtopping, create adequate spillway that meets current design standards. This should be done by engineer. 4. Reestablish protective cover.

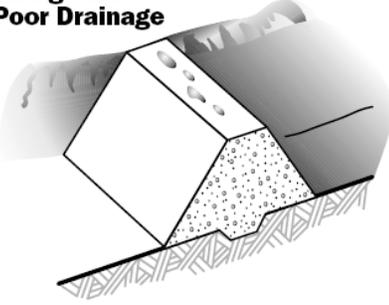
Problem	Probable Cause and Possible Consequences	Recommended Actions
<p>Puddling on Crest— Poor Drainage</p>

<p>adequate or proper maintenance or proper crest surfacing</p> <ol style="list-style-type: none"> 1. Poor grading and improper drainage of crest. 2. Localized consolidation or settlement on crest allows puddles to develop. <ol style="list-style-type: none"> 1. Causes localized saturation of the crest. 2. Inhibits access to all parts of the dam and crest. 3. Becomes progressively worse if not corrected. 	<ol style="list-style-type: none"> 1. Drain standing water from puddles. 2. Regrade and recompact crest to restore integrity and provide proper drainage to upstream slope. 3. Provide gravel or road base material to accommodate traffic. 4. Periodically maintain and regrade to prevent low areas reforming.

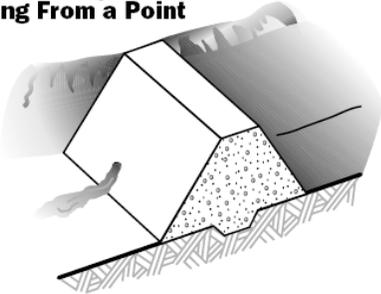
Problem	Probable Cause and Possible Consequences	Recommended Actions
<p>Excessive Quantity and/or Muddy Water Exiting From a Point</p>

<ol style="list-style-type: none"> 1. Water has created an open pathway, channel or pipe through the dam. The water is eroding and carrying embankment material. 2. Large amounts of water have accumulated in the downstream slope. Water and embankment materials are exiting at one point. Surface agitation may be causing the muddy water. 3. Rodents, frost action or poor construction have allowed water to create an open pathway or pipe through the embankment. 	<ol style="list-style-type: none"> 1. Begin measuring outflow quantity and establishing whether water is getting muddier, staying the same or clearing up. 2. If quantity of flow is increasing, water level in reservoir should be lowered until flow stabilizes or stops. 3. Search for opening on upstream side and plug if possible. 4. A qualified engineer should inspect the condition and recommend further actions to be taken. <p>RDSO NOTIFICATION REQUIRED</p>

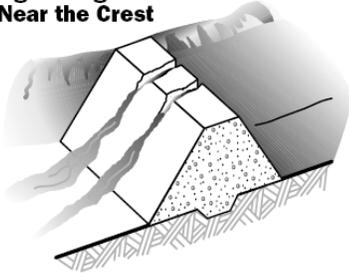
<p>Stream of Water Exiting Through Cracks Near the Crest</p>

<ol style="list-style-type: none"> 1. Continued flows can saturate parts of the embankment and lead to slides in the area. 2. Continued flows can further erode embankment materials and lead to failure of the dam. 	<ol style="list-style-type: none"> 1. Severe drying has caused shrinkage of embankment material. 2. Settlement in the embankment or foundation is causing the transverse cracks. Flow through the crack can cause failure of the dam. <p>RDSO NOTIFICATION REQUIRED</p>
<p>Wet Area in Horizontal Band</p>

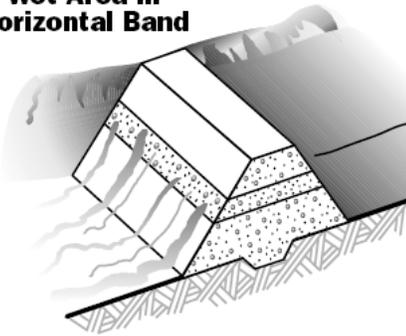
<p>Frost layer or layer of sandy material in original construction.</p> <ol style="list-style-type: none"> 1. Wetting of areas below the area of excessive seepage can lead to localized instability of the embankment, resulting in slides. 2. Excessive flows can lead to accelerated erosion of embankment materials and failure of the dam. 	<ol style="list-style-type: none"> 1. Plug upstream side of crack to stop flow. 2. Lower water level in the reservoir should be lowered until below level of cracks. 3. A qualified engineer should inspect the condition and recommend further actions. <p>RDSO NOTIFICATION REQUIRED</p> <ol style="list-style-type: none"> 1. Determine as closely as possible the flow being produced. 2. If flow increases, reservoir level should be reduced until flow stabilizes or stops. 3. Stake out the exact area involved. 4. Using hand tools, try to identify the material allowing the flow. 5. A qualified engineer should inspect the condition and recommend

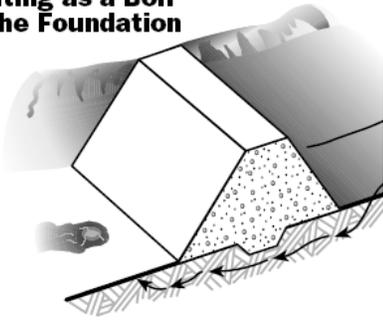
Problem	Probable Cause and Possible Consequences	Recommended Actions
<p>Seepage Water Exiting as a Boil in the Foundation</p>

<p>Some part of the foundation material is supplying a flow path. This could be caused by a sand or gravel layer in the foundation. Increased flows can lead to erosion of the foundation and failure of the dam. See Figures 6-9 thru 6-13 for examples.</p>	<ol style="list-style-type: none"> 1. Examine the boil for transportation of foundation materials. 2. If soil particles are moving downstream, sandbags or earth should be used to create a dike around the boil. The pressures created by the water level with the dike may control flow velocities and temporarily prevent further erosion. 3. If erosion is becoming greater, the reservoir level should be lowered. 4. A qualified engineer should inspect the condition and recommend further actions. <p>RDSO NOTIFICATION REQUIRED</p>

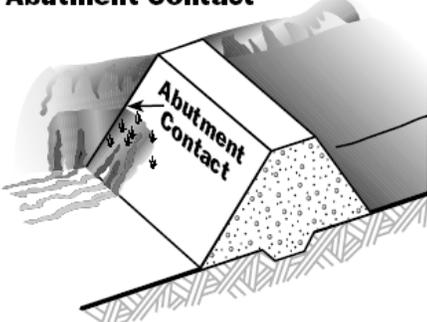
<p>Seepage Exiting at Abutment Contact</p>

<ol style="list-style-type: none"> 1. Water flowing through pathways in the abutment. 2. Water flowing through the embankment. Can lead to erosion of embankment materials and failure of the dam. 	<ol style="list-style-type: none"> 1. Study leakage area to determine quantity of flow and extent of saturation. 2. Inspect daily for developing slides. 3. Water level in reservoir may need to be lowered to assure the safety of the embankment. 4. A qualified engineer should inspect the condition and recommend further actions. <p>RDSO NOTIFICATION REQUIRED</p>
<p>Large Area Wet or Producing Flow</p>

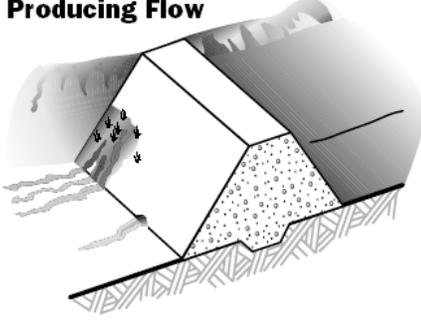
<p>A seepage path has developed through the abutment or embankment materials and failure of the dam can occur.</p> <ol style="list-style-type: none"> 1. Increased flows could lead to erosion of embankment material and failure of the dam. 2. Saturation of the embankment can lead to local slides which could cause failure of the dam. 	<ol style="list-style-type: none"> 1. Stake out the saturated area and monitor for growth or shrinking. 2. Measure any outflows as accurately as possible. 3. Reservoir level may need to be lowered if saturated areas grow at a fixed storage level or if flow increases. 4. A qualified engineer should inspect the condition and recommend further actions. <p>RDSO NOTIFICATION REQUIRED</p>

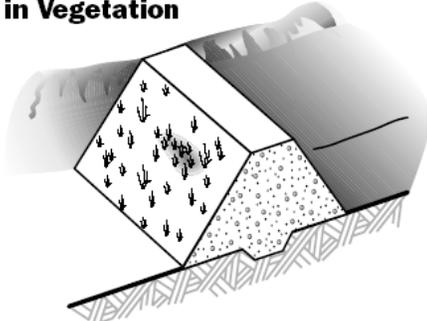
Problem	Probable Cause and Possible Consequences	Recommended Actions
<p>Marked Change in Vegetation</p>

<ol style="list-style-type: none"> 1. Embankment materials are supplying flow paths. 2. Natural seeding by wind. 3. Change in seed type during early post-construction seeding. Can show a saturated area. 	<ol style="list-style-type: none"> 1. Use probe and shovel to establish if the materials in this area are wetter than surrounding areas. 2. If area shows wetness, when surrounding areas are dry or drier, a qualified engineer should inspect the condition and recommend further actions. <p>RDSO NOTIFICATION REQUIRED</p>
<p>Bulge in Large Wet Area</p>

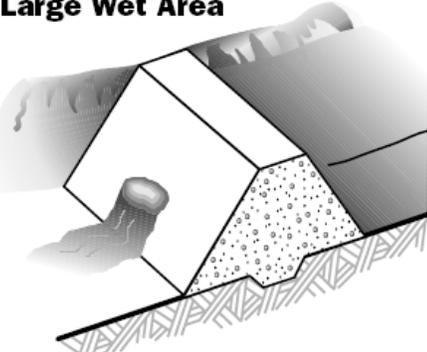
<p>Downstream embankment materials have begun to move. Failure of the embankment resulting from massive sliding can follow these early movements.</p>	<ol style="list-style-type: none"> 1. Compare embankment cross-section to the end of construction condition to see if observed condition may reflect end of construction. 2. Stake out affected area and accurately measure outflow. 3. A qualified engineer should inspect the condition and recommend further actions. <p>RDSO NOTIFICATION REQUIRED</p>

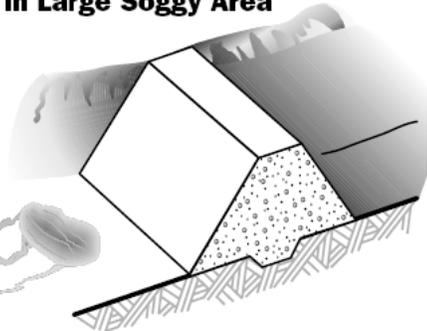
<p>Trampoline Effect in Large Soggy Area</p>

<p>Water moving rapidly through the embankment or foundation is being controlled or contained by a well-established turf root system. Condition shows excessive seepage in the area. If control layer of turf is destroyed, rapid erosion of foundation materials could result in failure of the dam.</p>	<ol style="list-style-type: none"> 1. Carefully inspect the area for outflow quantity and any transported material. 2. A qualified engineer should inspect the condition and recommend further actions. <p>RDSO NOTIFICATION REQUIRED</p>

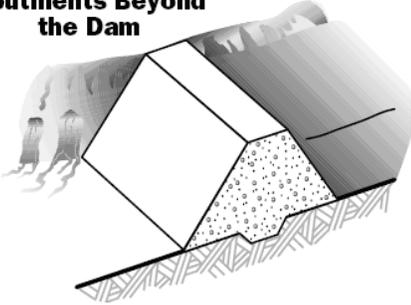
Problem	Probable Cause and Possible Consequences	Recommended Actions
<p>Leakage From Abutments Beyond the Dam</p>

<p>Water moving through cracks and fissures in the abutment materials. Can lead to rapid erosion of abutment and evacuation of the reservoir. Can lead to massive slides near or downstream from the dam.</p>	<ol style="list-style-type: none"> 1. Carefully inspect the area to determine quantity of flow and amount of transported material. 2. A qualified engineer or geologist should inspect the condition and recommend further actions. <p>RDSO NOTIFICATION REQUIRED</p>

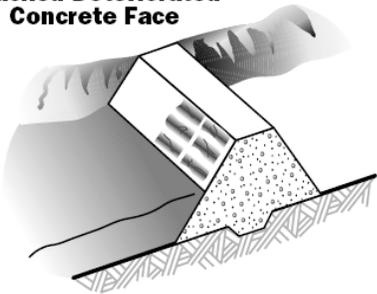
<p>Concrete deteriorated from weathering. Joint filler deteriorated or displaced. Soil is eroded behind the face and caverns can be formed. Unsupported sections of concrete crack. Ice action may displace concrete.</p>	<ol style="list-style-type: none"> Determine cause. Either patch with grout or contact engineer for permanent repair method. If damage is extensive, a qualified engineer should inspect the condition and recommend further actions. <p style="text-align: center;">RDSO NOTIFICATION REQUIRED</p>

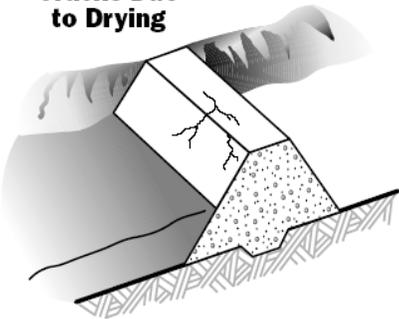
<p>Cracks Due to Drying</p>

<p>Soil loses its moisture and shrinks, causing cracks. <i>Note:</i> Usually limited to crest and downstream slope. Heavy rains can fill cracks and cause small parts of embankment to move along internal slip surface.</p>	<ol style="list-style-type: none"> Monitor cracks for increases in width, depth, or length. A qualified engineer should inspect condition and recommend further actions. <p style="text-align: center;">RDSO NOTIFICATION REQUIRED</p>

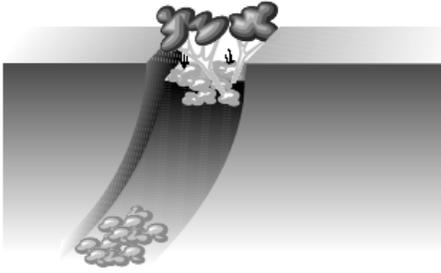
Problem	Probable Cause and Possible Consequences	Recommended Actions
<p>Excessive Vegetation or Debris in Channel</p>

<p>Accumulation of slide materials, dead trees, excessive vegetative growth, etc., in spillway channel.</p> <p>Reduced discharge capacity; overflow of spillway, overtopping of dam. Prolonged overtopping can cause failure of the dam.</p>	<p>Clean out debris periodically; control vegetative growth in spillway channel. Install log boom in front of spillway entrance to intercept debris.</p>
<p>Erosion Channels</p>

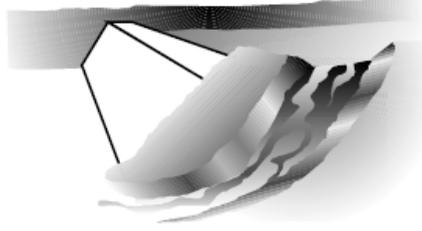
<p>Surface runoff from intense rainstorms or flow from spillway carries surface material down the slope, resulting in continuous troughs. Livestock traffic creates gullies where flow concentrates varies.</p> <p>Unabated erosion can lead to slides, slumps or slips which can result in reduced spillway capacity. Inadequate spillway capacity can lead to embankment overtopping and result in dam failure.</p>	<p>Photograph condition. Repair damaged areas by replacing eroded material with compacted fill. Protect areas against future erosion by installing suitable rock riprap. Re-vegetate area if appropriate. Bring condition to the attention of the engineer during next inspection.</p>

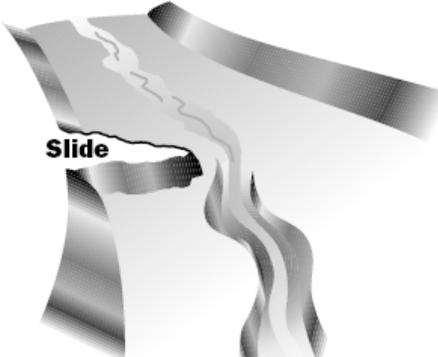
<p>Excessive Erosion in Earth-Slide Causes Concentrated Flows</p>

<p>Discharge velocity too high; bottom and slope material loose or deteriorated; channel and bank slopes too steep; bare soil unprotected; poor construction protective surface failed.</p> <p>Disturbed flow pattern; loss of material, increased sediment load downstream, collapse of banks; failure of spillway; can lead to rapid evacuation of the reservoir through the severely eroded spillway.</p>	<p>Minimize flow velocity by proper design. Use sound material. Keep channel and bank slopes mild. Encourage growth of grass on soil surface. Construct smooth and well-compacted surfaces. Protect surface with riprap, asphalt or concrete. Repair eroded portion using sound construction practices.</p>

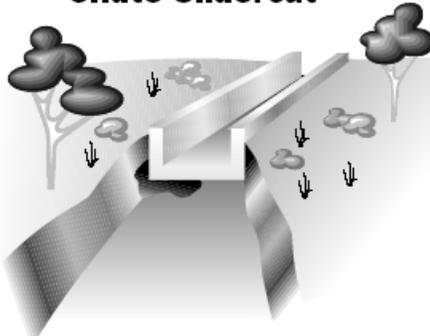
End of Spillway Chute Undercut

Poor configuration of stilling basin area. Highly erodible materials. Absence of cut-off wall at end of chute.

Structural damage to spillway structure; collapse of slab and wall lead to costly repair.

Dewater affected area; clean out eroded area and properly backfill. Improve stream channel below chute; provide properly sized riprap in stilling basin area. Install cutoff wall.

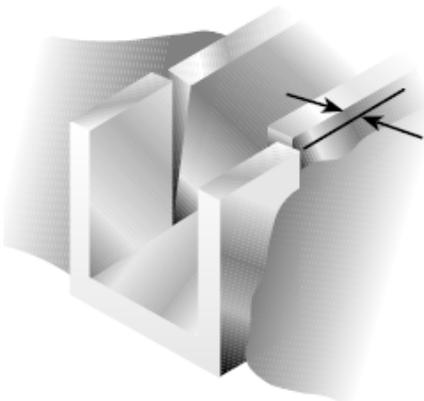
Wall Displacement

Poor workmanship; uneven settlement of foundation; excessive earth and water pressure; insufficient steel bar reinforcement of concrete.

Minor displacement will create eddies and turbulence in the flow, causing erosion of the soil behind the wall. Major displacement will cause severe cracks and eventual failure of the structure. See Figure 5-5 for examples.

Reconstruction should be done according to sound engineering practices. Foundation should be carefully prepared. Adequate weep holes should be installed to relieve water pressure behind wall. Use enough reinforcement in the concrete. Anchor walls to prevent further displacement. Install struts between spillway walls. Clean out and back flush drains to assure proper operations. Consult an engineer before actions are taken.

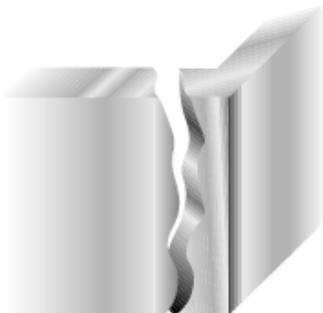
Large Cracks

Construction defect; local concentrate distress; local material deterioration; foundation failure, excessive backfill pressure. Disturbance in flow patterns; erosion of foundation and backfill; eventual collapse of structure. See Figure 5-5 for examples.

Large cracks without large displacement should be repaired by patching.

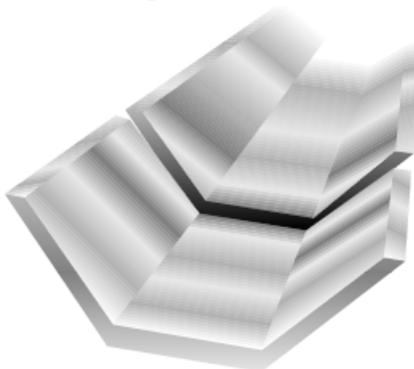
Open or Displaced Joints

Excessive and uneven settlement of foundation; sliding of concrete slab; construction joint too wide and left unsealed. Sealant deteriorated and washed away.

Erosion of foundation material may weaken support and cause further cracks; pressure induced by water flowing over displaced joints may wash away wall or slab, or cause extensive undermining.

Construction joint should be no wider than 1/2". All joints should be sealed with asphalt or other flexible materials. Water stops should be used where feasible. Clean the joint, replace eroded materials, and seal the joint. Foundations should be properly drained and prepared. Underside of chute slabs should have ribs of enough depth to prevent sliding. Avoid steep chute slope.

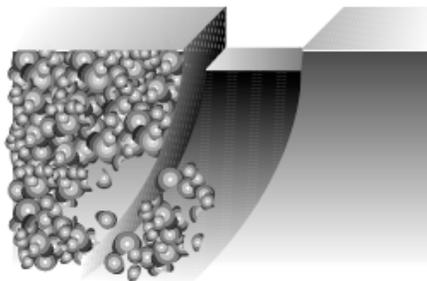
Breakdown and Loss of Riprap

Slope too steep; material poorly graded; failure of subgrade; flow velocity too high; improper placement of material; bedding material or foundation washed away.

Erosion of channel bottom and banks; failure of spillway.

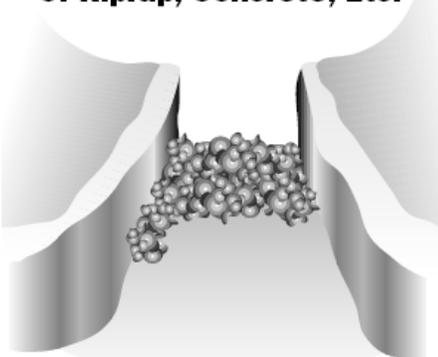
Problem	Probable Cause and Possible Consequences	Recommended Actions
<p>Material Deterioration—Spalling and Disintegration of Riprap, Concrete, Etc.</p>

<p>Use of unsound or defective materials; structures subject to freeze-thaw cycles; improper maintenance practices; harmful chemicals. Structure life will be shortened; premature failure.</p>	<p>Avoid using shale or sandstone for riprap. Add air-entraining agent when mixing concrete. Use only clean, good quality aggregates in the concrete. Steel bars should have at least 1" of concrete cover. Concrete should be kept damp and protected from freezing during curing.</p>

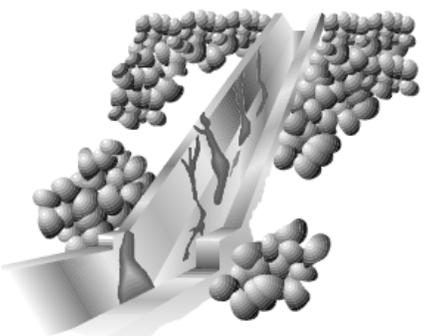
<p>Poor Surface Drainage</p>

<p>No weep holes; no drainage facility; plugged drains.</p> <p>Wet foundation has lower supporting capacity; uplift pressure resulting from seepage water may damage spillway chute; accumulation of water may also increase total pressure on spillway walls and cause damage.</p>	<p>Install weep holes on spillway walls. Inner end of hole should be surrounded and packed with graded filtering material. Install drain system under spillway near downstream end. Clean out existing weep holes. Back flush and rehabilitate drain system under the supervision of an engineer.</p> <p>RDSO NOTIFICATION REQUIRED</p>
------------------------------------------------------------------------------------------------------------------------	-------------------------------------------------------------------------------------------------------------------------------------------------------------------------------------------------------------------------------------------------------------------------------------	------------------------------------------------------------------------------------------------------------------------------------------------------------------------------------------------------------------------------------------------------------------------------------------------------------------------------------------------

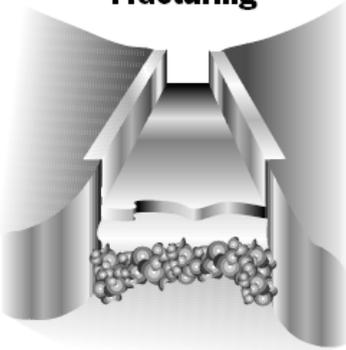
Problem	Probable Cause and Possible Consequences	Recommended Actions
<p>Concrete Erosion, Abrasion, and Fracturing</p>

<p>Flow velocity too high (usually occurs at lower end of chute in high dams); rolling of gravel and rocks down the chutes; cavity behind or below concrete slab.</p> <p>Pockmarks and spalling of concrete surface may progressively worsen; small hole may cause undermining of foundation, leading to failure of structure.</p>	<p>Remove rocks and gravels from spillway chute before flood season. Raise water level in stilling basin. Use good quality concrete. Assure concrete surface is smooth.</p> <p>RDSO NOTIFICATION REQUIRED</p>
<p>Leakage in or Around Spillway</p>

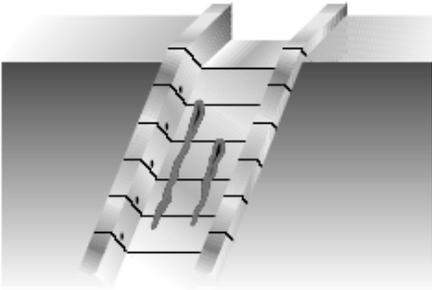
Problem	Probable Cause and Possible Consequences	Recommended Actions
<p>Too Much Leakage From Spillway Under Drains</p>

<p>Drain or cutoff may have failed.</p> <ol style="list-style-type: none"> 1. Excessive flows under the spillway could lead to erosion of foundation material and collapse of parts of the spillway. 2. Uncontrolled flows could lead to loss of stored water. 	<ol style="list-style-type: none"> 1. Examine exit area to see if type of material can explain leakage. 2. Measure flow and check for erosion of natural materials. 3. If flow rate or amount of eroded materials increases rapidly, reservoir level should be lowered until flow stabilizes or stops. 4. A qualified engineer should inspect the condition and recommend further actions. <p>RDSO NOTIFICATION REQUIRED</p>
<p>Seepage From a Construction Joint or Crack in Concrete Structure</p>

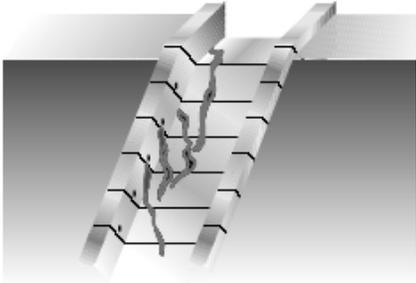
<p>Water is collecting behind structure because of insufficient drainage or clogged weep holes.</p> <ol style="list-style-type: none"> 1. Can cause walls to tip in and over. Flows through concrete can lead to rapid deterioration from weathering. 2. If spillway is located within embankment, rapid erosion can lead to failure of the dam. 	<ol style="list-style-type: none"> 1. Check area behind wall for puddling of surface water. 2. Check and clean as needed; drain outfalls, flush lines and weep holes. 3. If condition persists, a qualified engineer should inspect the condition and recommend further actions. <p>RDSO NOTIFICATION REQUIRED</p>

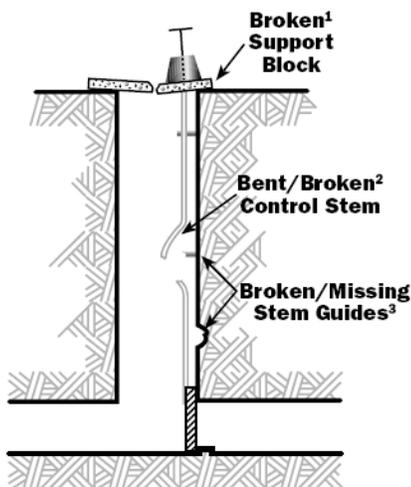
Control Works

- 1. BROKEN SUPPORT BLOCK** Concrete deterioration. Excessive force exerted on control stem by trying to open gate when it was jammed. Causes control support block to tile; control stem may bind. Control head works may settle. Gate may not open all the way. Support block may fail completely, leaving outlet inoperable.
- 2. BENT/BROKEN CONTROL STEM** Rust. Excess force used to open or close gate. Inadequate or broken stem guides. Outlet is inoperable.
- 3. BROKEN/MISSING STEM GUIDES** Rust. Inadequate lubrication. Excess force used to open or close gate when jammed. Loss of support for control stem. Stem may buckle and break under normal use (as in this example).

Any of these conditions can mean the control is either inoperable or, at best, partly operable. Use of the system should be minimized or discontinued. If the outlet system has a second control valve, consider using it to regulate releases until repairs can be made. Engineering help is recommended.

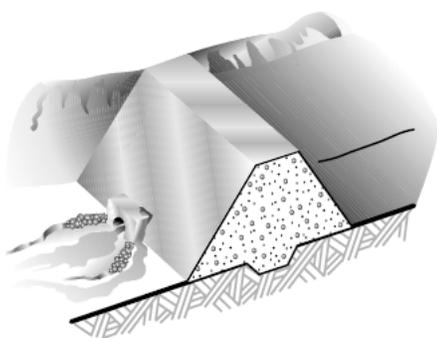
Seepage Water Exiting From a Point Adjacent to the Outlet

1. A break in the outlet pipe.
 2. A path for flow has developed along the outside of the outlet pipe.
- Continued flows can lead to erosion of the embankment materials and failure of the dam.

1. Thoroughly investigate the area by probing and/or shoveling to try to determine cause.
2. Determine if leakage water is carrying soil particles.
3. Determine quantity of flow.
4. If flow increases or is carrying embankment materials, reservoir level should be lowered until leakage stops.
5. A qualified engineer should inspect the condition and recommend further actions.
6. Investigate if there are any signs of settlement or sinkholes on the embankment along the alignment of the spillway pipe.

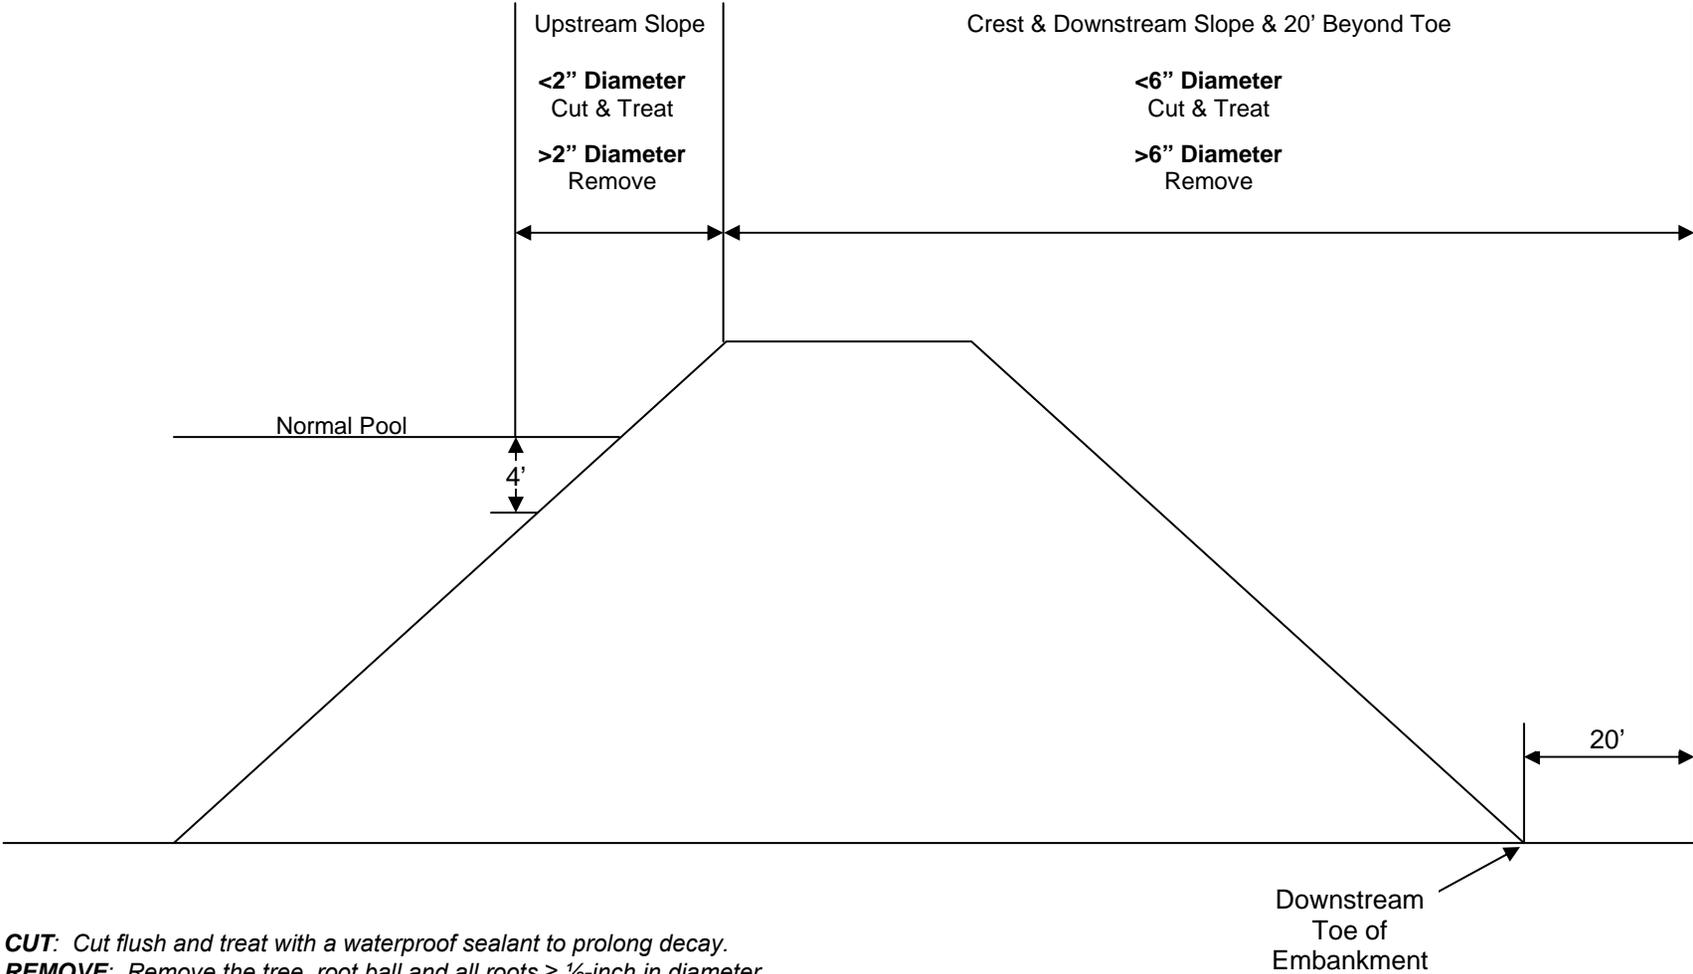
Fish and Wildlife Service Tree Removal Guidelines

CUT: Cut flush and treat with a waterproof sealant to prolong decay.
REMOVE: Remove the tree, root ball and all roots \geq 1/2-inch in diameter

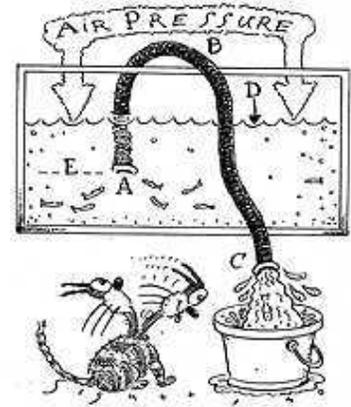
Figure 1

The crest height at which a siphon will successfully operate (point B in Figure 1) is limited by the effective atmospheric pressure and the fluid density of the reservoir. Theoretically, for water at standard atmospheric pressure in a vacuum, the maximum crest or “lift” height obtained is about 33 feet. A reservoir filled with mercury would limit this crest height to about 30 inches. However, in “real world” applications water typically begins to vaporize at lift heights approaching 20 feet, and for every 1,000 feet in elevation above sea level, the reduction in atmospheric pressure results in a decrease to the lift height of about 1 foot. This combined with the fact that a perfect vacuum cannot be obtained in field applications and minor air leaks will undoubtedly exist, the typical lift height is usually limited to about 15 feet.

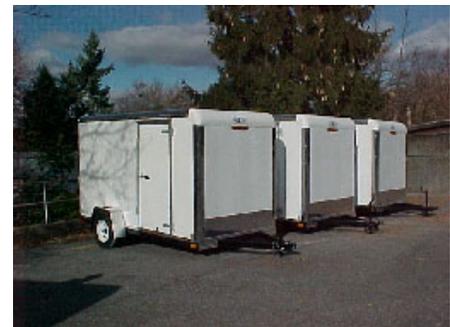
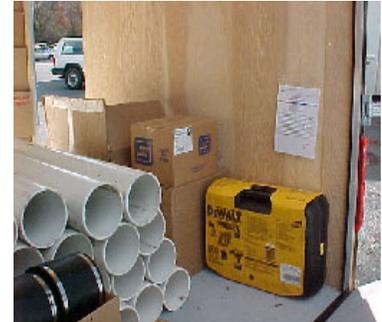
Siphon Equipment

- 6-foot by 12-foot cargo utility trailer
- 3.5 horsepower 2-inch diameter gasoline powered trash pump

- 6-inch diameter Schedule 40 pvc pipe (cut to 10-foot lengths)
- rubber Fernco[®] fittings for 6-inch diameter pipe
- assorted 6-inch diameter fittings and elbows
- battery powered cordless tool kit (drill, saw, etc.)
- assorted hand tools (pipe wrench, hammer, pliers, etc.)
- pad locks for trailers
- pvc cleaner and glue
- gas can and oil for trash pump
- personal protective equipment (gloves, goggles, etc.)
- reinforcing bars / steel stakes for anchoring siphon
- vehicle to pull trailer and associated hitching equipment

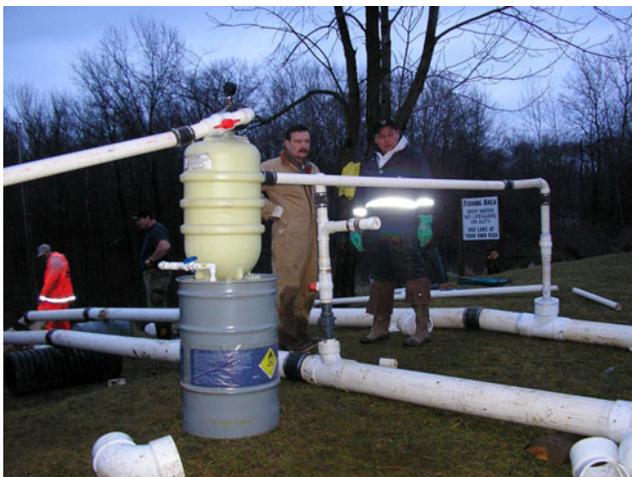
Using a Vacuum Pump

section containing a threaded plug must be placed within the crest section of the siphon. In place of threaded plugs shut off valves could be used; however these can be costly items to purchase. The second method replaces the trash pump with a vacuum pump. The vacuum pump is connected to the siphon at the crest section. As a vacuum is induced inside the siphon, water is pulled from the reservoir up the upstream leg of the siphon, and ultimately fills the downstream leg as the air is removed. Once the entire siphon is filled with water, a valve is closed at the vacuum pump connection and the discharge end of the siphon is opened. Using this method requires electricity to operate the vacuum pump, and therefore a generator should be included with the setup. Since this entire operation will take place around or in water, extreme caution should be taken when using electricity. In addition to the generator, an intermediate collection container must be placed between the vacuum pump and the siphon to prevent water from entering the electric vacuum pump.

As can be seen in the above photos, the use of the vacuum pump is more complicated and requires a great deal of small diameter pipe connections, fittings, and increased setup time.

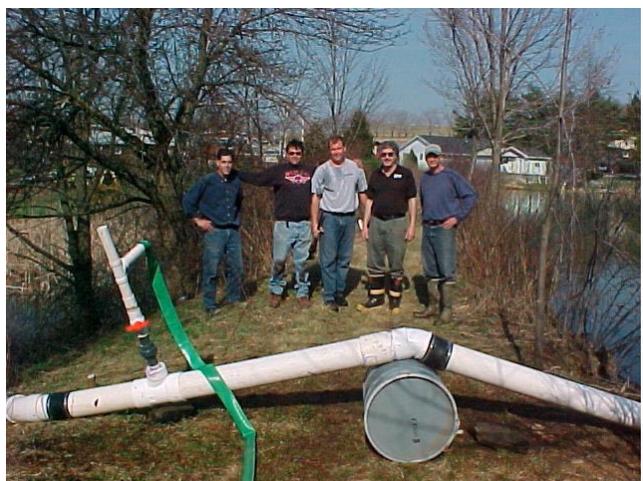
Using a Trash Pump

The section used across the crest should incorporate a means of “priming” the siphon. There are two main methods that have proven useful to prime an emergency siphon. The least complicated method is to use a trash pump to fill the downstream leg of the siphon with water. In order to do this, a threaded plug must be placed on the discharge end, and a tee

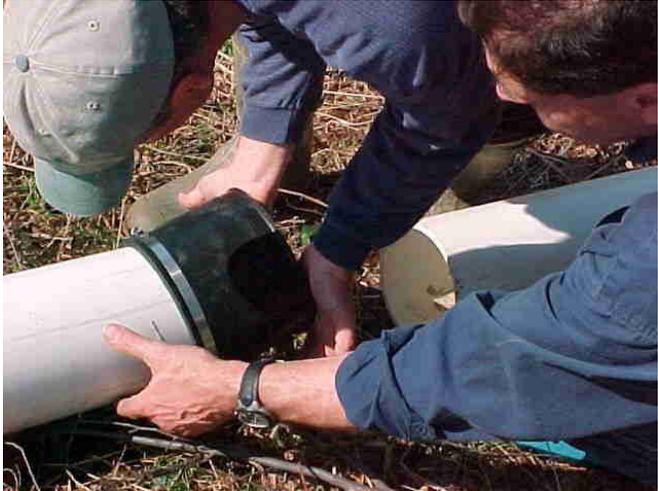
Connecting Straight Sections

The straight 10-foot long sections of pipe should be connected using the rubber Fernco[®] fittings. These fittings contain metal tightening bands on each end and are connected by turning the adjusting screw clockwise. The battery-powered drill, with the appropriate attachment, can be used to tighten these bands. The interior surface of the Fernco[®] fitting and the exterior surface of the pvc pipe must be clean and free of debris. Any type of dirt can cause a bad seal and reduce the effectiveness of the siphon. The pipe can be adjusted within the Fernco[®] fittings to make a tight straight connection or allow a small amount of movement resulting in an adjustable elbow connection. The tight straight connection is accomplished by butting the two ends of the pipe against each other within the fitting and tightening the metal bands. This action provides a minimal amount of open space between the two sections of pipe, which ultimately locks the pipes together. If open space is left within the center of the fitting, the two sections of pipe can move until they butt against each other. This adjustable elbow connection can be very useful for uneven terrain or small alignment changes.
