Crisis Management: Dealing with Massive Underflows in Karstic Limestone

Dr. Donald A. Bruce

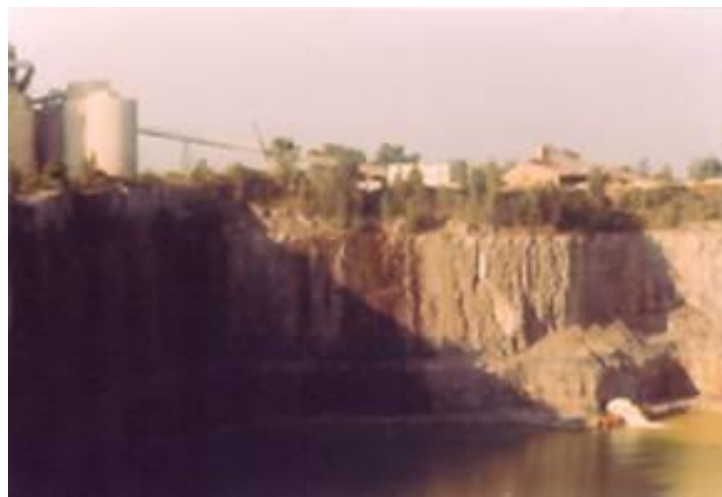
Sudden development of large flow (over 30,000gpm) through karst into the base of an operational quarry. Nearby river provides infinite source and driving head of over 300-feet.
